Virginia Department of
Behavioral Health &
Developmental Services

Preplanning Study

Central State Hospital Full Replacement 2018

December 1, 2018 rev.1

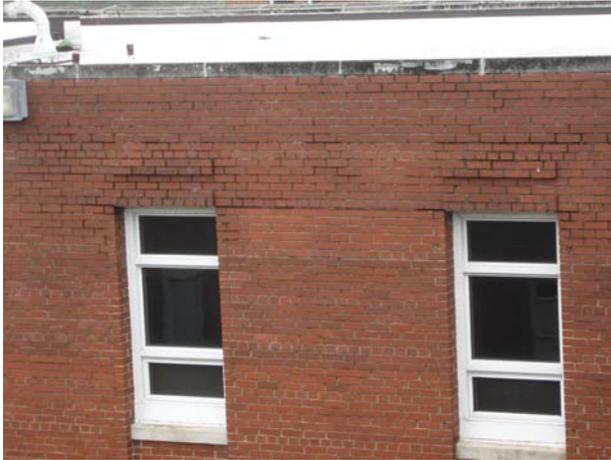
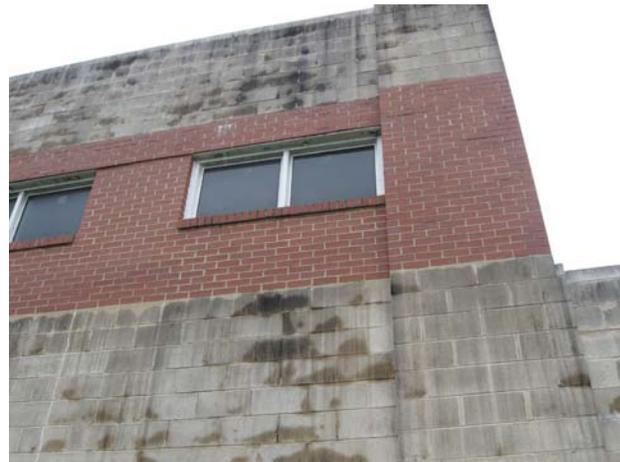
The poor physical condition of Building 39 is jointly affected by its age, its dated construction, limited funding for maintenance, and its services for forensics patients. The housing of residents who have been determined by the judicial system to be criminally insane indicates the type of physical restraint required of this type of facility, the need to withstand severe physical abuse, and provide physical means of protection for both residents and staff. The facility interiors and exterior recreation areas reflect these conditions.

These photos depict the building's failing exterior wall conditions. The photos on the left show damaged masonry. The photos on the right show severe moisture damage.

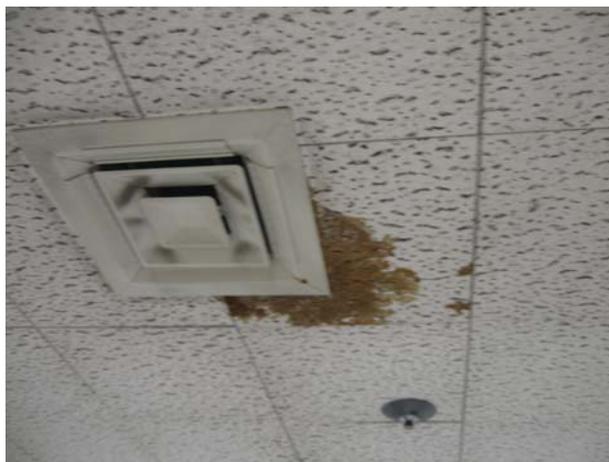
Interior ceiling damage due to duct insulation failure

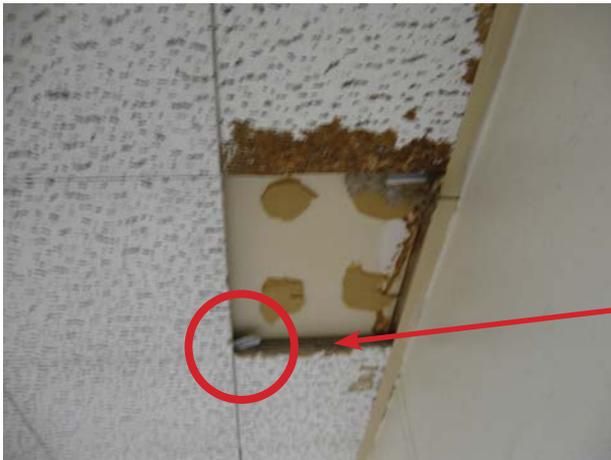
Interior ceiling damage due to duct masonry failure

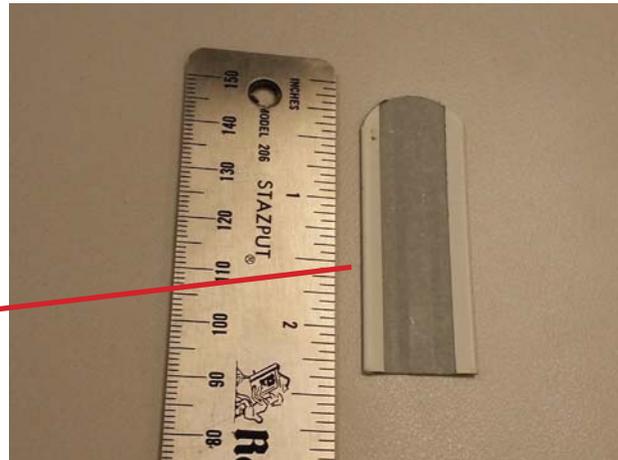
Close-up of metal strip in ceiling

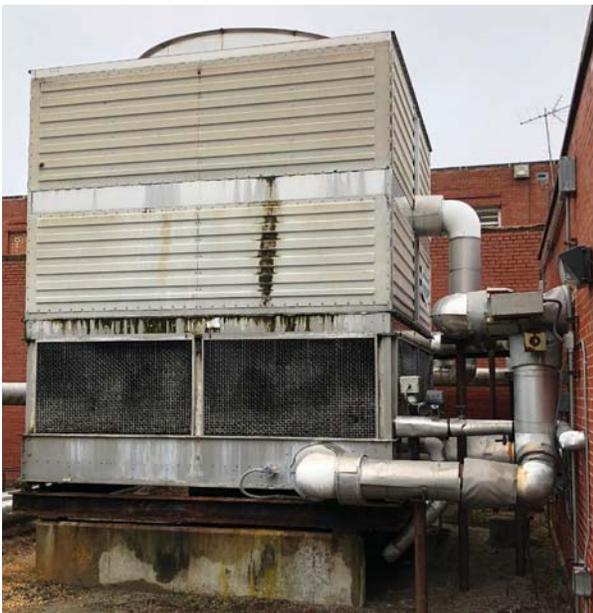
Cooling tower is in failing condition, as evidenced by leaks and algae growth

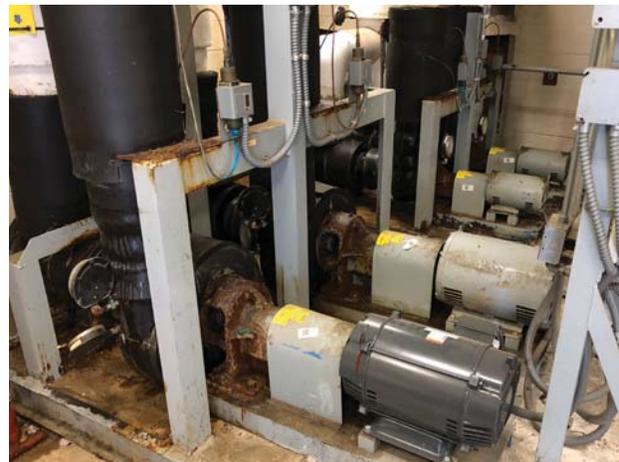
Chilled water pumps show signs of rust

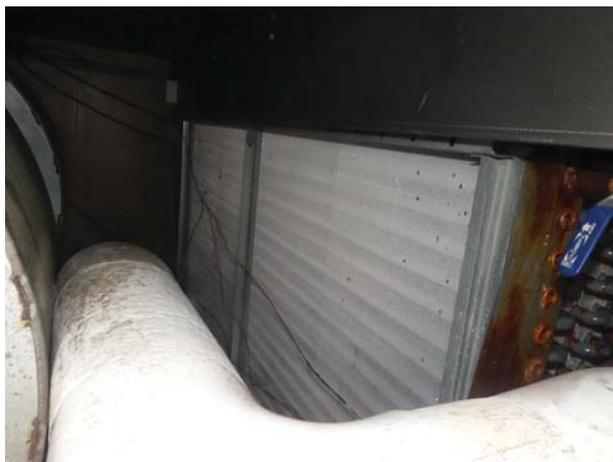
Inside one of the old roof top air handling units. The end of the chilled water coil is showing signs of rust and deterioration

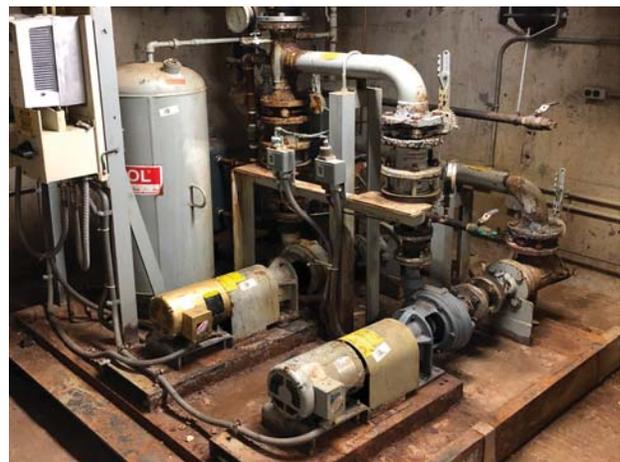
Hot water pumps and piping show visible signs of rust and deterioration

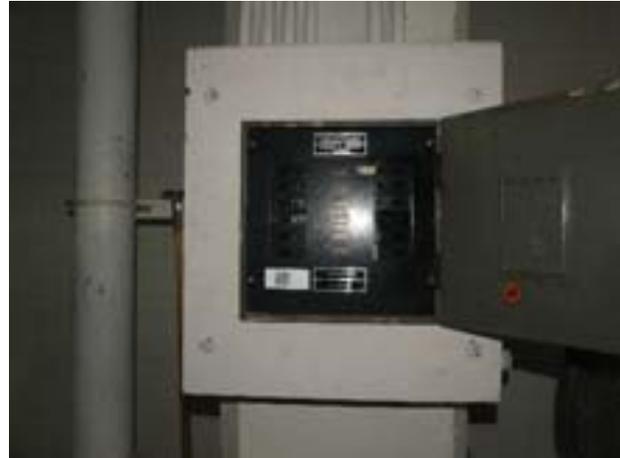
Most of the interior distribution panels have reached the end of their serviceable life and replacement parts are no longer available.

Existing interior distribution panels

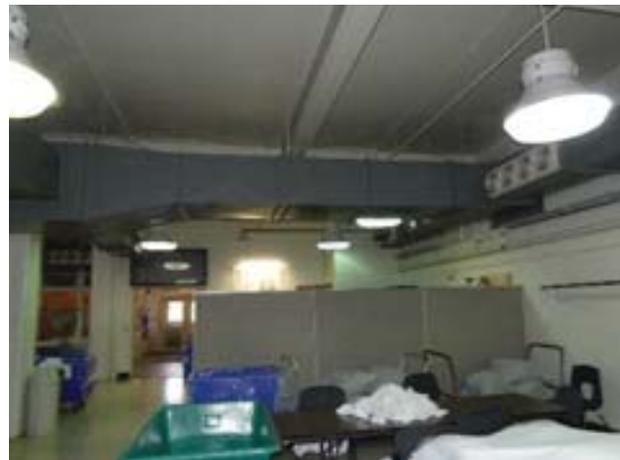
The interior lighting system does not meet today's emergency egress lighting requirements. Additional battery egress fixtures should be added to the main working areas.

Building interior lighting system

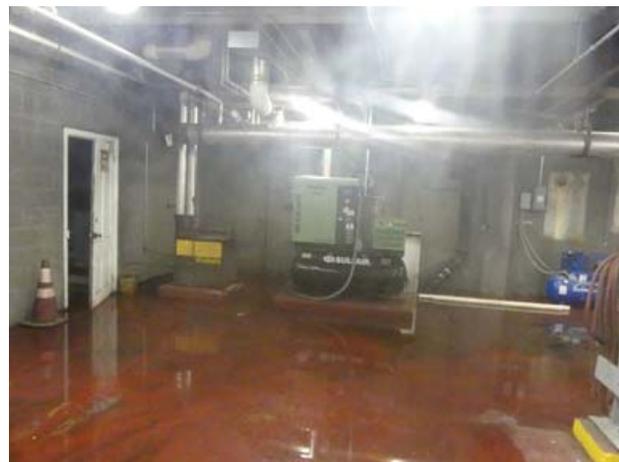
Flooded basement

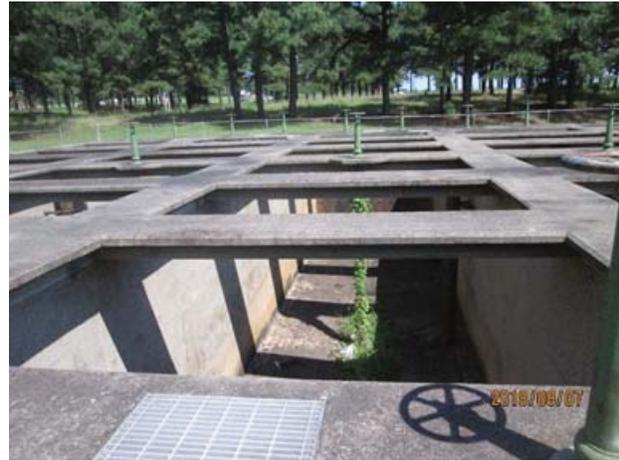
- The water treatment plant equipment (pumps, valves, piping, storage tanks, and open pits) remain and are abandoned.
- This area is surrounded by a four-foot-high fence, which is open at the top and provides limited access and protection. It is also a safety hazard.

Abandoned open tanks

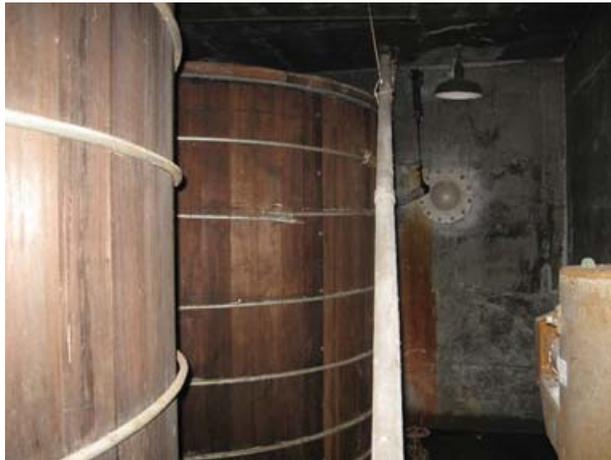
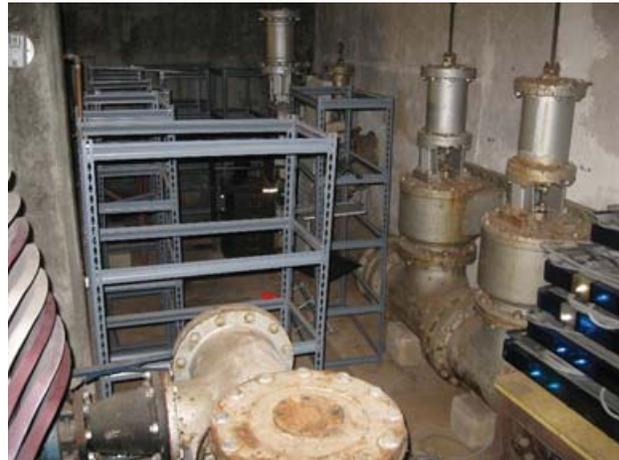
The first floor still contains the equipment used when the building served as the water treatment plant. A very large clean water wood tank is on the first floor. Open floor pits present a safety hazard. Scrape, patch, and paint all interior walls.

Abandoned equipment from water treatment plant

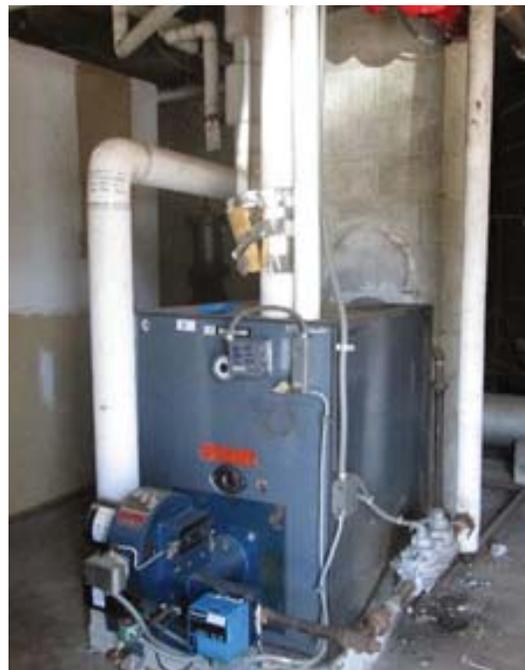
The boiler has exceeded its median life expectancy. It should be replaced in the next two years with a high-efficiency, condensing gas fired boiler. One of the pumps appears in fair condition and should last several more years with routine maintenance. The other pump appears much older and will likely need to be replaced in the next year.

Hot water heating boiler system

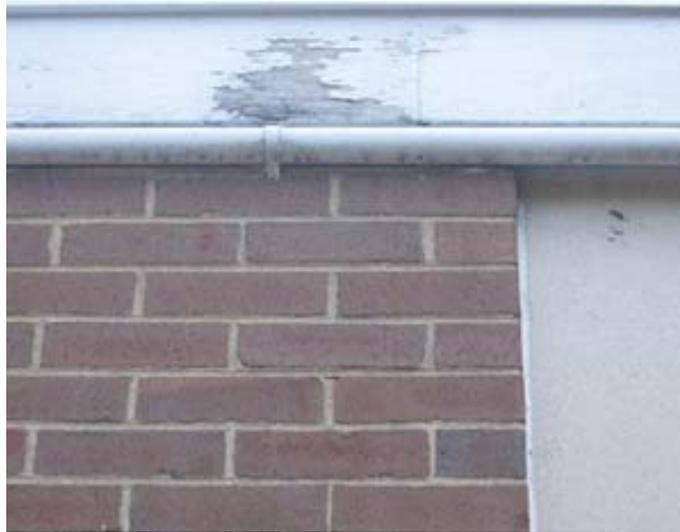
- The fascia board below the newly added gutters has peeling paint and exposed wood. Scraping, priming, and painting with a high quality exterior paint is required immediately.
- Some of the brick shows signs of water damage near areas where the down spouts output water on the splash blocks. Areas of concrete paving near the downspouts appear to have spalling and staining issues. De-icers may have contributed to the condition of the exterior concrete.

Exterior damage condition

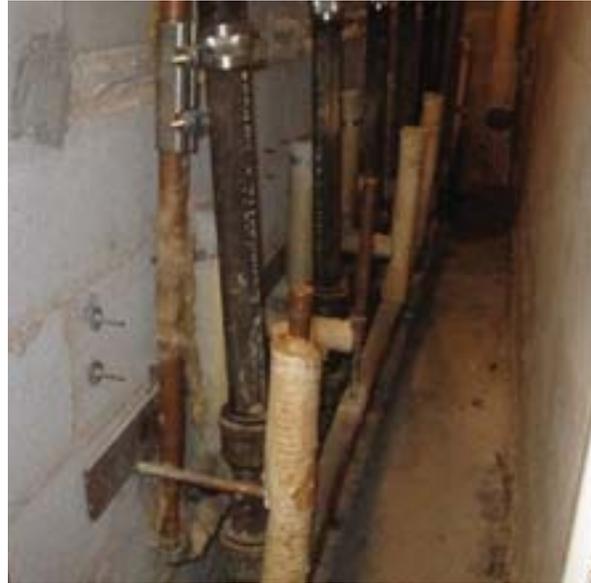
Plumbing chase with dead end service lines. Concerns for Legionella bacterial development in this type of condition

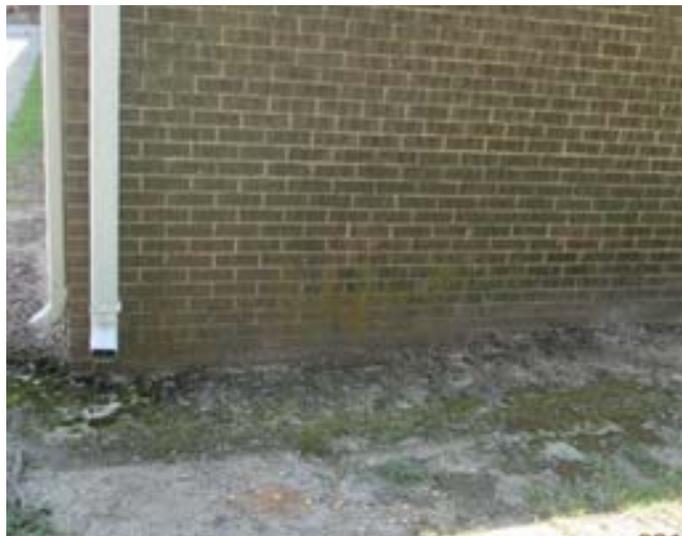
- The existing roof is relatively new. The new gutters on the low sloped roof appear to be undersized for heavy rainfall. Water overshoots the gutters in heavy rains.

Site drainage concerns noted typically around the building

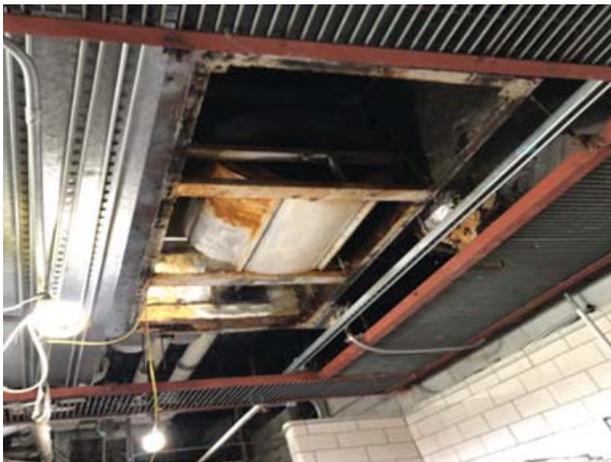
Indoor air handling unit disassembled and nonfunctional

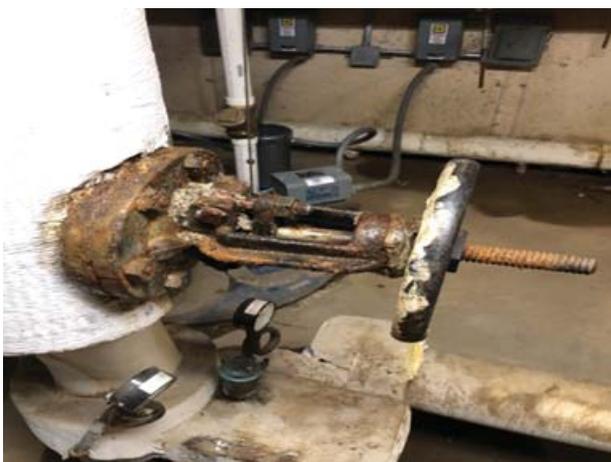
Corroded chilled water valve

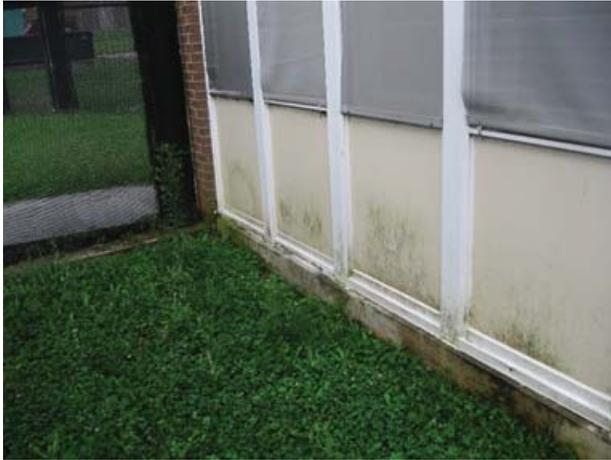
Mold and damaged foundation wall

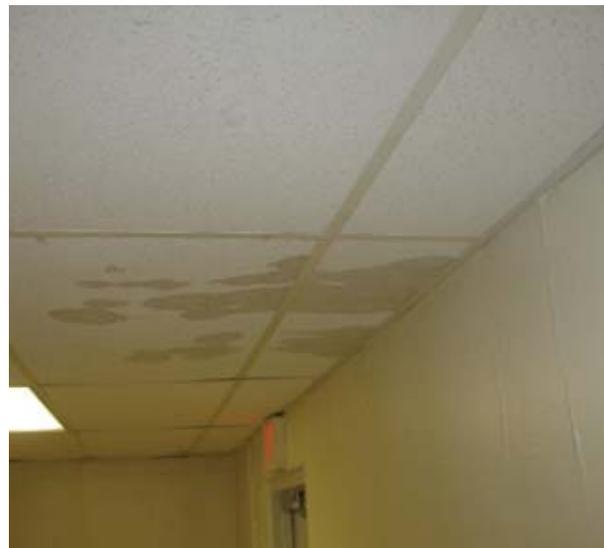
Typical condition throughout the building, water staining on ceiling tile
