**REPORT OF THE  
VIRGINIA DEPARTMENT OF GAME AND  
INLAND FISHERIES ON**

**TECHNICAL ALTERNATIVES  
ANALYSIS TO PROVIDE FISH  
PASSAGE AT EMBREY DAM**

**SENATE DOCUMENT NO. 18**

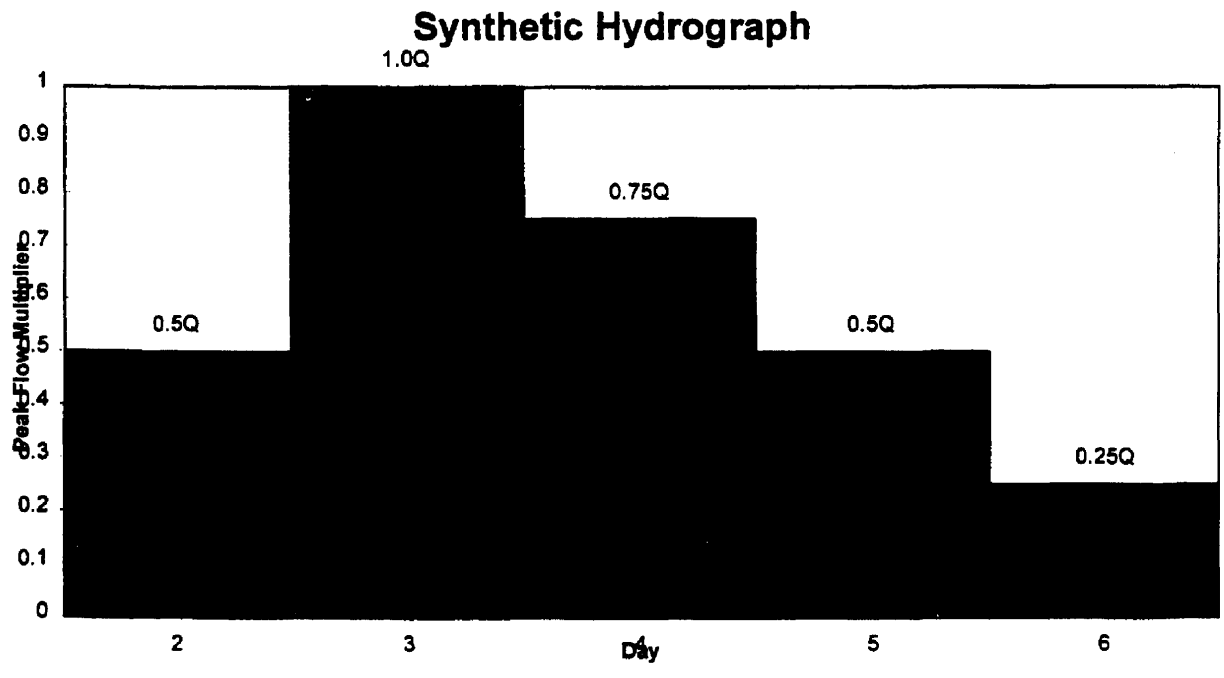
**Figure 2. General Shape of Synthetic Hydrograph**

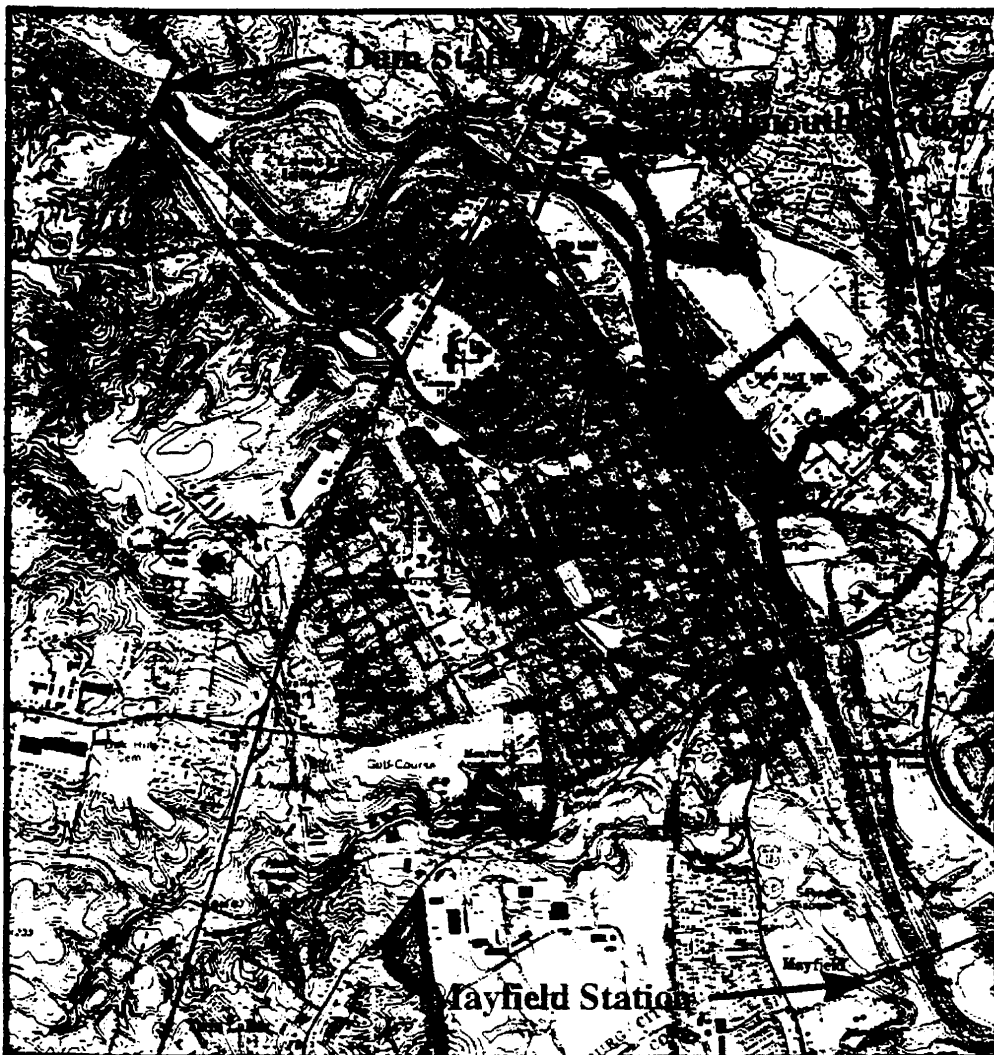
**Exhibit A - Location of Stations used in Model**
