# HARVELL DAM FISHWAY ALTERNATIVES ASSESSMENT

November 30, 2011

VIRGINIA DEPARTMENT OF GAME AND INLAND FISHERIES  
4010 WEST BROAD STREET  
RICHMOND, VIRGINIA 23230

***Gannett Fleming***

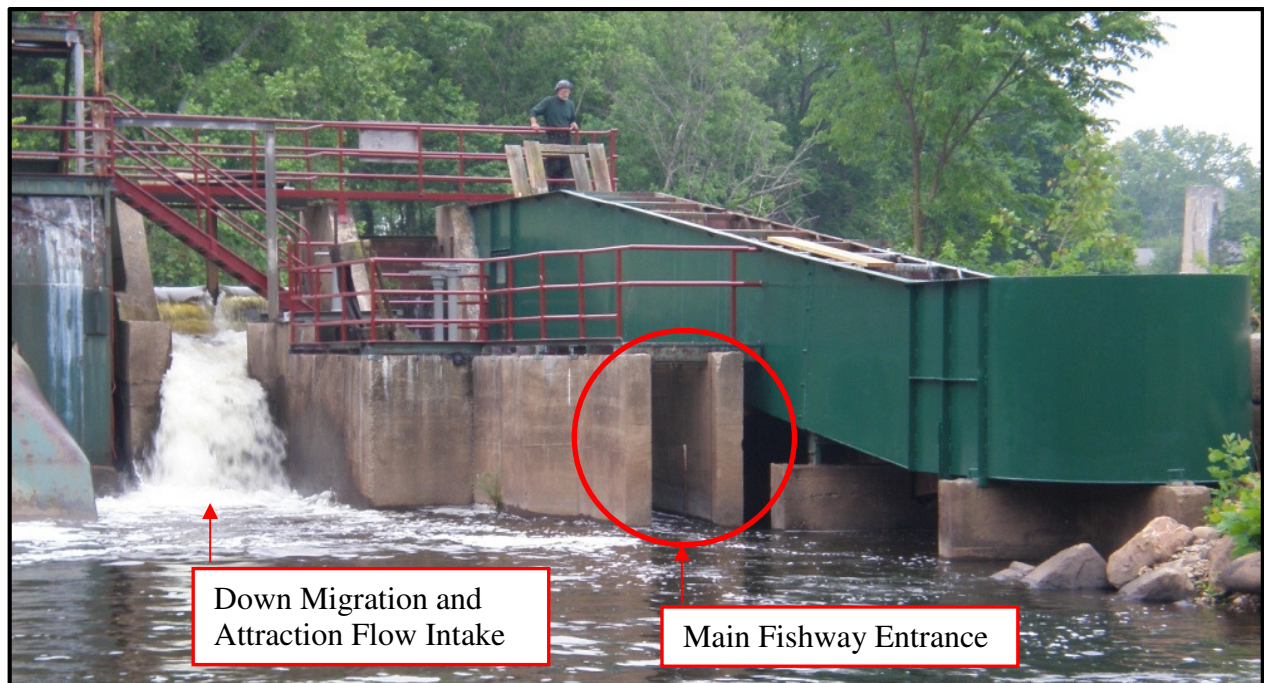
**Figure 2 Main (Lower) Fishway Entrance in Siphon Tailrace**

The Denil fishway has two separate fish entrance locations. The main (lower) entrance is located in the siphon turbines tailrace (refer to Figure 2). This entrance is intended to work in conjunction with the siphon turbines which can pass 300 cfs. The flow from the turbines is intended to attract upstream migrating fish into the siphon tailrace. The main fishway entrance is 2.5 feet wide and flow conditions immediately inside the entrance are controlled by manually adding or removing stop logs. This entrance is influenced by tidal flow.

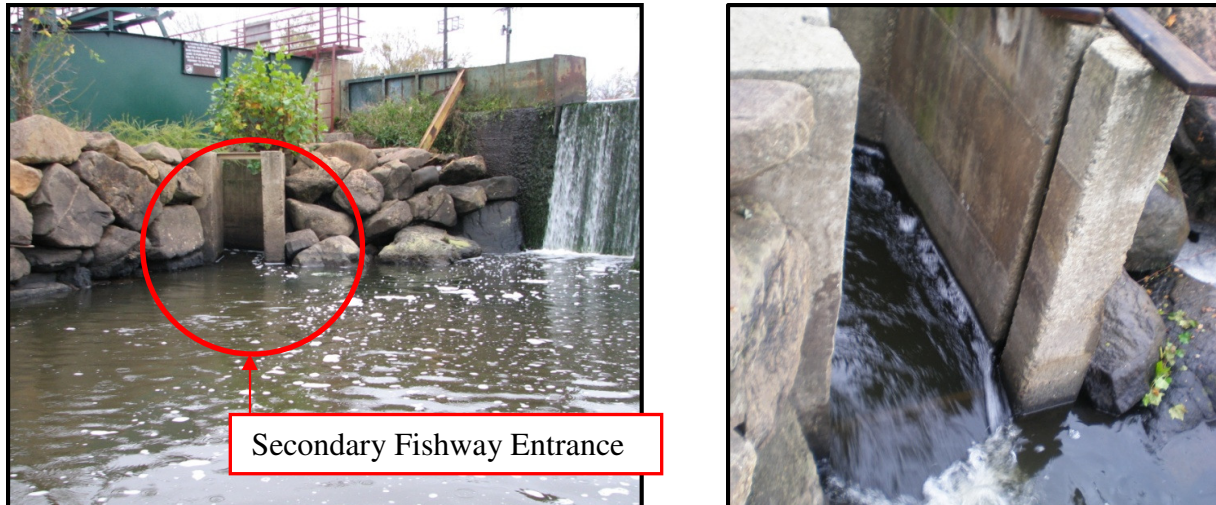
**Figure 3 Secondary (Upper) Fishway Entrance at Right Abutment of Spillway**

The second (upper) fish entrance is located adjacent to the dam spillway and is intended to operate when the river flows exceed 370 cfs. This entrance is also 2.5 feet wide. Flow conditions immediately inside the entrance are controlled by manually adding or removing stoplogs. This entrance is higher in elevation than the main entrance and is not influenced by tidal flow. A steel spillway barrier structure is present on top of the dam spillway immediately upstream of the second fish entrance. The purpose of the steel barrier is to create a calm black-water area immediately in front of the second fish entrance. Figure 3 provides a photograph of the secondary spillway entrance. The photo on the left shows the secondary entrance and the

steel spillway barrier on top of the dam. The right photo (taken on May 11, 2011) shows a close-up of the secondary entrance. The vertical stop log slot is visible immediately inside the entrance and several wooden stop logs which have been removed from the slot are sitting on top of the structure.

For low flow conditions in the Appomattox River (river flows less than 380 cfs), the secondary (upper) fishway entrance adjacent to the dam spillway (see Figure 3) is closed, leaving the main (lower) fishway entrance in the siphon tailrace (see Figure 2) as the only active entrance under these flow conditions. One or both of the siphon turbines will be in operation (each siphon turbine having the capability to pass 150 cfs) and the main powerhouse will remain closed. Approximately 15 cfs will enter the Denil fishway through the fishway exit channel. Excess flow will pass through either the downstream migration flow opening, which also serves as the attraction flow intake, or over the dam crest (a minimum flow of 10 cfs is to pass over the dam crest at all times). The attraction flow system is capable of adding up to 15 cfs to the fishway outflows. From June 1<sup>st</sup>

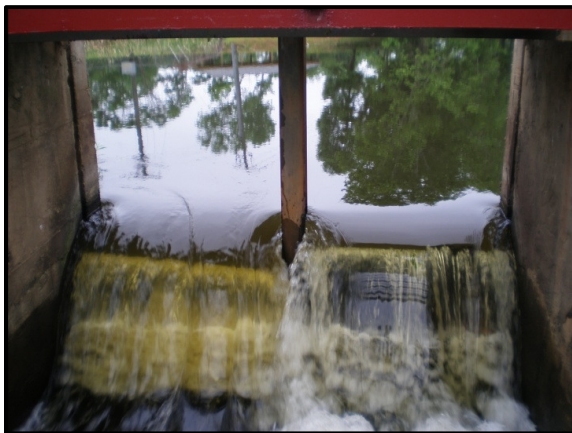
**Figure 4 Photo of Attraction Flow Inlet from Reservoir**

The Denil fishway includes a supplemental attraction flow system to attract fish into both the lower and upper fishway entrances. This system is also used for downstream migration of juvenile fish. The attraction flow system consists of two four-foot-wide stop log bays (refer to Figure 4) that allow water from the reservoir to pass over a wedgewire screen. Water passing through the wedgewire screen drops into a three-foot-wide channel where the flow can be distributed to Attraction Flow Chamber Nos. 1 and 2. Flow to each chamber can be controlled by one of two gates (refer to Figure 5). Attraction Flow Chamber No. 1 supplies flow to the main entrance in the siphon tailrace and Attraction Flow Chamber No. 2 supplies flow to the secondary entrance adjacent to the dam spillway.

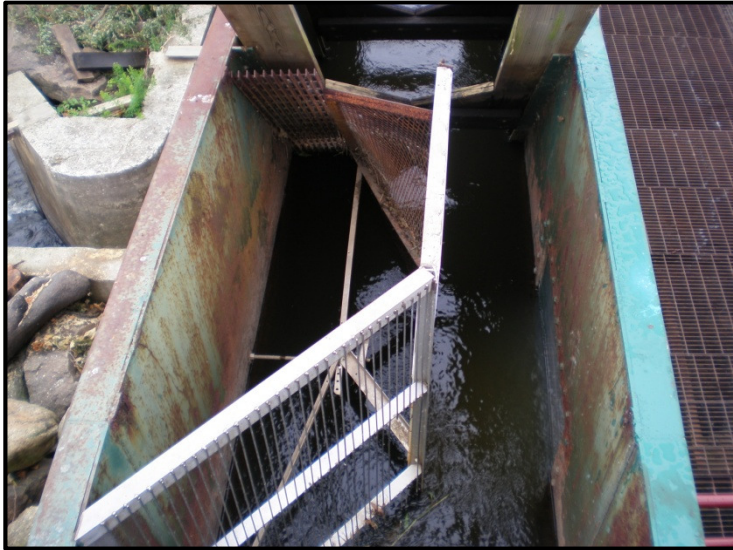
Figure 8 Photo of Crowder

A crowder and viewing window are located at the upper end of the fishway near the fishway exit for the purpose of counting fish and evaluating the performance of the fishway. The crowder consists of a metal frame with vertical bars which forces the fish to swim close to the window. Numerous modifications to the crowder are apparent in the form of dissimilar screen materials. The viewing window is made of Plexiglas which allows for viewing of the fish passing through the facility. Photos of the crowder and counting window are presented in Figures 8 and 9, respectively.

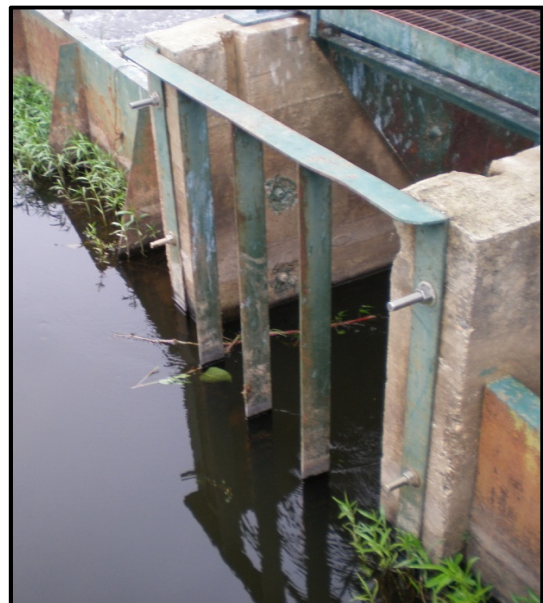
Figure 10 Photos of Denil Fishway Exit Into the Reservoir

The exit or upstream end of the fishway is connected to the reservoir pool at the upstream face of the existing dam immediately adjacent to the siphon turbines. The 4 foot wide exit channel is equipped with a steel trashrack to prevent large floating debris from entering the fishway. A photo of the fishway exit is presented in Figure 10.

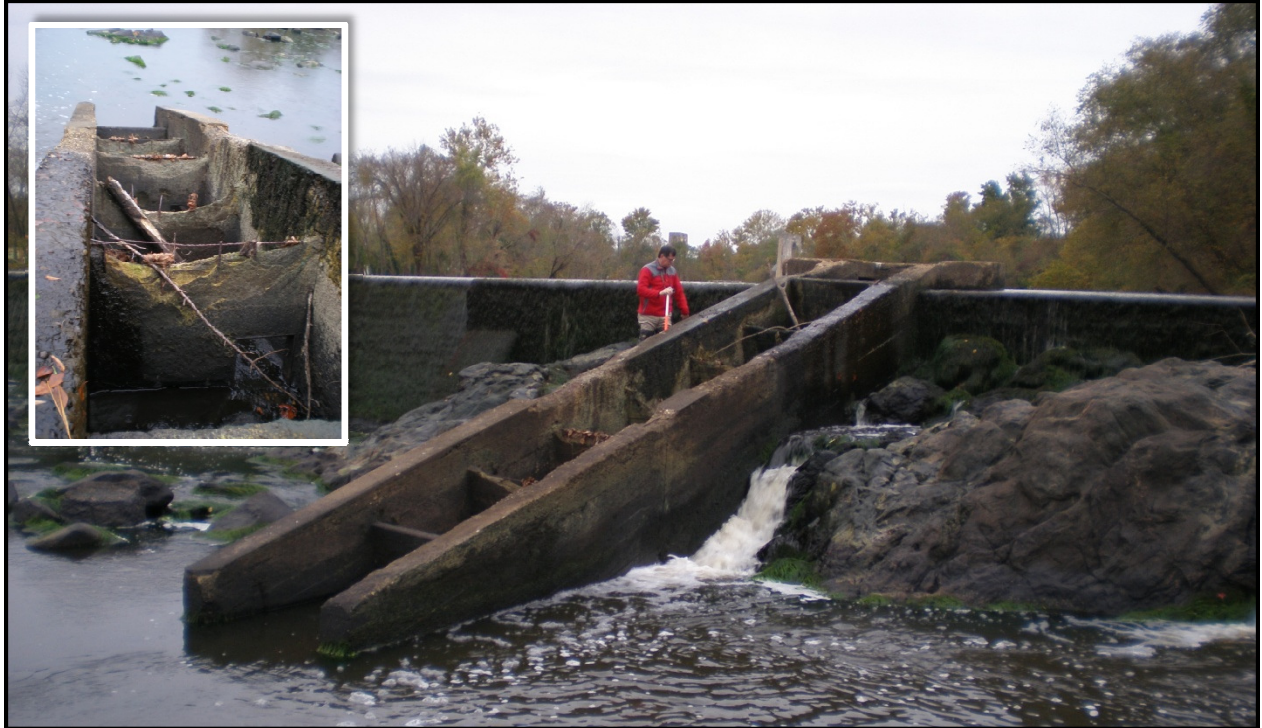
**Figure 13 Pool and Weir Fishway near Center of Dam**

An abandoned pool and weir fishway is located near the center of the dam. A photo of the pool and weir fishway is presented in Figure 13. The original construction date of this fishway is unknown. The pool and weir fishway was observed during a site visit on October 28, 2011. The fishway is located on the downstream face of the dam and is formed by two sloping concrete walls. These concrete walls are spaced approximately four feet apart, are four feet in height and are aligned parallel to the river. Perpendicular concrete walls within the pool and weir fishway (spaced approximately 4.5 feet apart, three feet in height and two inches thick) divide the structure into a series of six pools. Each perpendicular wall contains a square orifice (approximately 13 inches by 13 inches) at the base of the wall. The orifice locations alternate from the bottom left to the bottom right side of each adjacent wall. These orifices are intended to allow upward fish movement. A U-shaped concrete structure was visible at the exit (upstream end) of the pool and weir fishway. The majority of this upstream structure was submerged by the reservoir pool and unable to be viewed.

The perpendicular walls within the pool and weir fishway were observed to be deteriorating. Several of the walls were missing the top six to nine inches of concrete and the steel

reinforcement bars were exposed in many areas. Woody debris was observed within the fishway and the square orifice in the upper pool appeared to be sealed shut with a steel plate. Consequently, the pool and weir fishway was not operational at the time of this inspection.

Based on visual observations, the pool and weir fishway contains several deficiencies that prevent this structure from effectively passing the target species of fish. These deficiencies include the following:

- The high velocities through each orifice create a highly turbulent condition within each pool. These conditions are not favorable for passing American shad (*Mudre, Ney & Neves, 1985*).

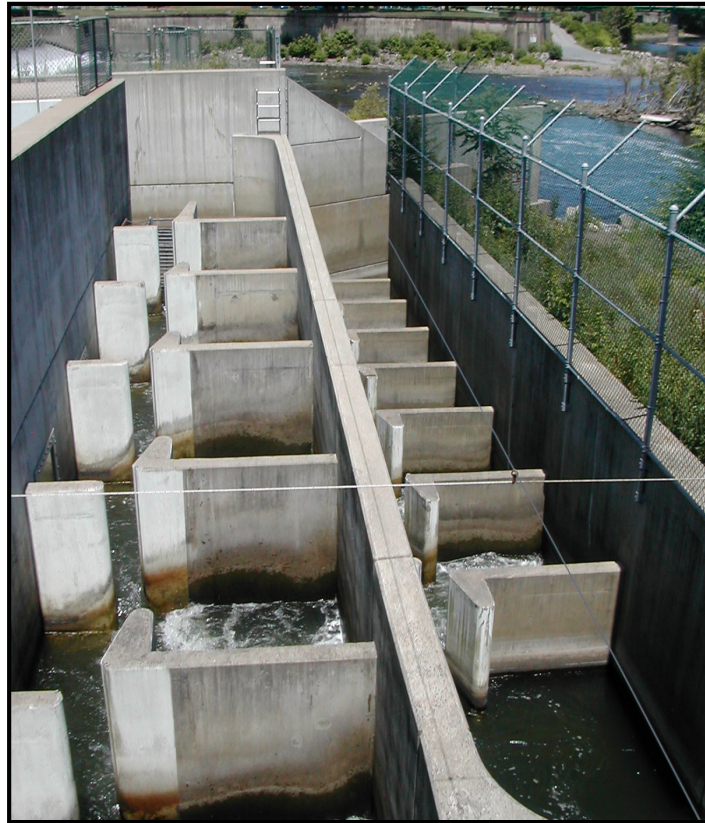
**Figure 15 Vertical Slot Fishway at Easton Dam on the Lehigh River, PA**

The vertical slot fishway is a common pool-type fishway for passing high volumes of fish and are typically used on large rivers like the Appomattox River. The vertical slot fishway at Easton Dam shown in Figure 15 is one of two vertical slot fishways constructed on the Lehigh River in Pennsylvania. The drainage area of the Lehigh River at Easton Dam is 1,345 square miles which is similar to the 1,359 square mile drainage area at Harvell Dam.

Like the Denil fishway, the vertical slot fishway contains a fish entrance with a supplemental attraction flow system. The body of the fishway consists of pools which are sized to accommodate the design fish population. Each pool is essentially a resting pool that contains a vertical slot that controls water flow between pools. Each pool generally rises 7 to 10 inches in elevation from the pool below and the pools continue until the required elevation difference between the downstream tailwater and the upstream reservoir has been overcome.

For Harvell Dam, a single vertical slot fishway is a viable option for passing the target population of fish species provided adequate attraction flow can be obtained to attract fish into the fishway. The vertical slot fishway could be located on the left abutment of the dam to work in combination with the existing Denil fishway or the vertical slot fishway could replace the existing Denil fishway. The Virginia Department of Game and Inland Fisheries reports that the existing vertical slot fishway at Boshers Dam on the James River has a properly designed attraction flow system and that the fishway has been successful in passing a wide range of fish. At least 23 species of fish, including American shad, have been reported passing through the Boshers Dam vertical slot fishway.

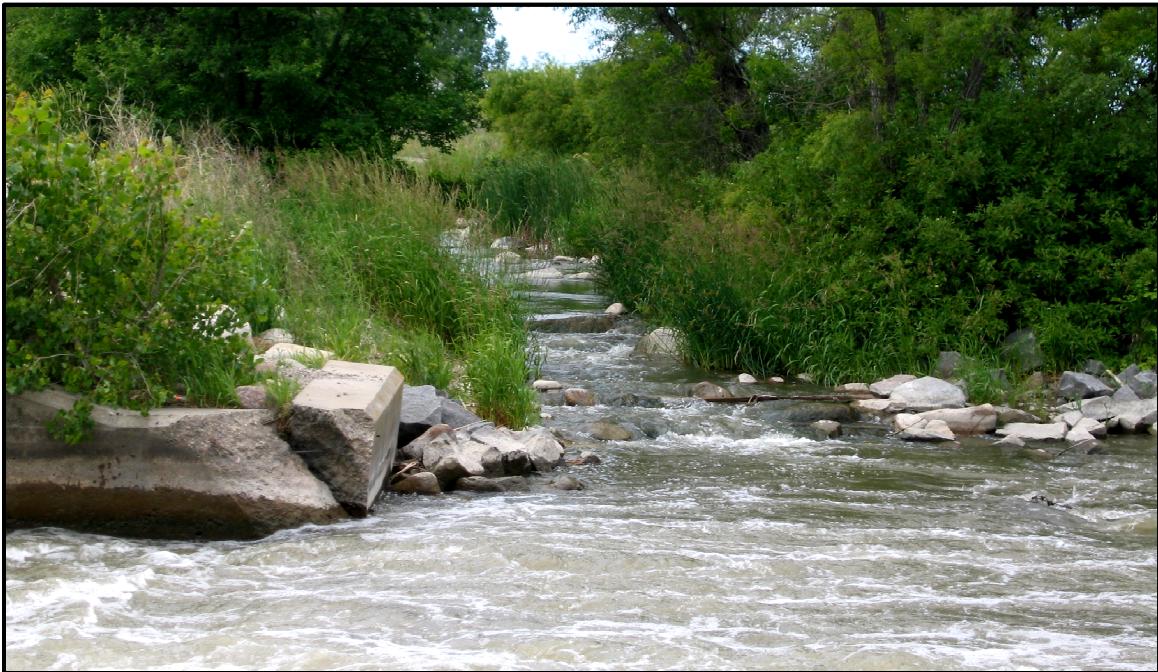
**Figure 16 Nature-Like Bypass Channel (Photo courtesy of Dr. Luther Aadland)**

The bypass channel fishway involves the construction of a channel through or around the dam embankment that connects the reservoir to the immediate tailwater below the dam. These channels emulate naturally occurring streams within the surrounding watershed and provide a means for up migrating fish to bypass a manmade impediment such as a dam. This fishway requires sufficient land to be available immediately adjacent to the reservoir for locating the by-pass channel. Consequently, space limitations and topography often prohibit the use of a by-pass channel, especially in developed areas.

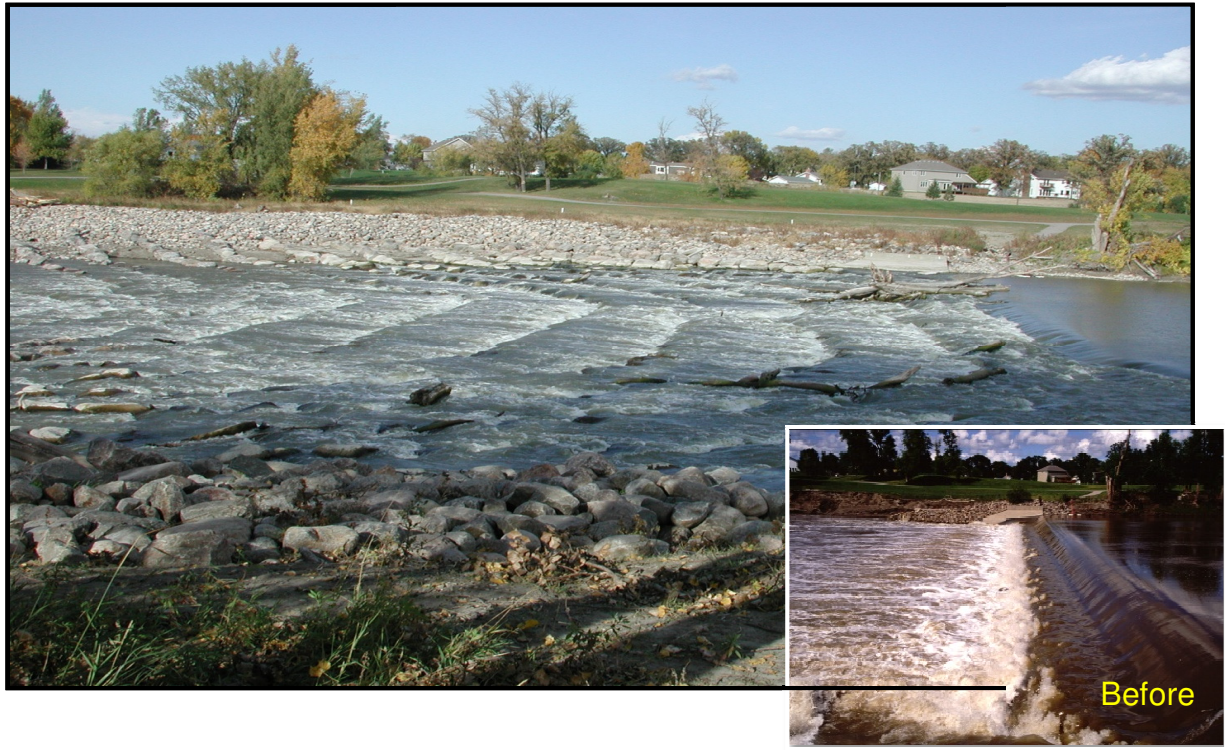
**Figure 17 Before and after Photos of Rock Ramp Fishway Constructed at Riverside Dam (Photos courtesy of Dr. Luther Aadland).**

The rock ramp fishway involves placing a wedge of rock fill material immediately below the dam to create a passable slope over the dam. This facility is well suited for low head dams and is typically contained within the bed and banks of the watercourse. As a result, land acquisition is typically not required. The infill material is typically large field stones or quarried rock infilled with gravel which provides habitat and over time becomes a living part of the river bed (Aadland, 2010). In addition to providing fish passage, the rock ramp fishway also effectively eliminates downstream scour and the dangerous hydraulic roller which is associated with drowning at many low head dams.

The rock ramp fishway appears to be a viable option for providing fish passage at the Harvell Dam. A conceptual layout and associated details of this facility are shown on Exhibits 3 and 4, respectively. The area below the dam would be infilled with large diameter boulders and graded to a flat slope (three percent slope is recommended). This slope would extend from the top of dam downstream until this slope intersects the existing river bed. The infill material would be graded such that the finished grade at the center of the river is slightly lower than at the edges of the river. This configuration would channelize flows towards the center of the river, creating variable flow regimes across the width of the rock ramp. Large weir stones would be placed on the contour to create a series of pools across the full width of the river. The weir stones would be strategically placed to create localized openings that allow migrating fish to pass through each weir. In the center of the river, the pools provided by each weir would be supplemented with small localized depressions that provide additional resting pools for migrating fish. The entire surface of the rock ramp fishway would be chinked with smaller diameter rock to form a smoother and less permeable surface.

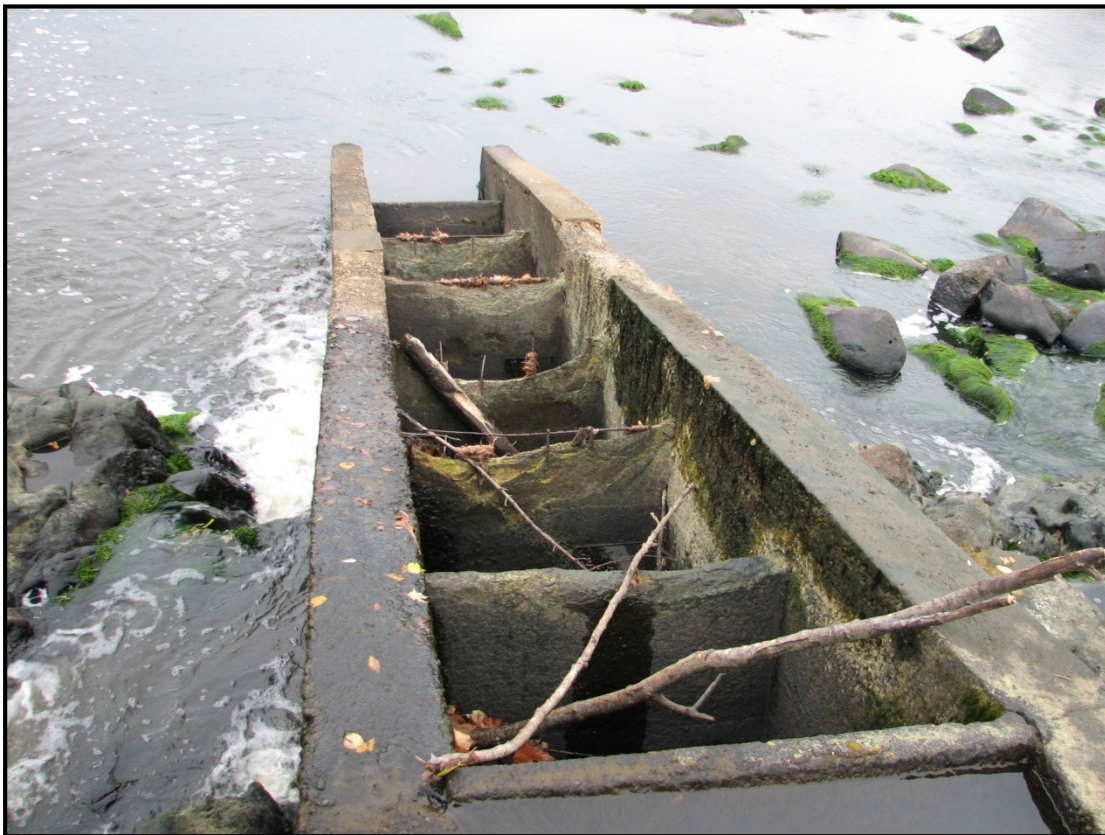
A pool and weir fishway exists near the center of the Harvell Dam. The fishway is formed by two sloping concrete walls parallel to the river. These concrete walls are spaced approximately four feet apart and are four feet in height. Perpendicular concrete walls within the pool and weir fishway (spaced approximately 4.5 feet apart, three feet in height and two inches thick) divide the structure into a series of six pools. Each perpendicular wall contains a square orifice (approximately 13 inches by 13 inches) at the base of the wall. The orifice locations alternate from the bottom left to the bottom right side of each adjacent wall.

The upper-most square orifice was observed to be sealed shut at the time of the site visit on October 28, 2011. Consequently, the pool and weir fishway was not in operation.

**Pool and Weir Fishway near Center of Harvell Dam**
