**REPORT OF THE VIRGINIA DEPARTMENT OF  
ENVIRONMENTAL QUALITY**

**Evaluation of Environmental  
Concerns in the Upper  
Reaches of Buchanan Creek**

# Evaluation of Environmental Concerns in Buchanan Creek

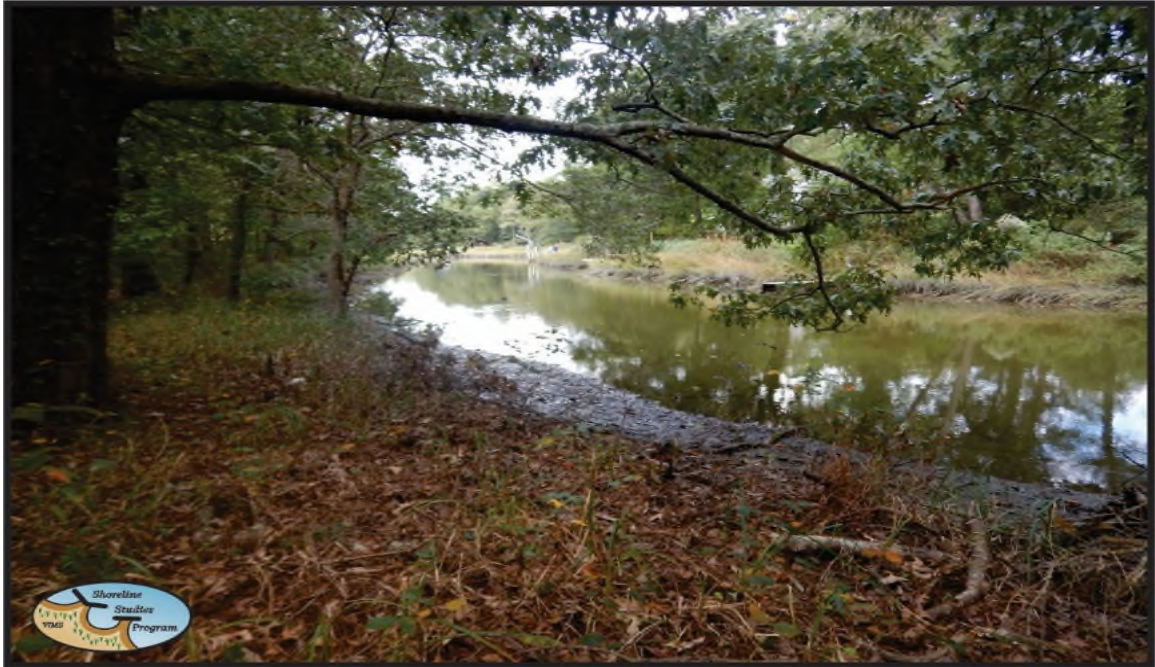
**Figure 1.12.** Buchanan Creek looking downstream from about profile 11 at wide terrace on south side

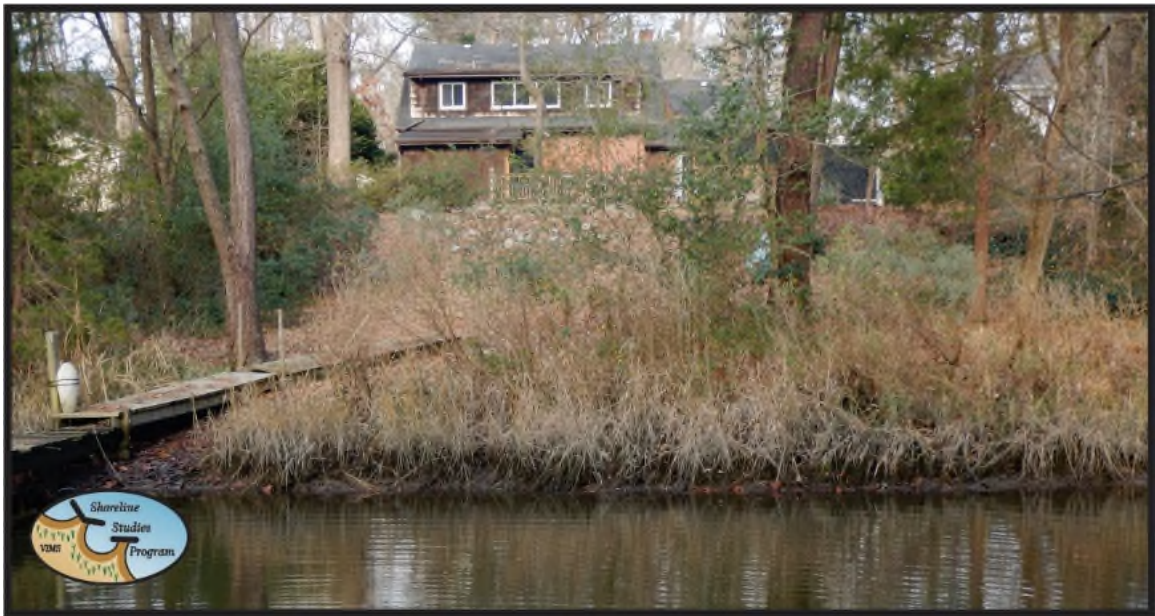
**Figure 1.13.** Buchanan Creek upstream from profile 12 where the channel was incised into the upland so the banks are higher. 2019.

The cross-sections extracted from the 2013 LIDAR DEM are plotted in Appendix B. They show a steadily decreasing channel depth and increasing bank heights moving from profile 1 to profile 21. From profile 1 to 11, remnant marsh fringe exists on the north and south shoreline. This low fringe is a terrace in front of the upland banks which provides erosion protection to the adjacent low upland banks from tidal action (Figure 1.12). At profile 12, the nature channel and marsh ended; therefore, the dredged channel continued into the underlying upland strata rather than existing natural sub-bottom or natural marsh. Upstream from profile 12, the channel banks get higher, steeper and more exposed proceeding upstream (Figure 1.13).

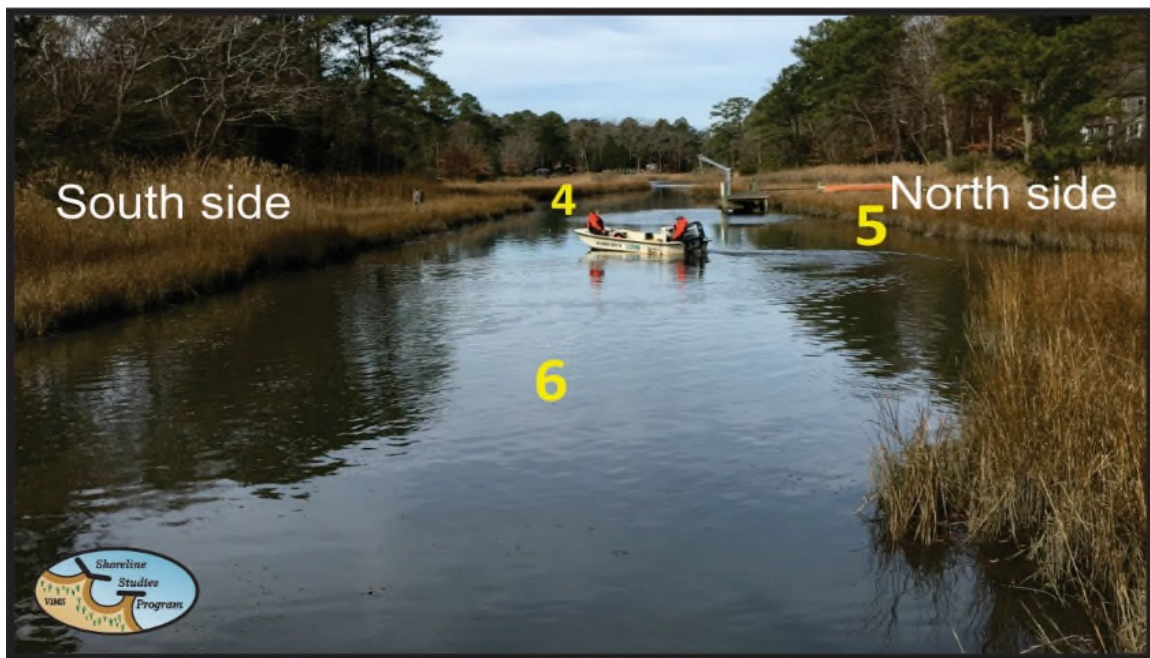
**Figure 1.17.** Approximate location of profiles 4, 5, and 6. Both the north and south sides of the creek have wide fringe marshes to protect the upland bank.

From Profile 1 to Profile 7, low marsh fringes occur on both sides of the creek with adequate width to buffer the adjacent upland bank (Figure 1.17). The front edges are relatively stable and not undercut so the Do Nothing approach is most appropriate. Moving upstream, at about profile 7 to profile 9, the low intertidal marsh fringe is reduced on the south side but still wide and vibrant on the north side (Figure 1.18). Although some low marsh exists along the very upper reaches of the tide range, the lack of marsh on the south side can be attributed to shading. No upland bank scarping occurs on either side. Thinning trees on the north side may allow enough light to help promote low marsh growth farther into the creek. However, the lower limit to which *Spartina alterniflora* will grow is about mid-tide so not much more fringe can be expected. On the south side, thinning of trees and planting existing substrate may promote marsh growth; however, no erosion problem exists so the Do Nothing option is preferable.

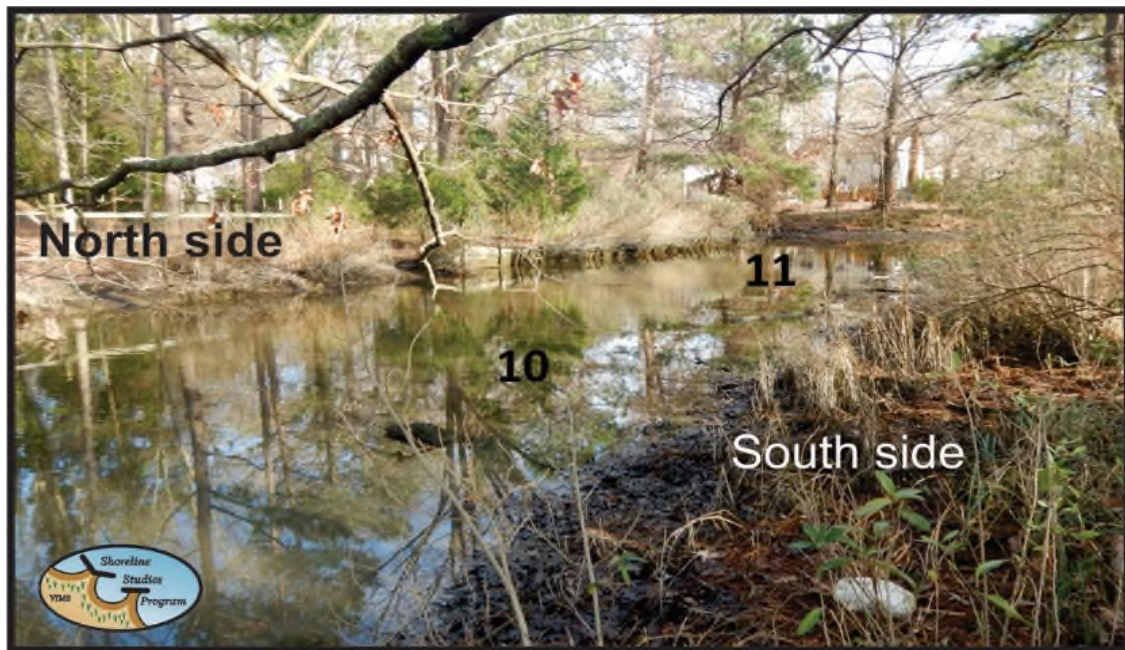
**Figure 1.19.** Approximate location of profiles 10 and 11. The north side of the creek still has a wide fringe marsh, but no marsh occurs on the south side due to shading.

At profile 10 (Figure 1.19) the north and south side marsh fringes are very sparse. An old wood bulkhead can be seen on the north side of profile 11. The recommended option is still a Do Nothing approach. Replacing the old wood bulkhead would be a secondary option.

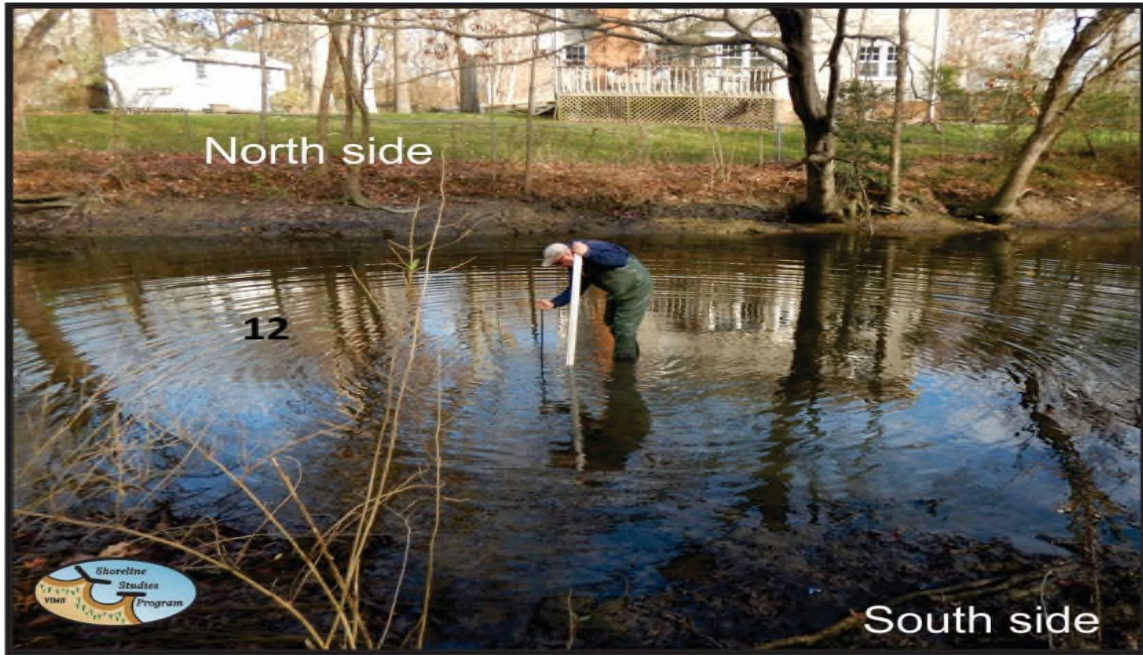
**Figure 1.20.** Approximate location of profile 12. The intertidal zone is exposed clay substrate though the upper bank is heavily vegetated creating an overall stable profile.

Profile 12 (Figure 1.20) begins the increase in bank height along the creek because the channel was originally incised into the upland. No significant marsh fringe occurs along the shoreline at profiles 12, 13, and 14 (Figure 1.21). The intertidal zone is exposed clay, and the upland bank portions are heavily vegetated. Trees do grow on the bank and should be thinned before they fall and create local pockets of bank instability. No structural options are necessary along the shoreline; however, if trees are thinned, a marsh can be planted for landscaping purposes or as a tertiary buffer for stormwater runoff and sedimentation. A living shoreline can be constructed with coir logs staked in the nearshore and backfilled with sand (Figure 1.22). Marsh grasses can be planted on the new substrate. Up the creek from profile 12, sections of shoreline that receive enough sunlight will support a narrow fringe marsh in the intertidal zone (Figure 1.23).

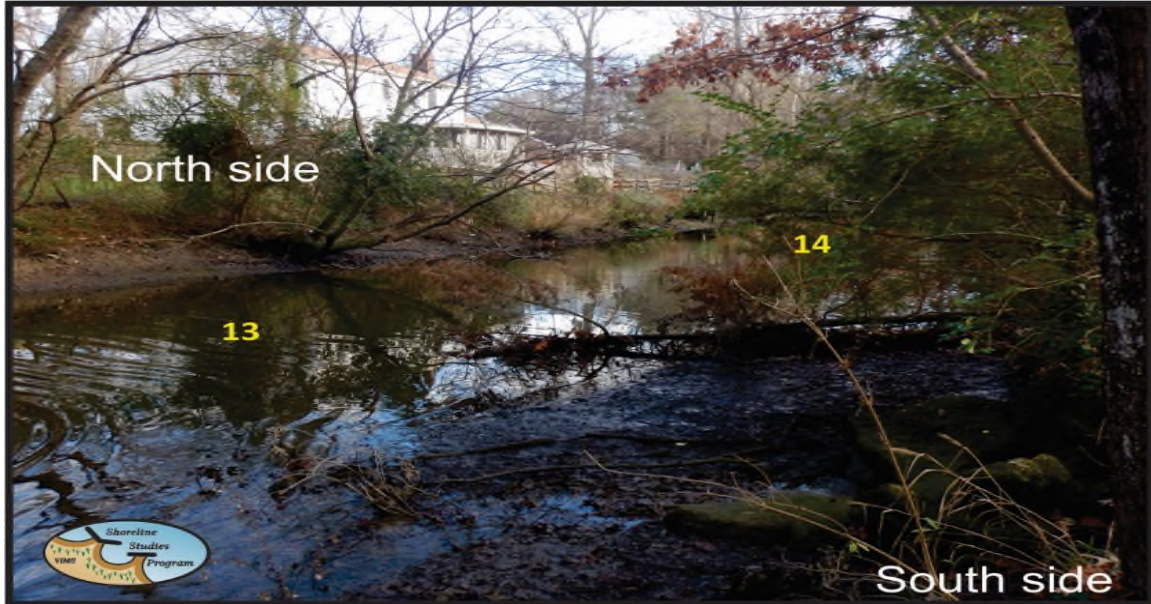
**Figure 1.21.** Approximate location of profiles 13 and 14. The intertidal zone is exposed clay substrate though the upper bank is heavily vegetated creating an overall stable profile.

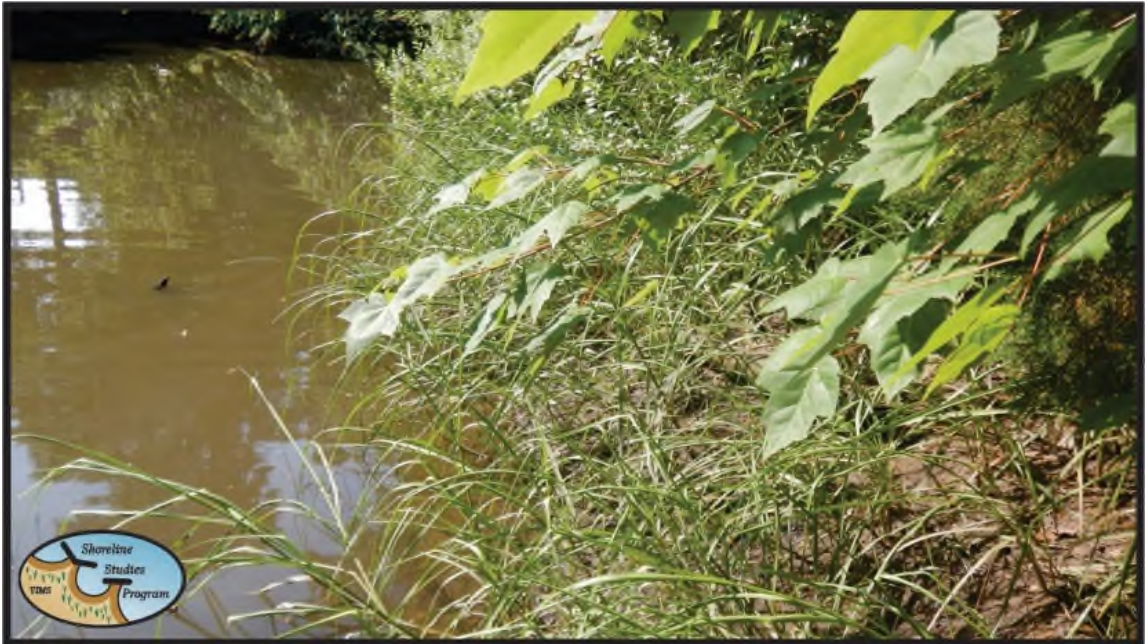
**Figure 1.23.** In areas of the creek above profile 12 that receive enough sunlight, a narrow fringe marsh can exist in the intertidal zone.

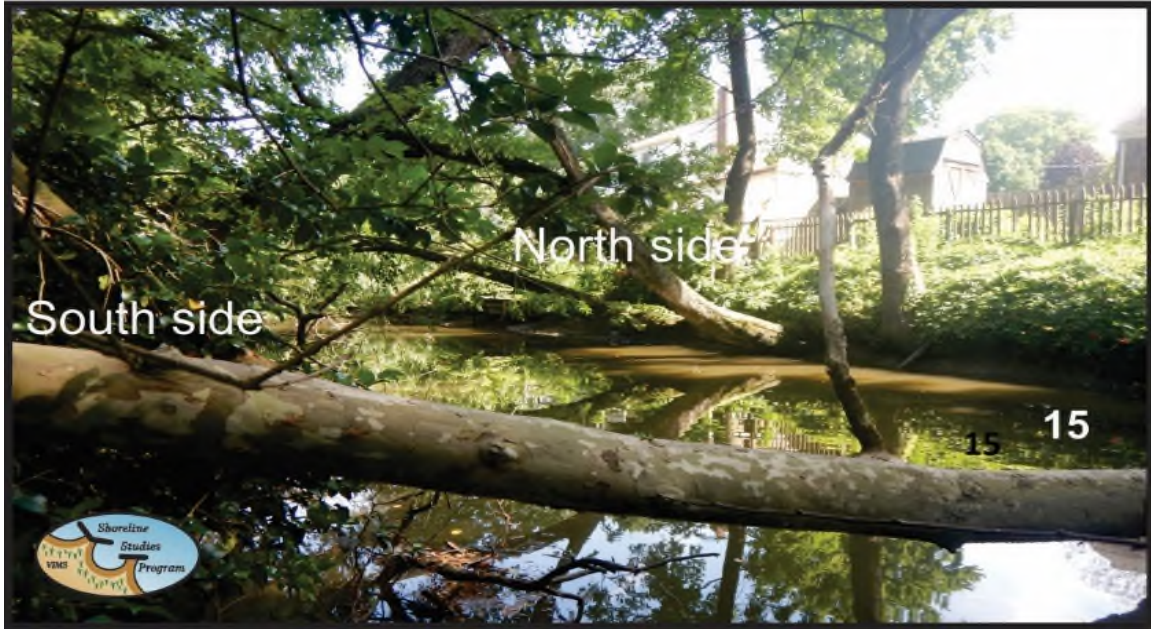
**Figure 1.24.** Approximate location of profile 15. The intertidal zone is exposed clay substrate though the upper bank is heavily vegetated creating an overall stable profile. However, fallen trees create locally unstable banks and block recreational access.

Profile 15 also has an exposed intertidal zone and heavily vegetated bank on both sides of the creek. In addition, many trees have grown up along the shoreline. As they fall, the creek is blocked for recreational access (Figure 1.24). This trend continues up the creek through all of the profiles (Figure 1.25). In addition, the channel is narrowing and becoming shallower. Sedimentation from the stormwater outfall pipes have silted in the channel at profile 21 such that it is dry at low water (Figure 1.26). Because the channel has filled in above mean low water the areas between mid-tide and mean high water could be planted with *Spartina alterniflora*.

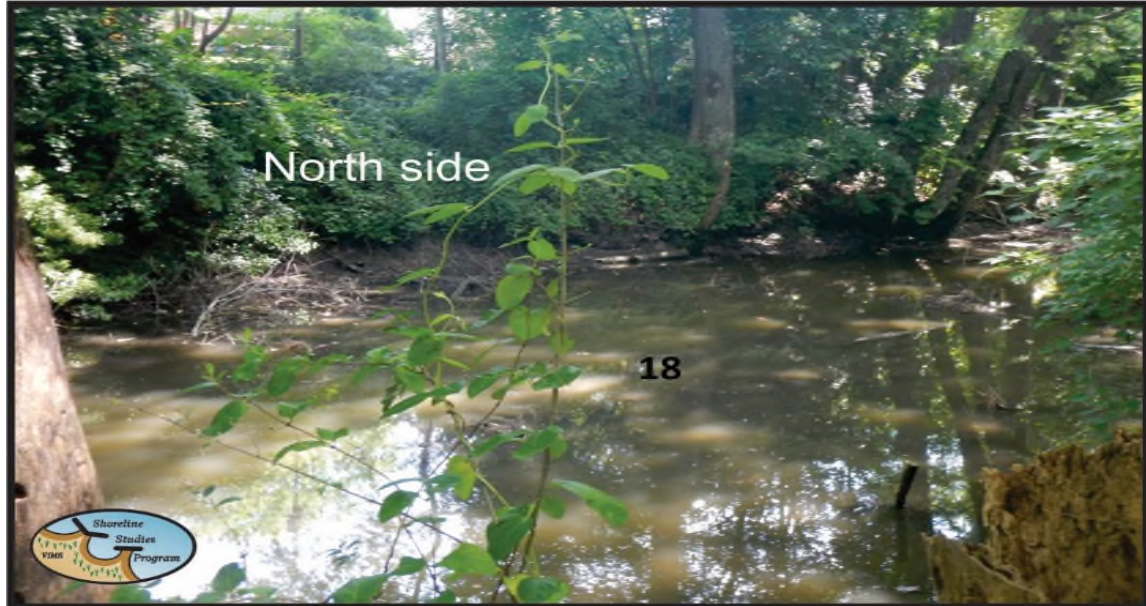
**Figure 1.25.** Approximate location of profile 18. The intertidal zone is exposed clay substrate though the upper bank is heavily vegetated creating an overall stable profile, and the channel is narrowing and becoming more shallow up the creek.

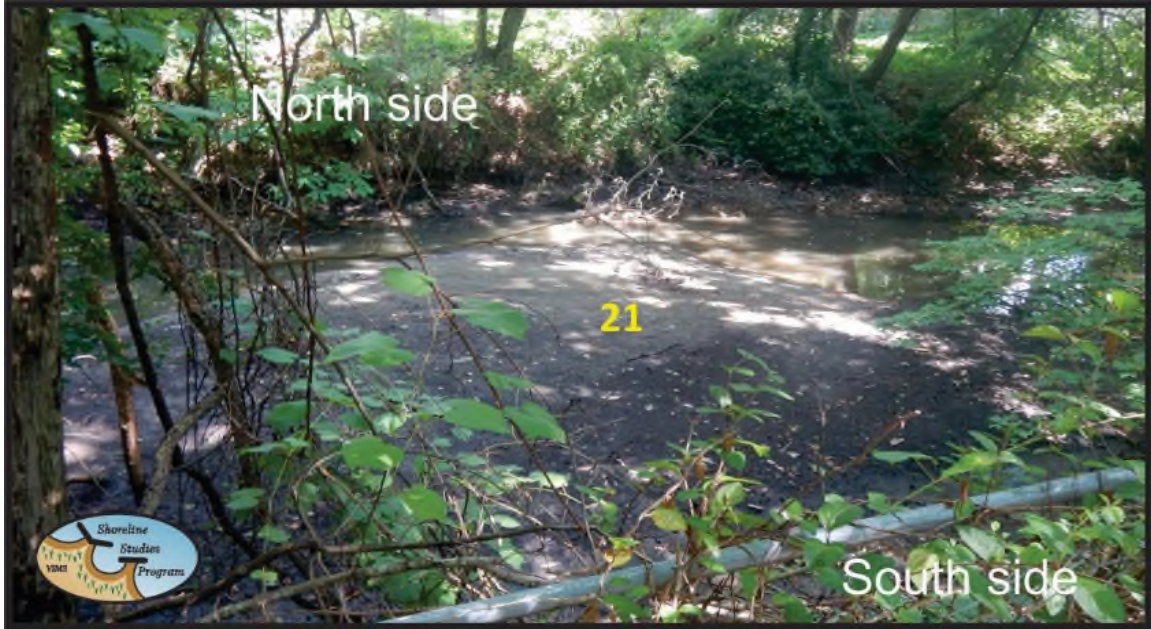
**Figure 1.26.** At the uppermost reach of the creek at profile 21, sediment from the stormwater outfall has accreted and the channel is dry at low water.

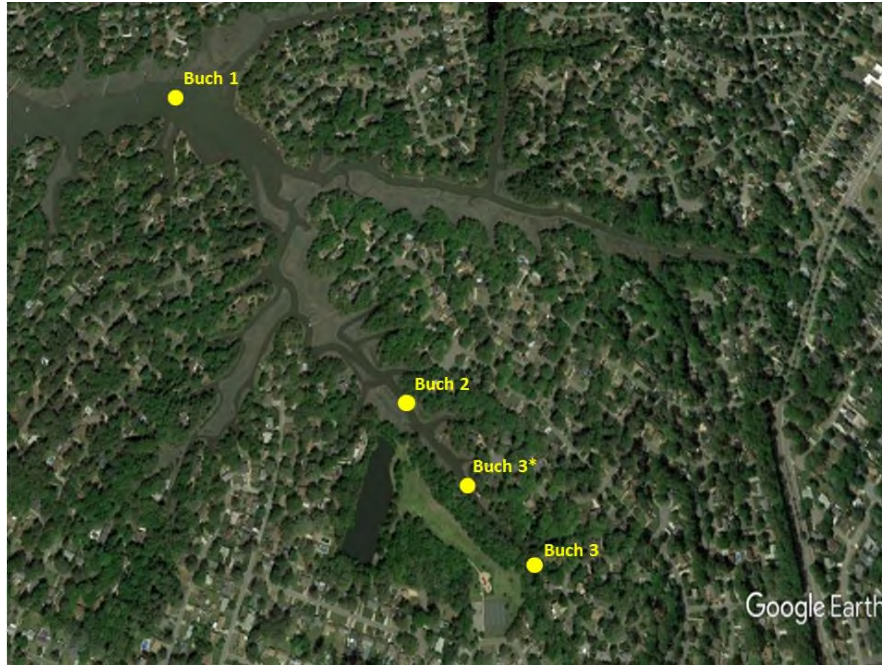
**Figure 2.2.** Detailed map depicting continuous monitoring water quality station locations within Buchanan Creek system.

This study established a total of six continuous monitoring (ConMon) stations to support project efforts. Three stations were located in Buchanan Creek proper from 0.8 km (0.5 mi) upstream from the mouth (Station ID: Buch 1) to approximately 1.8 km (1.1 mi) upstream (Station ID: Buch 3) adjacent to Birchwood Malibu Park. A single ConMon station (Station ID: Boundary) was maintained in the Western Branch of the Lynnhaven River, downstream of Buchanan Creek, to provide information on adjacent open water boundary conditions in support of modeling efforts. The two remaining ConMon stations were established in Wolfsnare Creek and Thalia Creek, to serve as suitable reference sites to Buchanan Creek. ConMon station locations are provided in Figures 2.1 and 2.2 (depicts Buchanan Creek stations in detail) with additional station information provided in Table 2.1. ConMon water quality stations were deployed on four occasions to observe and describe seasonal and storm influences on water quality. Deployment periods along with daily precipitation over the study period (Sept. 2019 through Apr. 2019) are depicted in Figure 2.3 with additional details provided in Table 2.2.

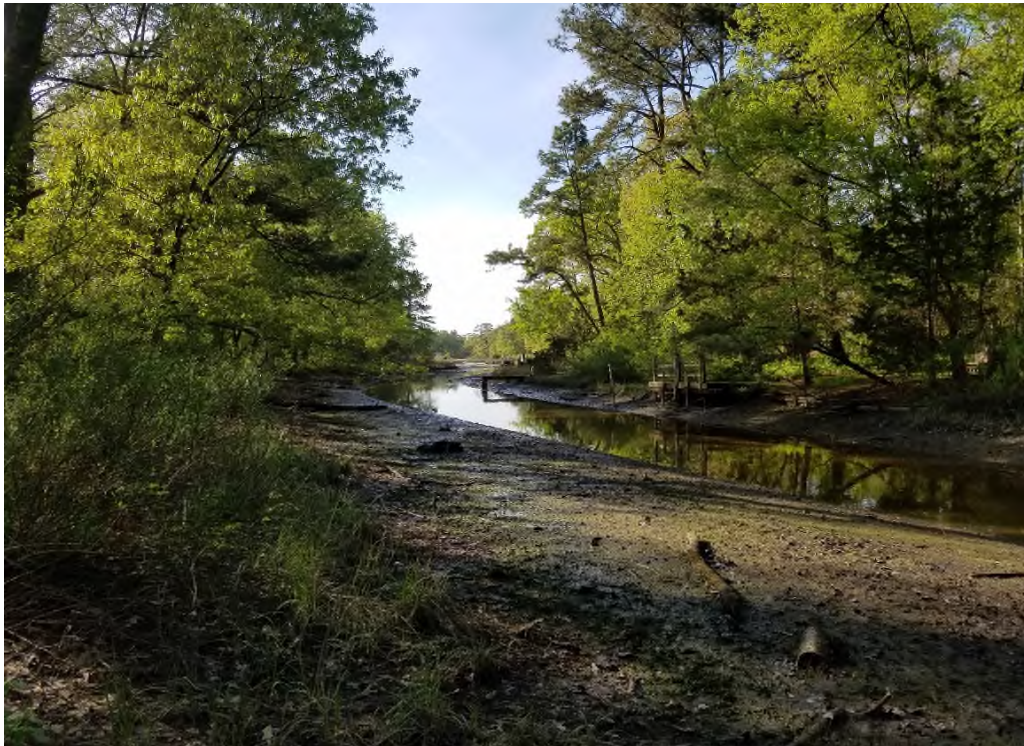
**Figure 2.4.** Image of upper tidal Buchanan Creek looking downstream of Buch 3 station.

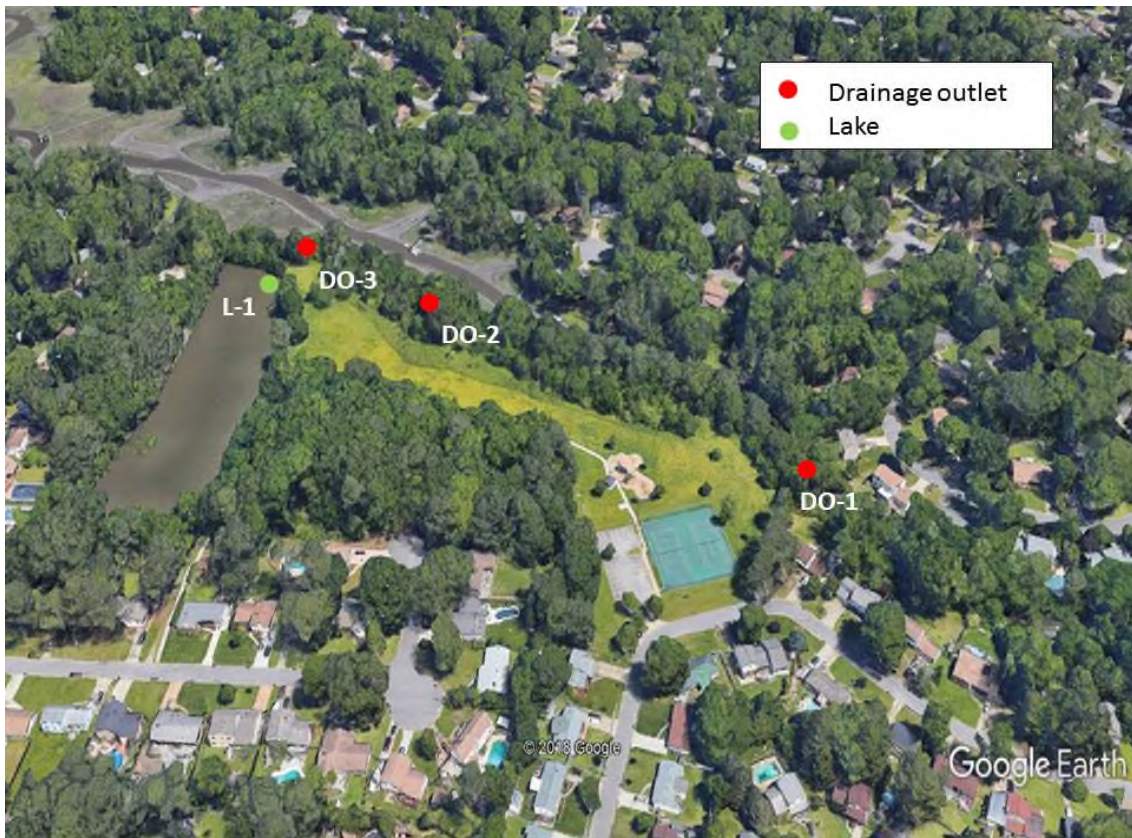
**Figure 2.5.** Selected water quality grab sample station locations within Buchanan Creek and Birchwood-Malibu Park.

As opportunities presented themselves, efforts were made to survey water runoff from Birchwood Malibu Park. This effort focused on three discharge outlet structures and included a lake sample site; see Figure 2.5 for station locations. DO-1 was a large diameter pipe that was semi-exposed at low tide and submerged at high tide (see Figure 2.38). DO-1 appeared to be under maintenance at the time of the study and discharge was not noticeable except on one occasion where a slight surface density gradient could be observed. The degree of connectivity between the DO-1 outlet in Buchanan Creek and an up-gradient stormwater retention basin is uncertain (see Figure 2.39) and will be discussed below. DO-2 is a small concrete pipe located midway up the hillslope to the maintained lawn at the park. Discharge was never observed from this outlet and samples were collected in a small pool in front of the outlet. DO-3, a small diameter pipe located near the downstream edge of the park and lake, exhibited low and intermittent flow over the study period. While sampling was limited, it does provide basic information to characterize pollutant discharge from the park into headwaters of Buchanan Creek. Bacteria (*Enterococcus* sp.) and supplemental information for DO-2 is presented in Table 2.26 with nutrient information presented in Table 2.27, Tables 2.28 and 2.29 for DO-3, and Tables 2.30 and 2.31 for the lake sampling station.

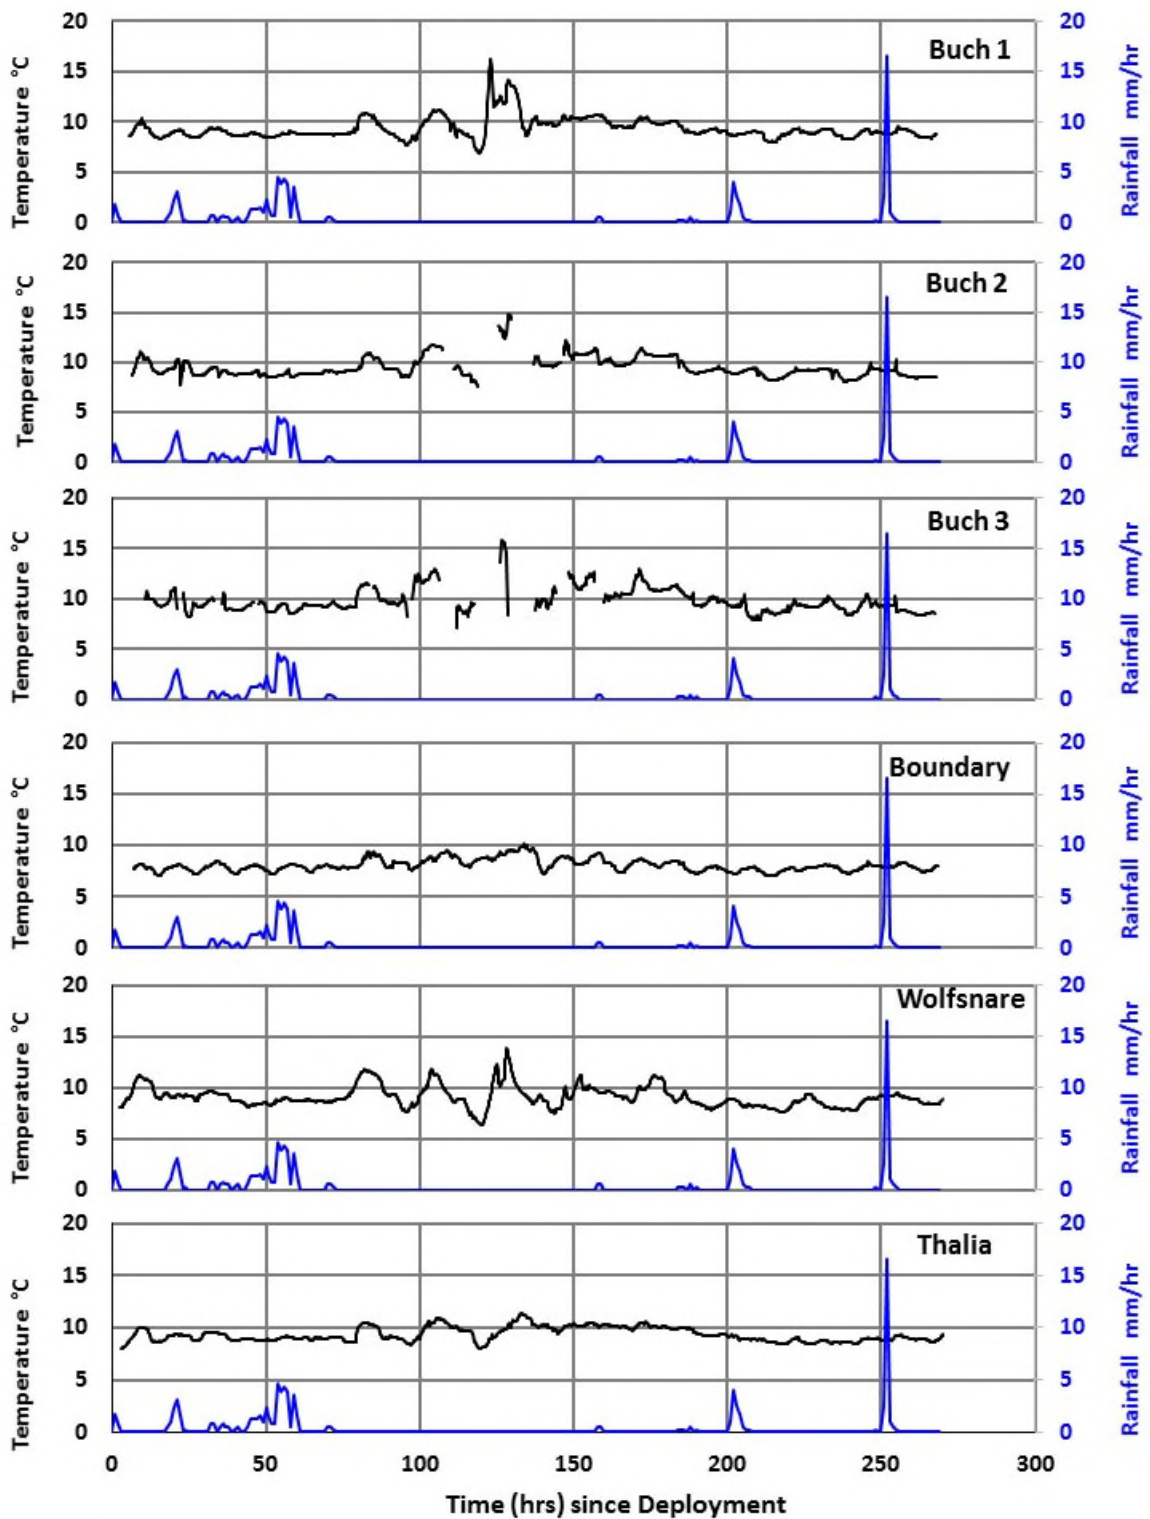
**Figure 2.8.** Continuous monitoring temperature (°C) and hourly precipitation (mm) time series during third (2/21/2019 - 3/4/2019) deployment period.

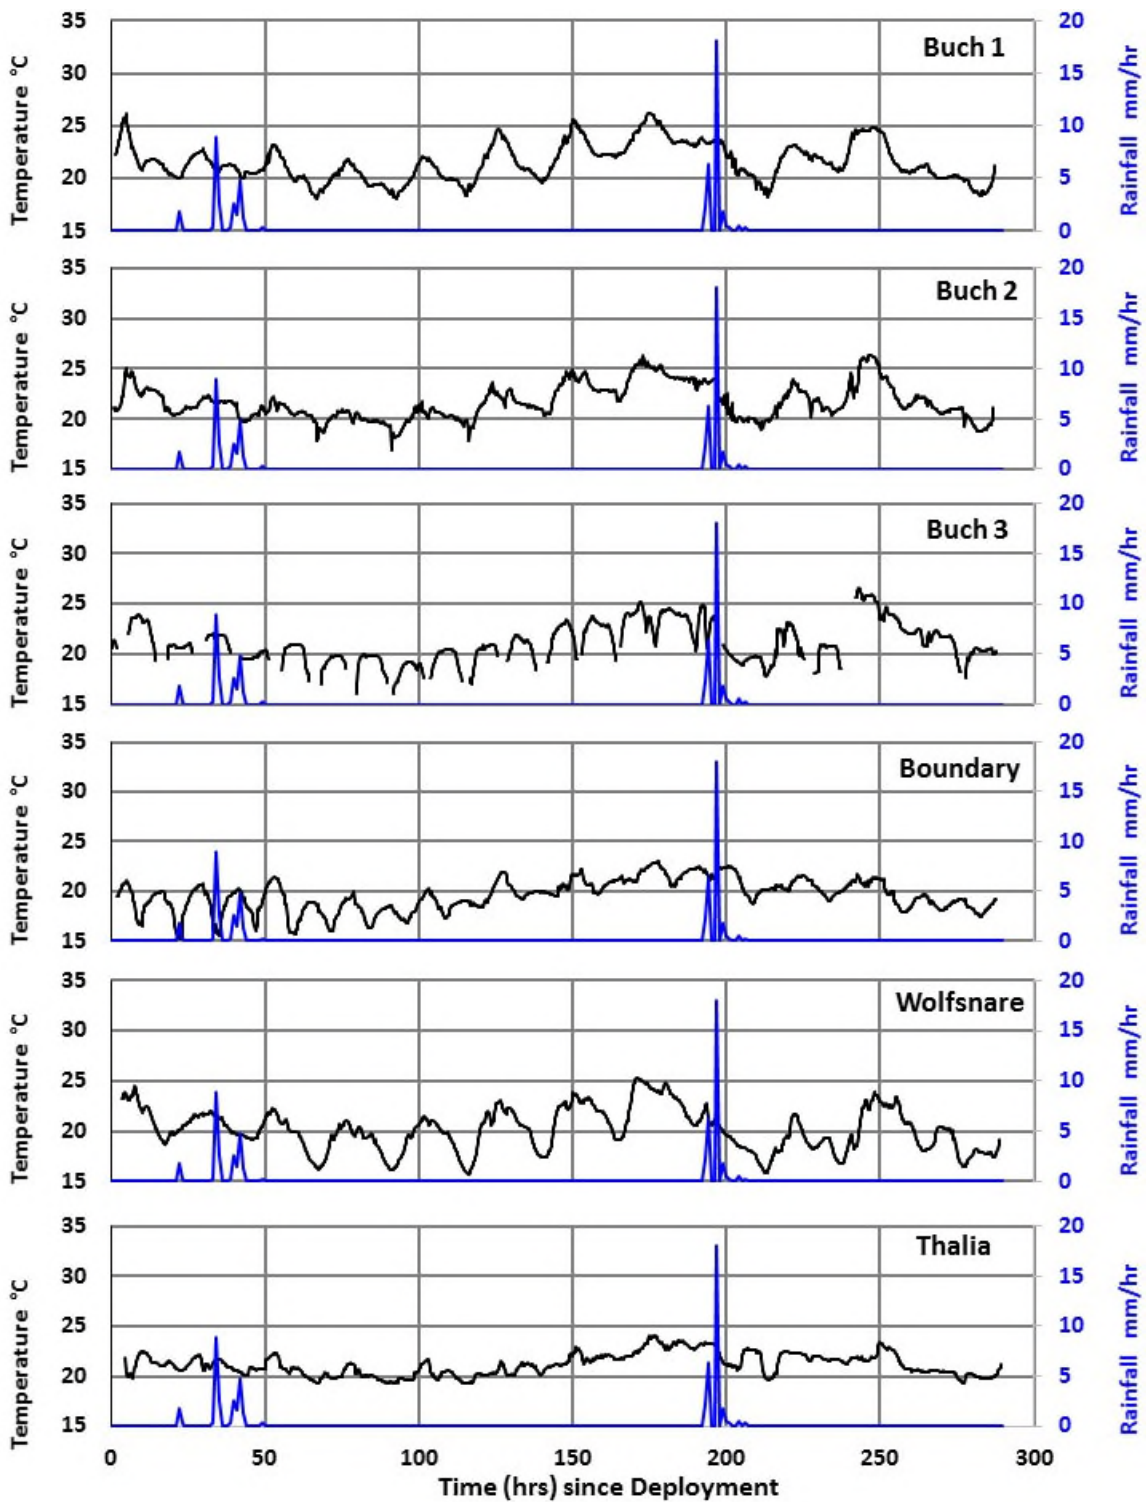
**Figure 2.9.** Continuous monitoring temperature (°C) and hourly precipitation (mm) time series during fourth (4/18/2019 - 4/30/2019) deployment period.

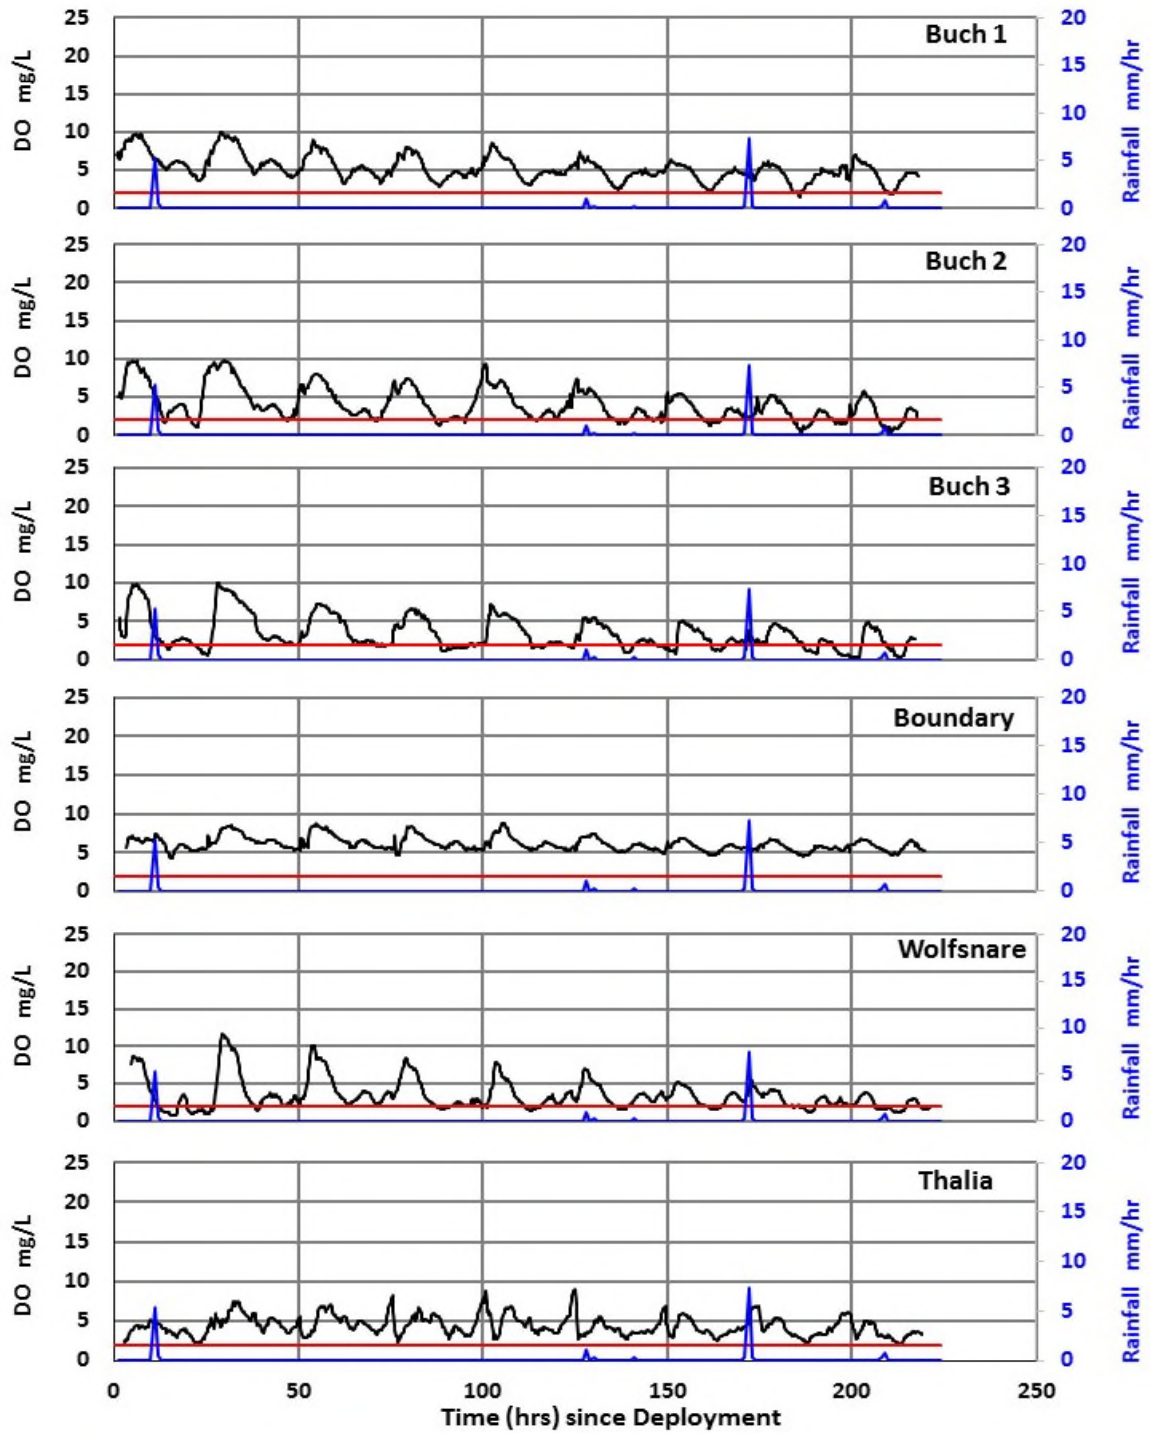
**Figure 2.15.** Continuous monitoring  $DO_{conc}$  (mg/L) and hourly precipitation (mm) time series during first (9/18/2018 - 9/27/2018) deployment period. Note: red dashed line represents hypoxia (< 2 mg/L) concentration limit.

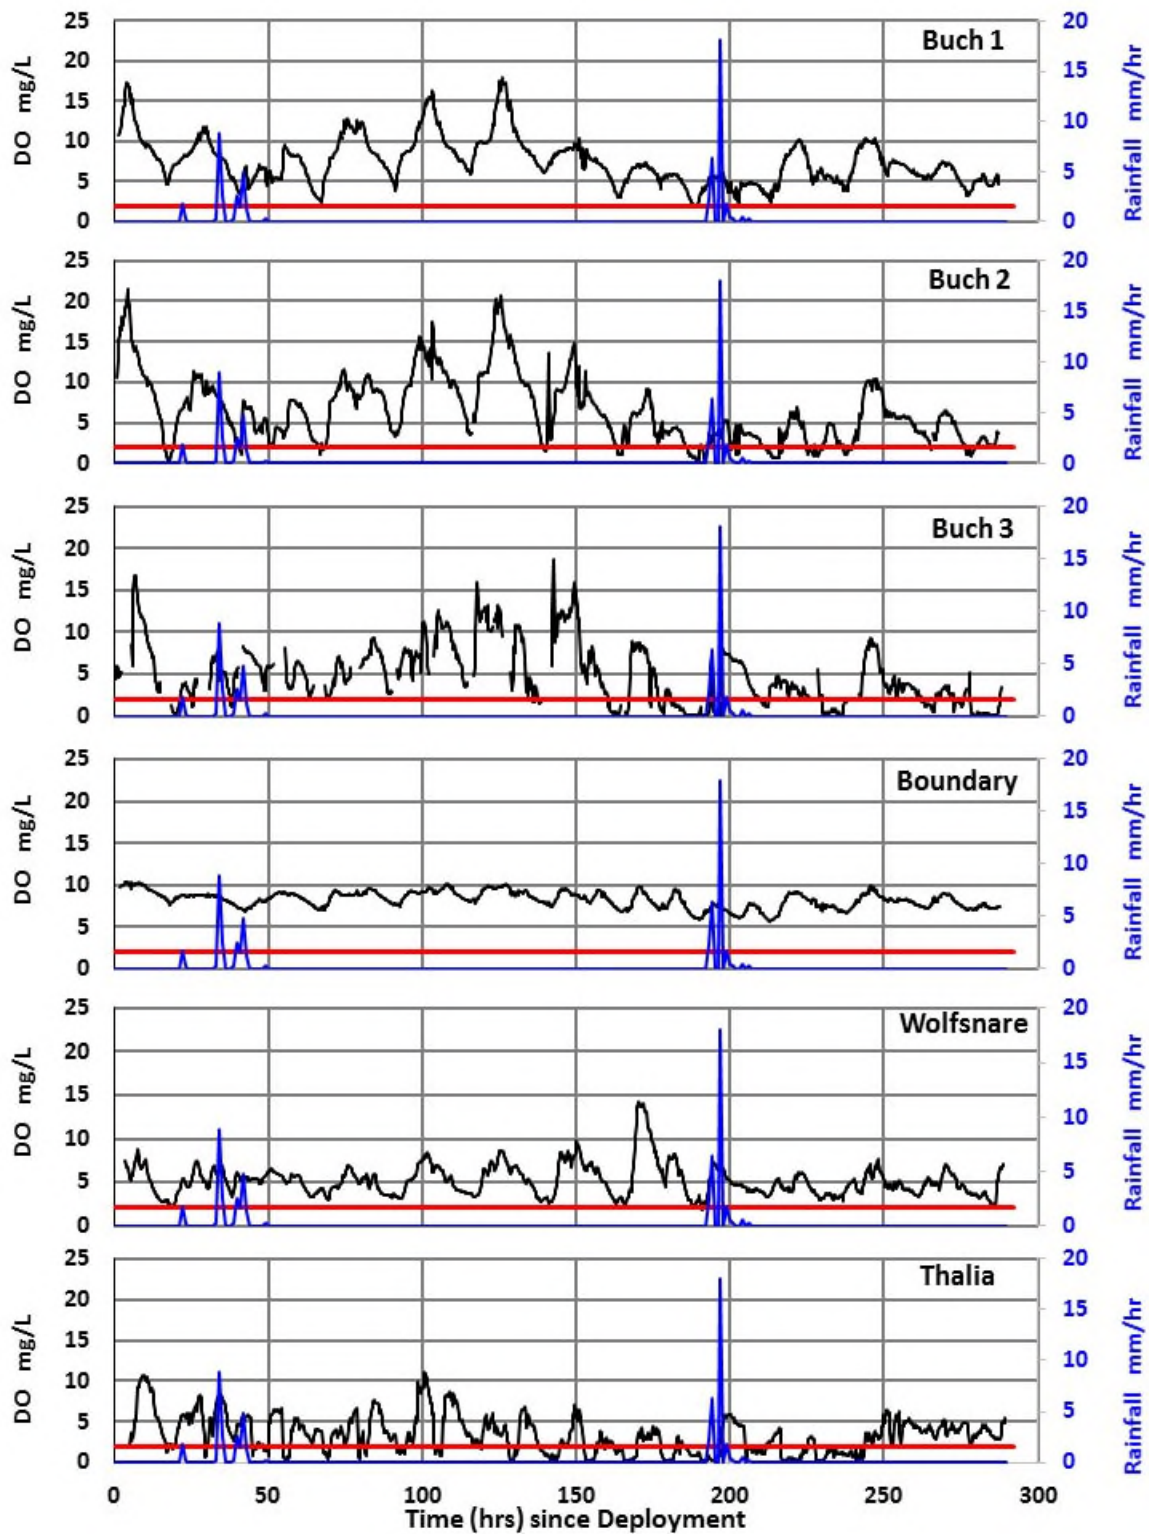
**Figure 2.18.** Continuous monitoring  $DO_{conc}$  (mg/L) and hourly precipitation (mm) time series during fourth (4/18/2019 - 4/30/2019) deployment period. Note: red dashed line represents hypoxia ( $< 2$  mg/L) concentration limit.

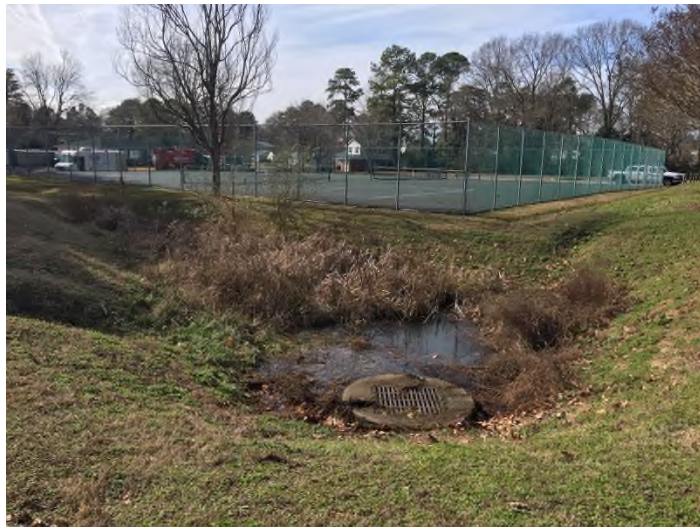
**Figure 2.39.** Image of stormwater retention basin upland from DO-1. Connectivity with the DO-1 outlet in Buchanan Creek is uncertain.

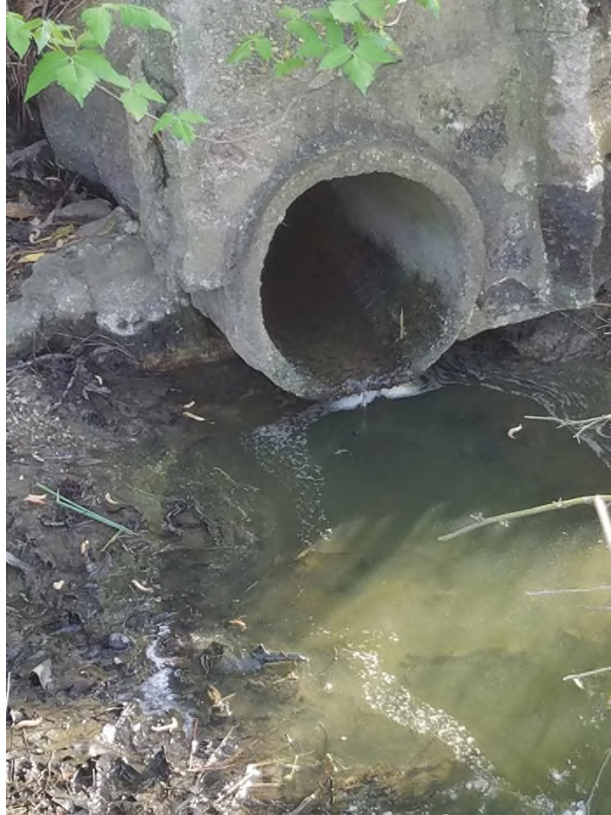
**Figure 2.40.** Image of DO-3. Flow rate is estimated at 200 ml/sec.

Relative to the adjacent Buchanan Creek station (Buch 3; 2,175 MPN/100 ml), geometric mean densities of *Enterococcus* associated with discharge from DO-2 (262 MPN/100 ml) and DO-3 (213 MPN/100 ml) were significantly reduced. In comparison, averaged TDN and TDP levels associated with DO-2 and DO-3 effluent was 2 and 5 times greater than observed in Buchanan Creek. Origin of the discharge is suspected to be upland groundwater seepage into the DO-2 pipe network and a mix of upland seepage and lake overflow/drainage into the DO-3 pipe network. Of note was the high (330.9 µg/L) Chl-a level in DO-3 effluent on April 18, 2019 when the lake was experiencing bloom conditions. Initial assessment would indicate that identified drainage (DO-2 and DO-3) at Birchwood Malibu Park would have limited impact on Buchanan Creek given its low and intermittent discharge coupled to moderate effluent concentrations of nutrient and Enterococci bacteria. Additional effort may be warranted to assess pollutant concentrations and flow rates under storm event conditions. Of note, on the initial survey date of January 23, 2019, maintenance activities were occurring on the street stormwater drainage system near the park's entrance. Water was being pumped from the drainage system and being discharge in the Park's parking lot drain which subsequently discharged through an unmarked discharge pipe creek-ward of the assumed upland retention basin for DO-1 (see Figure 2.41). Discharge and creek samples were collected and analyzed for Enterococci bacteria densities and nutrients. The discharge water was characterized by elevated enterococci (GM: 3,039 MPN/100 ml) and TDN (1.4 mg/L as N) levels; TDP levels were in comparison low (0.03 mg/L as P). Bacterial survey results for this event are provided in Figure 2.42. Impacts from maintenance activities may warrant additional observations and, at minimum, be planned to minimize impact to Buchanan Creek.

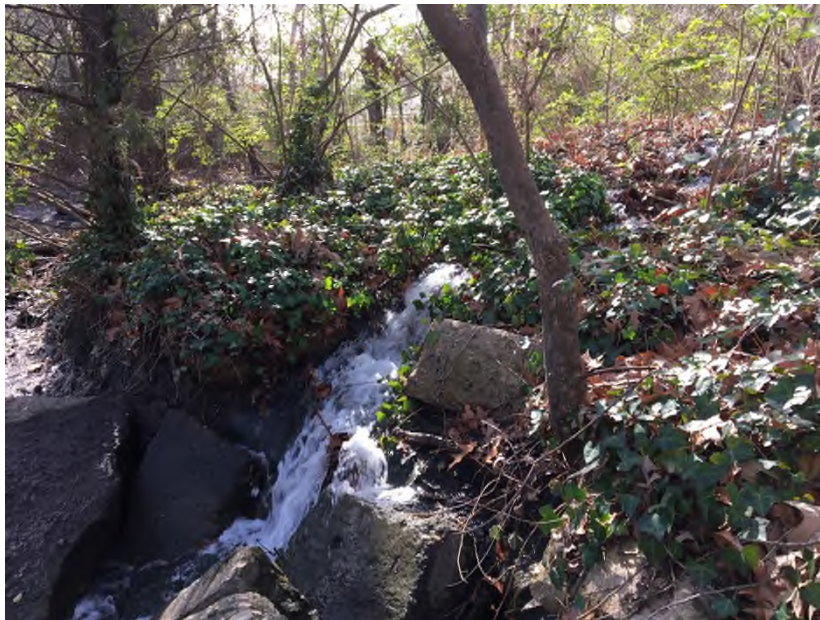
**Figure 2.41.** Image of unmarked discharge pipe during January 23, 2019 sampling survey.

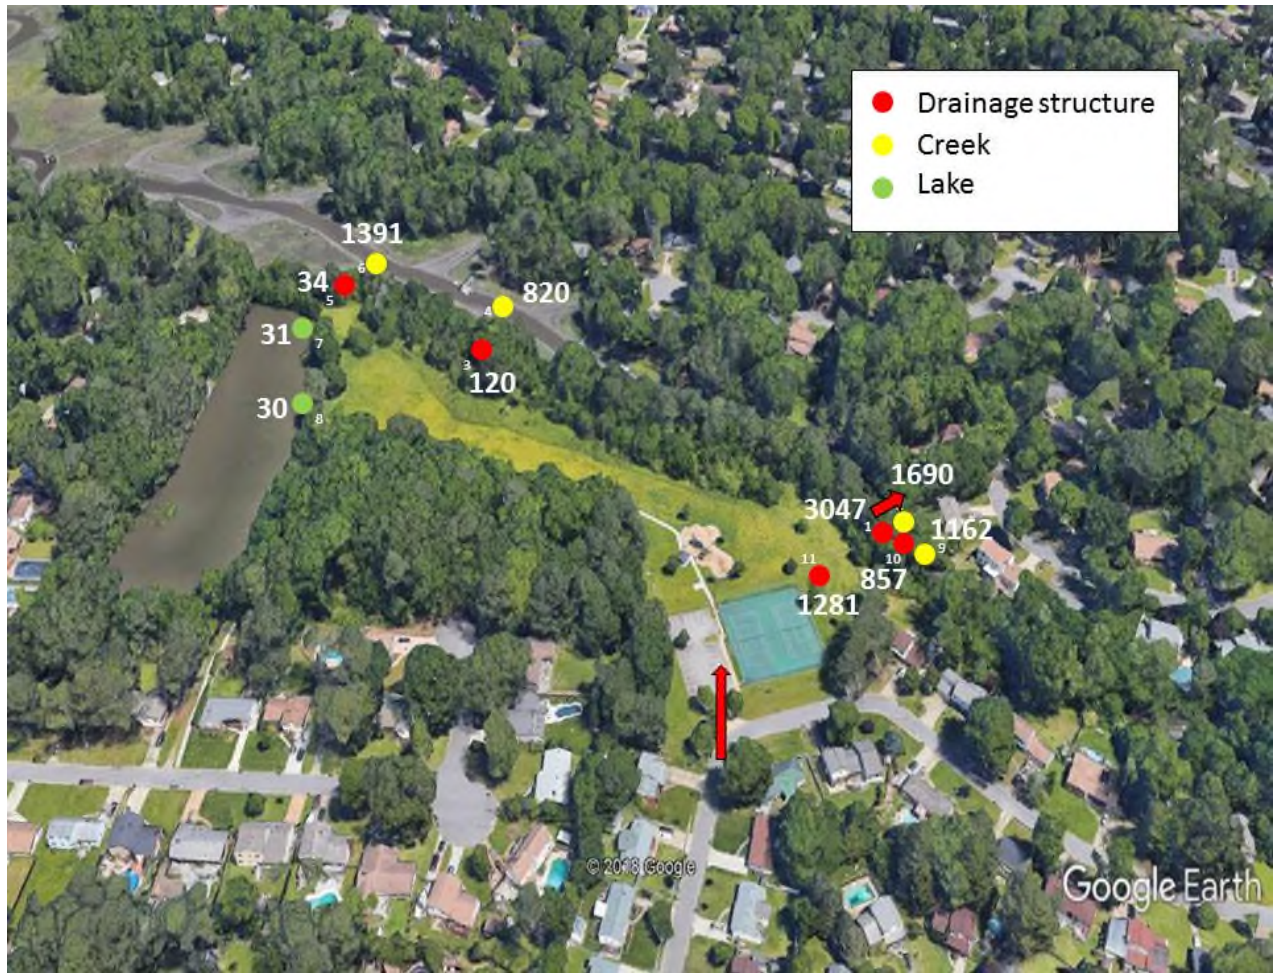
**Figure 2.42.** Enterococci bacteria levels (MPN/100 ml) for the January 23, 2019 survey sampling. Arrows denote known path of discharged stormwater system water
