**REPORT OF THE VIRGINIA DEPARTMENT OF  
ENVIRONMENTAL QUALITY**

**Evaluation of Environmental  
Concerns in the Upper  
Reaches of Buchanan Creek**

# Evaluation of Environmental Concerns in Buchanan Creek

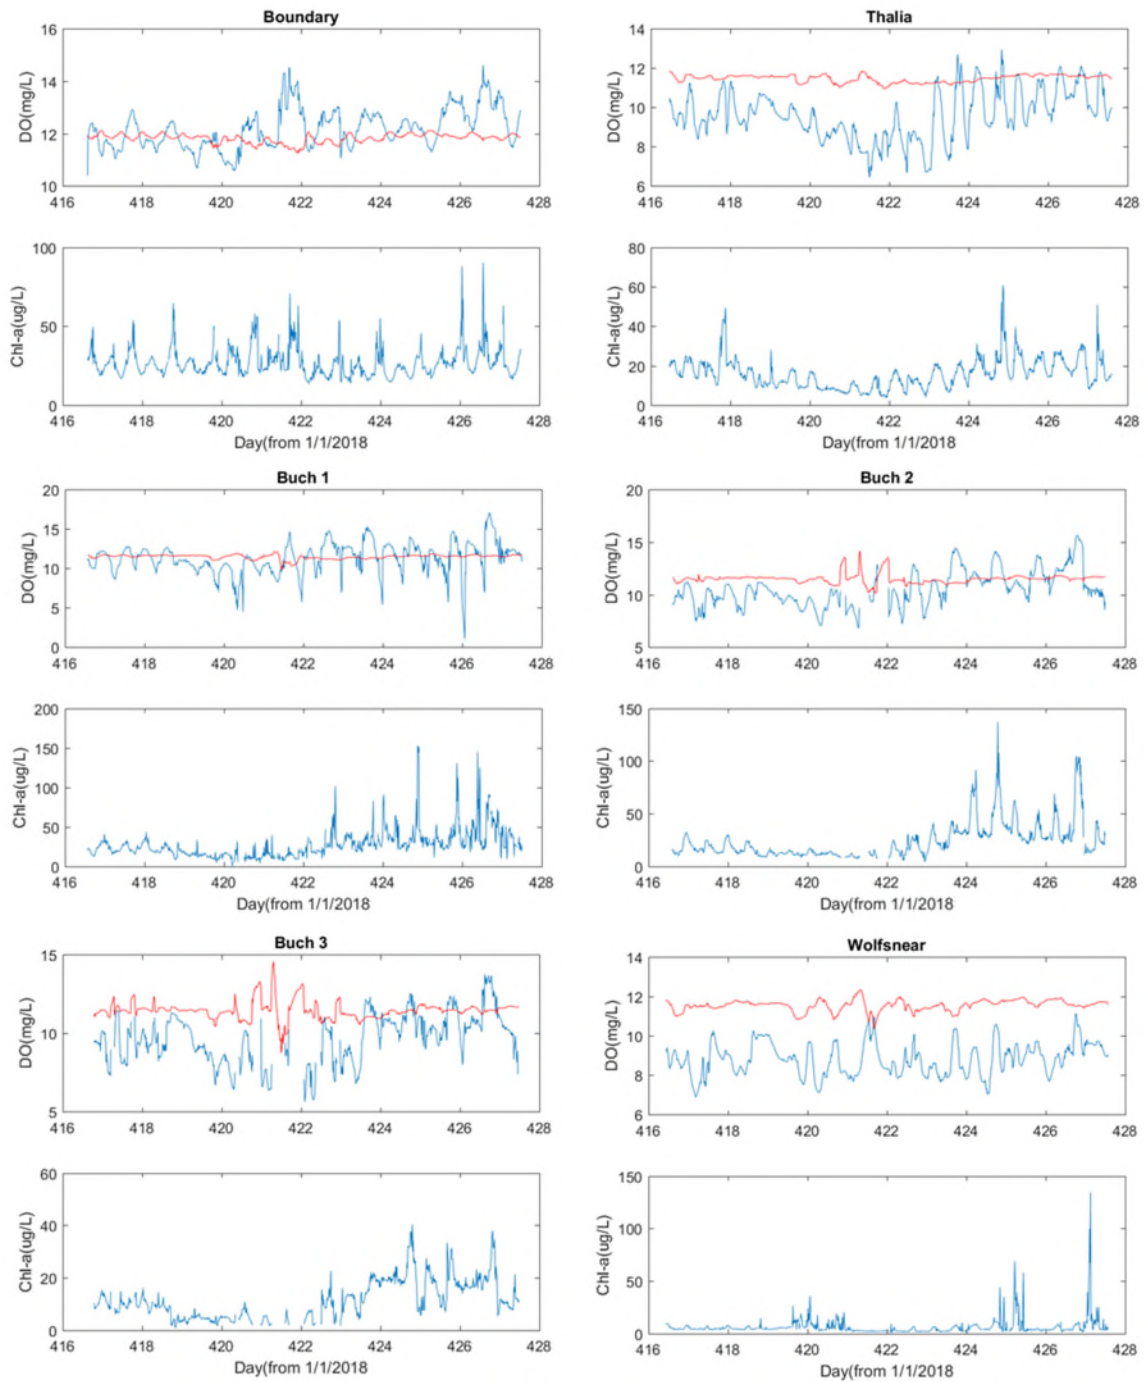
**Figure 3.6.** Chl-a and DO measured at the Boundary location, 3 stations in Buchanan Creek, and reference stations in Thalia and Wolfsnare creeks during Feb. 2019.

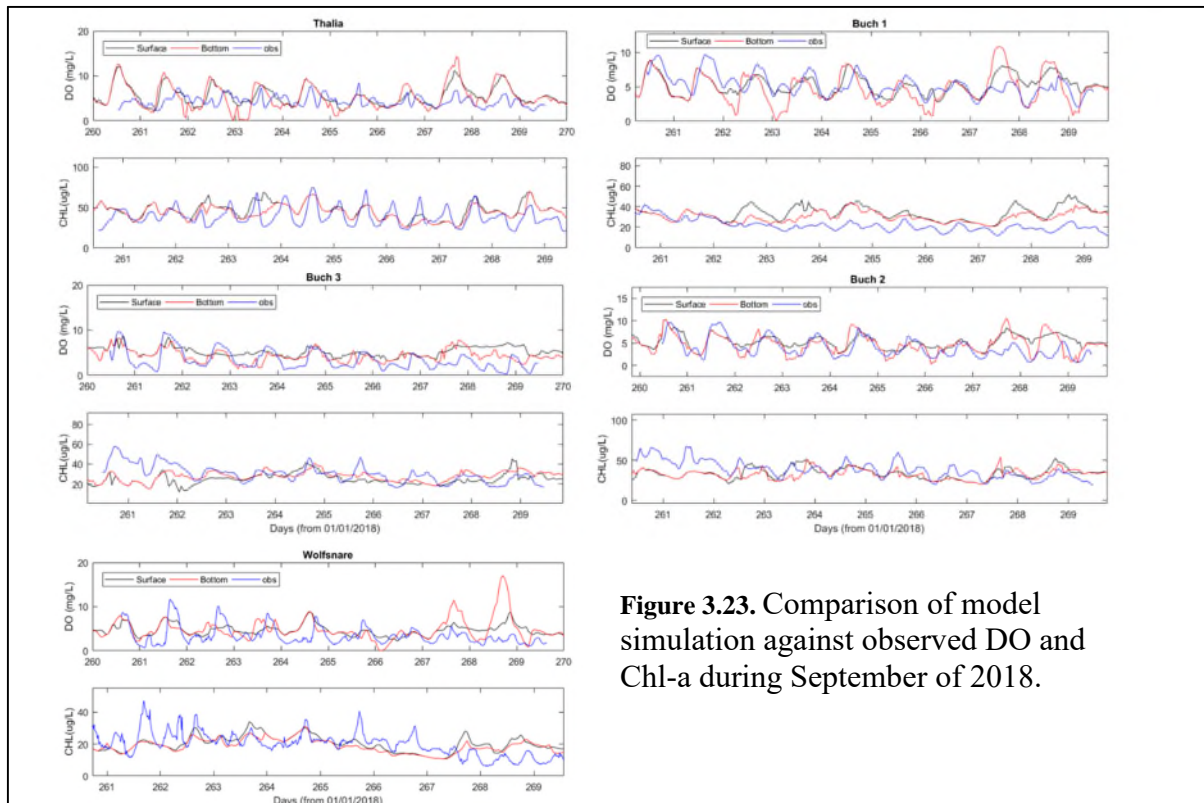
**Figure 3.23.** Comparison of model simulation against observed DO and Chl-a during September of 2018.

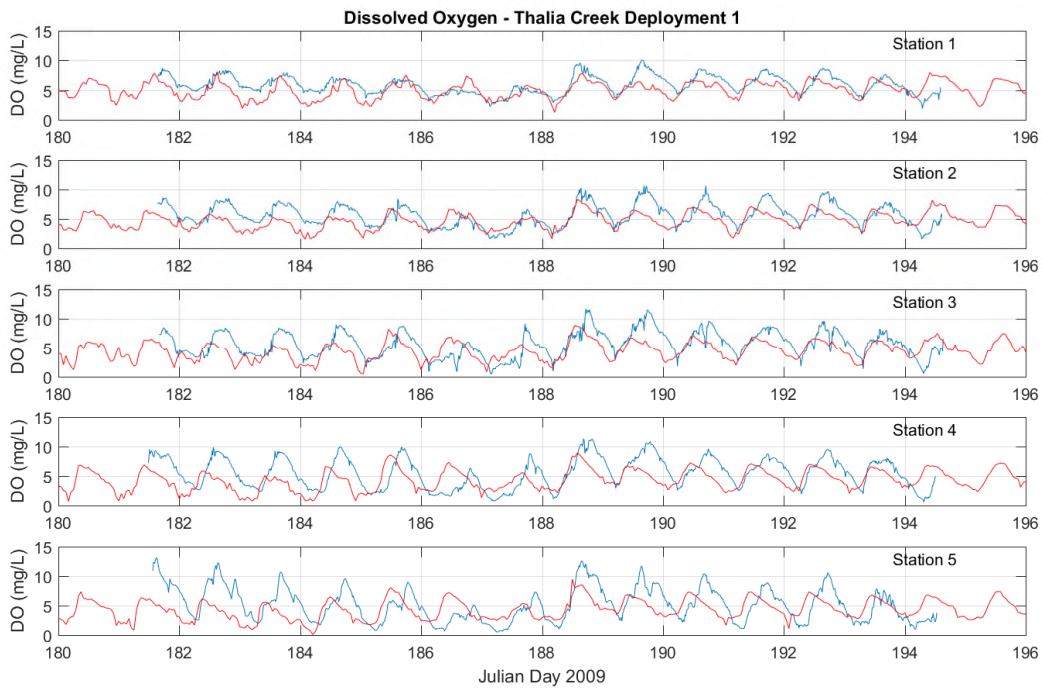
**Figure C.12a.** Real-time comparisons of predicted vs. observed DO at five stations in the Thurston Branch and Thalia Creek during deployment period 1
