Passenger Vehicle Crashes Into Stationary Large Trucks

HOUSE DOCUMENT NO. 17

PASSENGER VEHICLE CRASHES INTO STATIONARY LARGE TRUCKS: INCIDENCE AND POSSIBLE COUNTERMEASURES

A Report to the Governor and the General Assembly of Virginia in Response to House Joint Resolution No. 23, 2002 Session

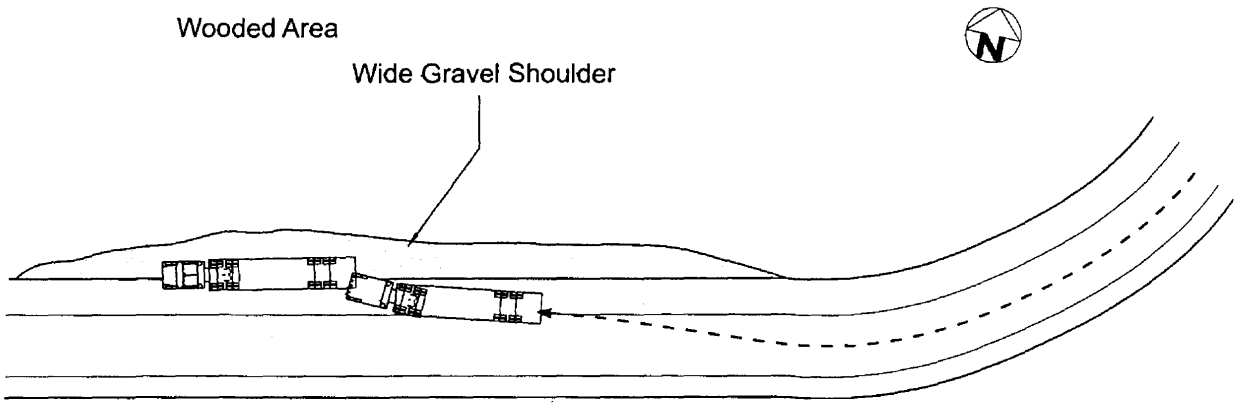
Figure 6. Case Study 1: Crash Diagram, Suburban Interstate Ramp

Parked on the ramp's right side, completely off the paved shoulder and onto the gravel shoulder, was a 1999 three-axle Freightliner tractor and a 2000 two-axle Wabash semi-trailer. The truck was illegally stopped on the shoulder, i.e., not due to an emergency or mechanical defect, and was displaying its trailer's rear and side-marker lights. *Its four-way flashers were not activated. The white-painted box-type trailer was properly marked on its rear with typical white and red reflective tape and red circular reflex-reflectors in compliance with DOT requirements.* The truck company's name and markings located on the trailer's rear were also reflectorized. This truck had been parked on the shoulder for about 40 minutes with its 57-year-old driver resting in the cab.

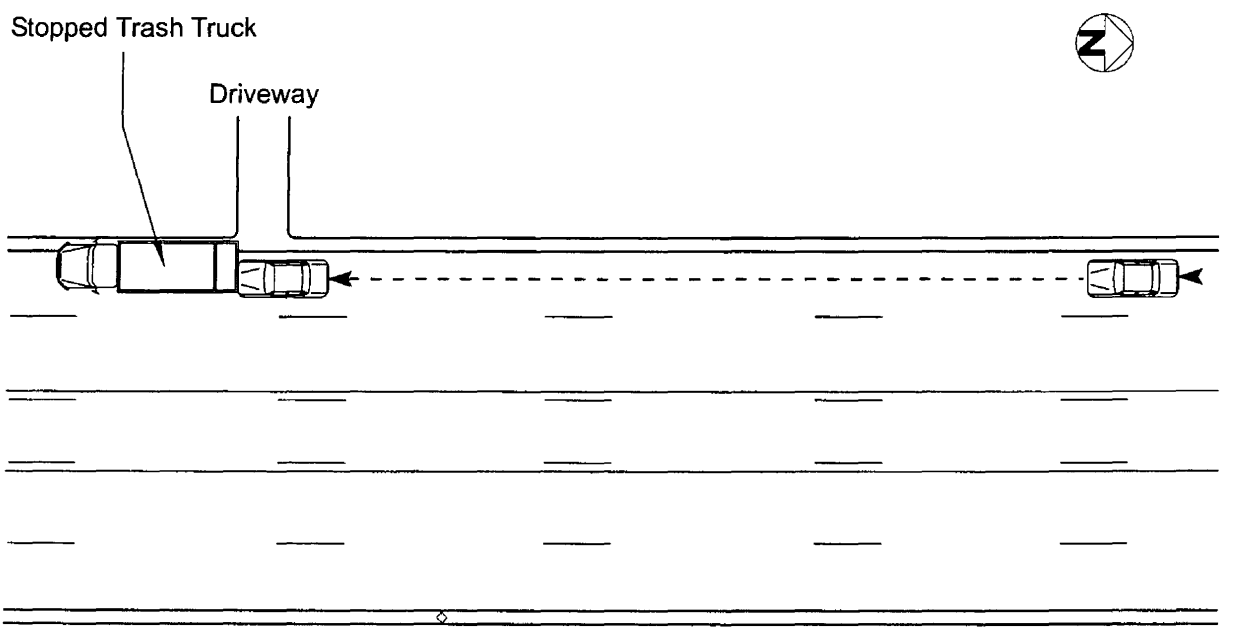
Figure 10. Case Study 2: Crash Diagram, Suburban County Street

Although the car's airbags deployed on impact, the driver did not survive the collision. Because he was not belted, he moved forward at impact and collided with the deploying airbag and steering wheel. He died 18 minutes after the collision, while still in his vehicle, from major trauma to his chest.

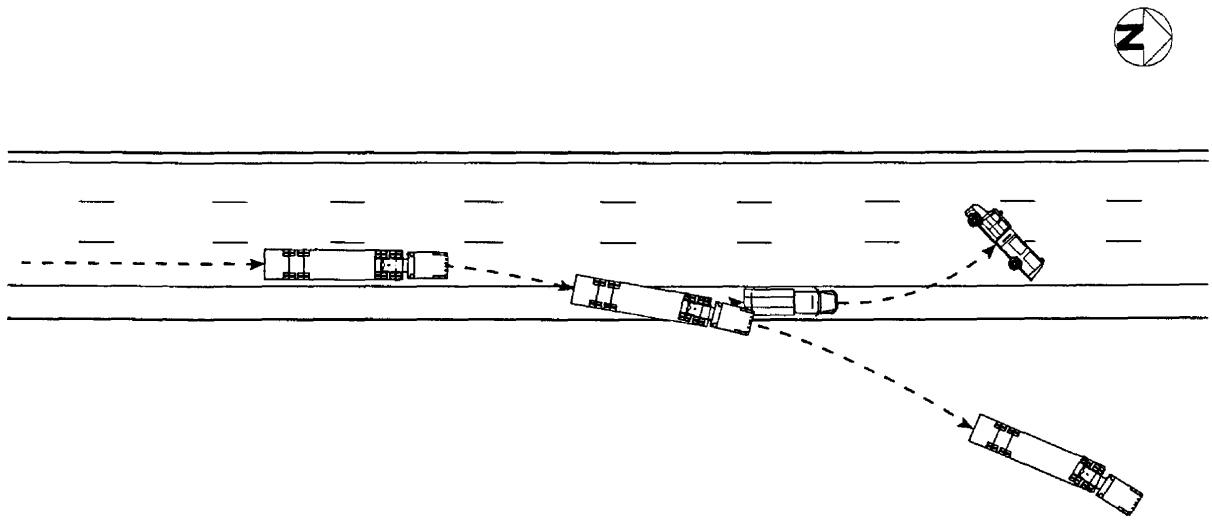
Figure 13. Case Study 3: Crash Diagram, Rural Interstate, Northbound Lane

60 mph as he pulled onto the shoulder. He does not recall whether he signaled when he drove onto the emergency shoulder. The crash truck driver began to brake, and his speed decelerated to only about 2 mph in anticipation of stopping behind the tanker truck.

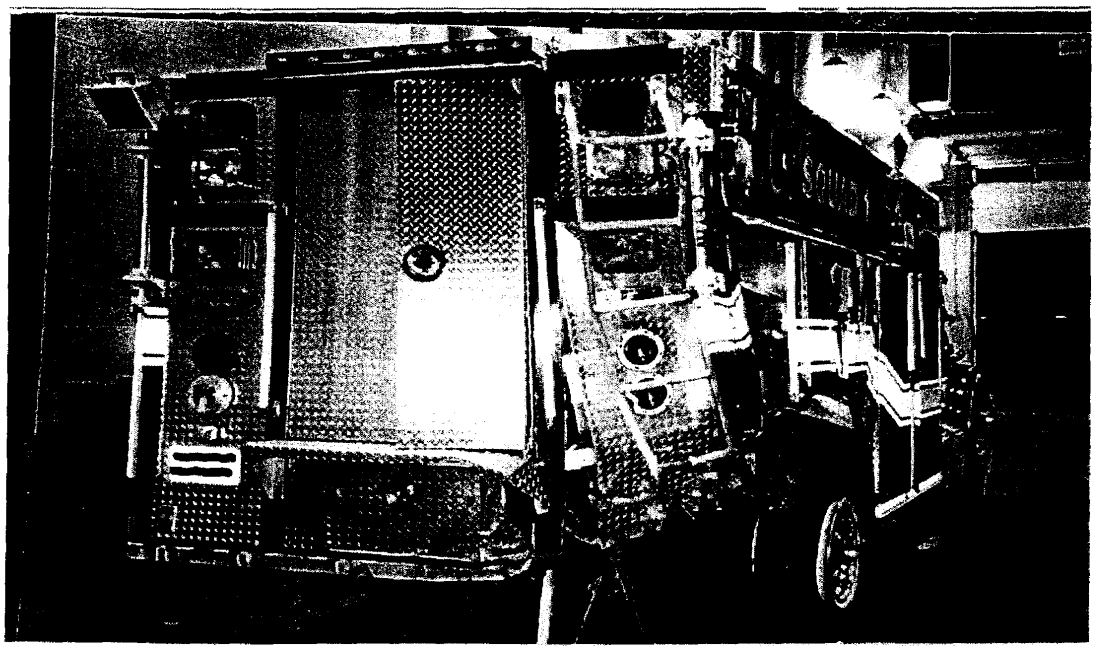
Figure 15. Case Study 3: View Looking at Rear of Involved Fire Truck Showing Damage to Right Corner
