WASHINGTON METRORAIL SAFETY COMMISSION  
ANNUAL REPORT ON THE SAFETY OF THE WMATA RAIL SYSTEM IN 2021

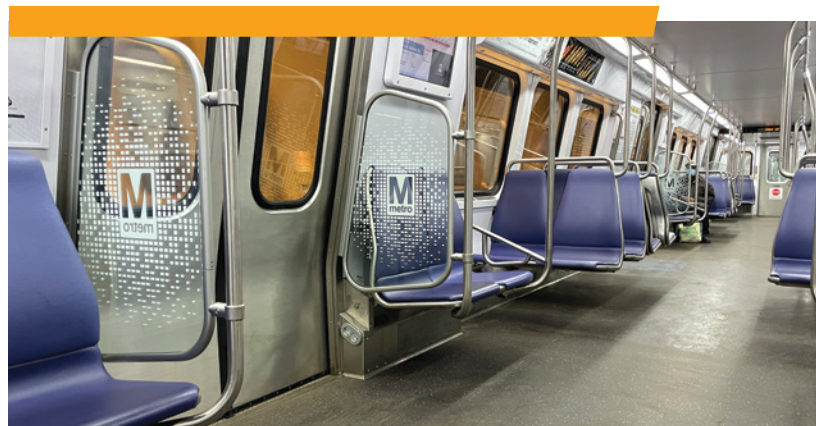
After the derailment, an examination of the derailed car, car 7200, showed that both wheels had moved outward on the axle that derailed. As a result, Metrorail conducted a special inspection of wheel back-to-back measurements of all 7000 series railcars. Twenty railcars failed that special inspection due to wheels that were too far apart on at least one axle.

**"BACK-TO-BACK"  
MEASUREMENT:  
THE DISTANCE  
BETWEEN THE  
INSIDES OF THE  
WHEELS ON A  
GIVEN AXLE.**

Metrorail also included in its plan steps to use a more accurate tool, called a dial gauge, when axles failed using the incremental gauge. In addition, if the measurement increased over two consecutive inspections, the procedure stated that the wheelset would be condemned.

More generally, Metrorail's plan increased the scheduled frequency of back-to-back measurements from every 90 days as part of other inspections, to every 7 days as a standalone inspection.
