Virginia Department of
Behavioral Health &
Developmental Services

Preplanning Study

Central State Hospital Full Replacement 2018

December 1, 2018 rev.1

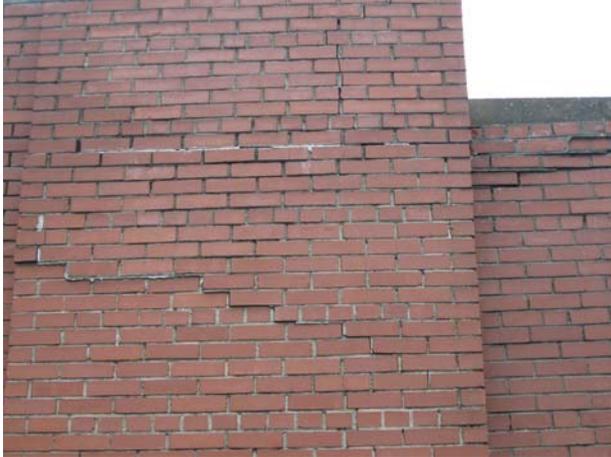
These photos depict the building's failing exterior wall conditions. The photos on the left show damaged masonry. The photos on the right show severe moisture damage.

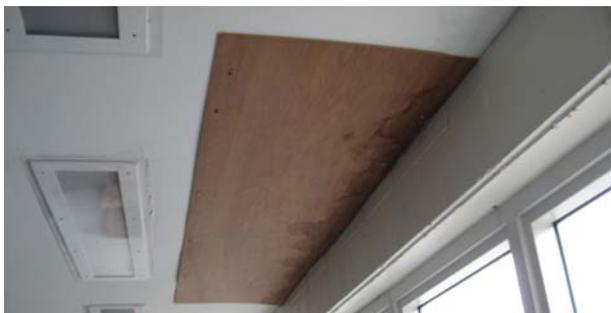
Ceiling collapse, temporary repair, staining on temporary repair near windows

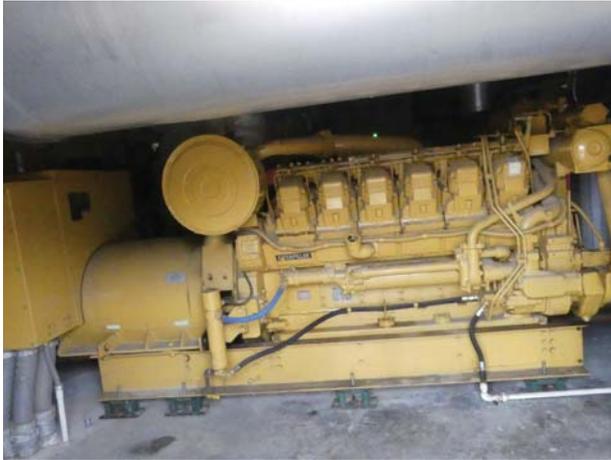
Existing 1000kw diesel generator

life and requires replacement within the next four to six years. Our immediate concerns for the current electrical service are related to the potential for failure of the standby generator and the lack of a secondary connection point (plug) to allow a temporary generator setup. If there is a utility failure and the emergency generator fails, it may require several days for a replacement installation to support the building's electrical service.

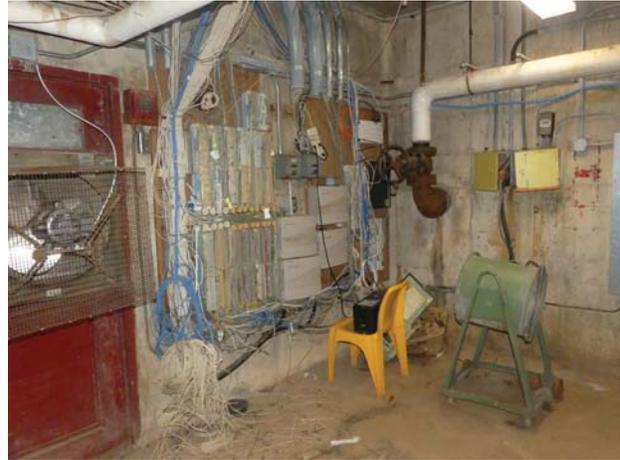
Telephone equipment in unconditioned space

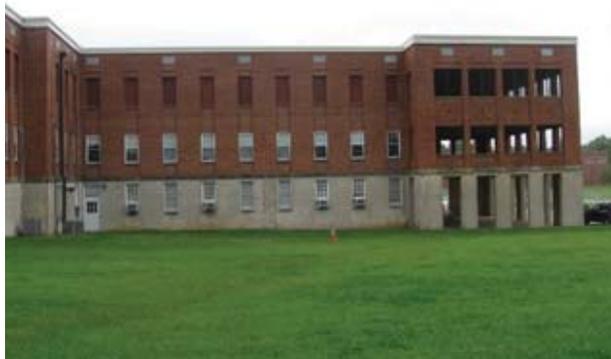
Building exterior, abandoned second floor

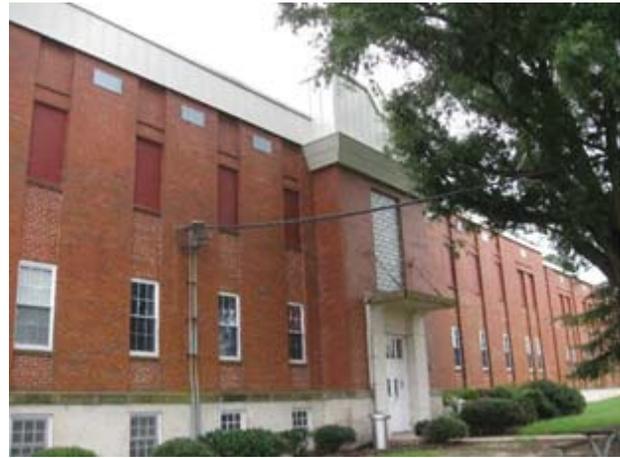
Building exterior, abandoned second floor

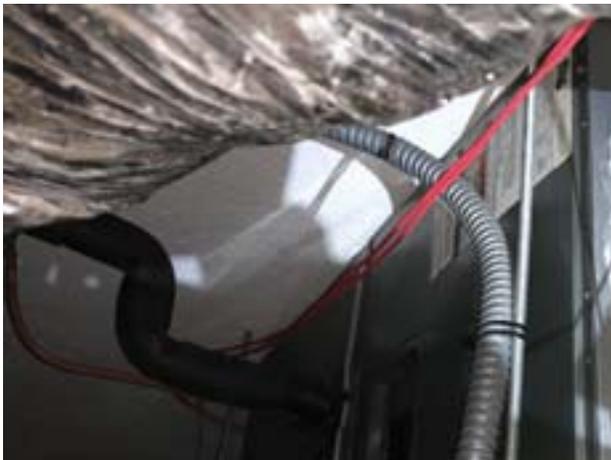
The ages of the heat pumps vary from six to 21 years old. Since outside air is ducted directly to the return for each air handling unit, humidity in the space continually fluctuates as the heat pumps turn on and off resulting in poor indoor air quality throughout the building. Furthermore, it is suspected that ventilation rates are lower than the code-required values for the spaces served.

Indoor air handling unit located in ceiling plenum

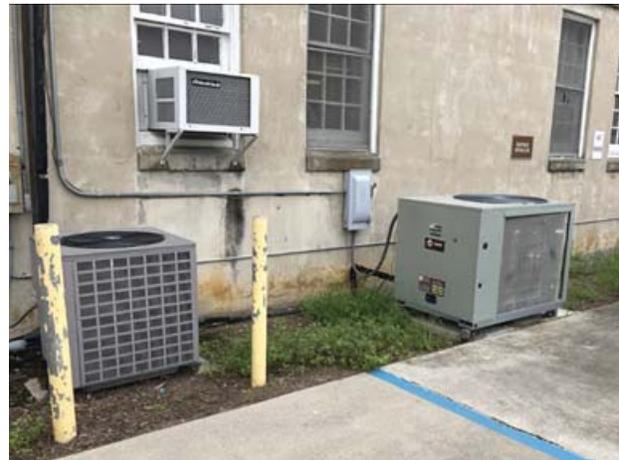
Heat pumps and window air conditioner

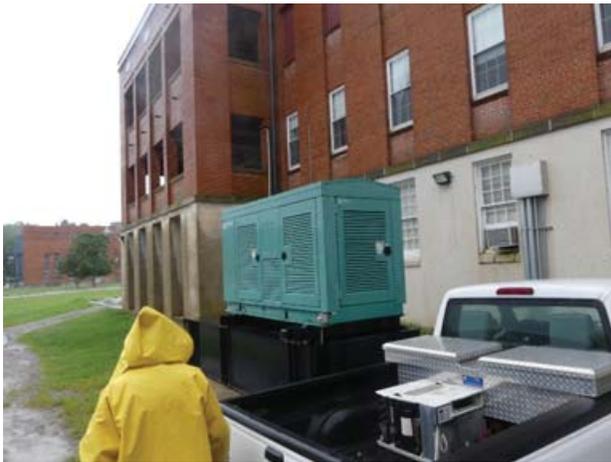
The electrical service primary equipment is in acceptable condition. Some interior panels and wiring are no longer serviceable and may cause outages in parts of the building for days. There is no secondary connection point in the electrical system to allow a temporary generator to be connected to the electrical system. If there is a utility failure and the stand-by generator was to fail, it would require several days to disconnect the existing generator and connect the temporary generator to the existing electrical system.

Existing 300kw diesel generator

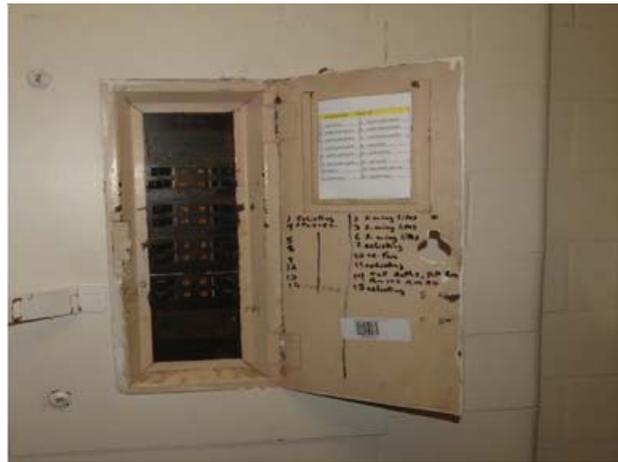
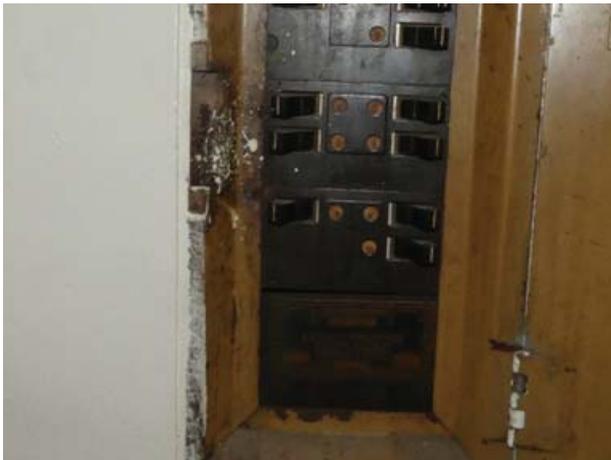
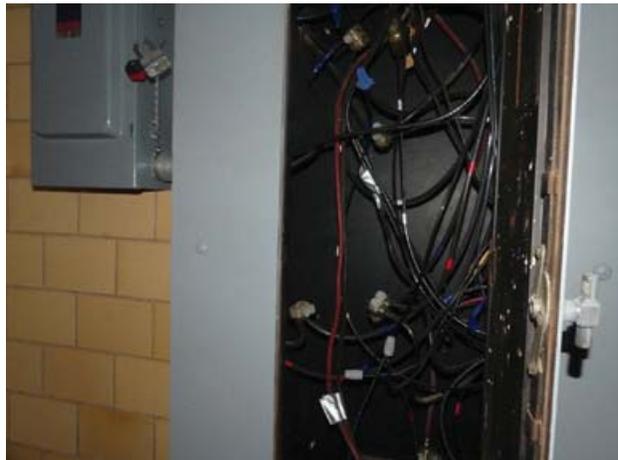
Interior distribution panels

Interior distribution panels/interior wiring

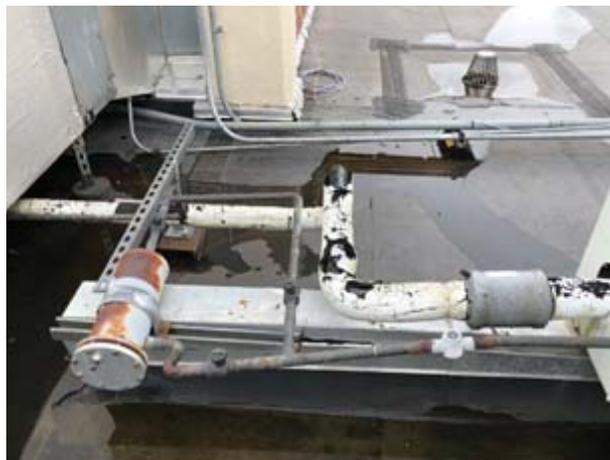
The HVAC systems were renovated within the past 15 years and appear in fair condition. The refrigerant piping between the condensing unit and the duct-mounted cooling coils are in poor condition and show signs of rust and deterioration. The refrigerant pipe insulation is damaged and missing in multiple locations. The heat pump and various exhaust fans are also past their median life expectancy.

Refrigerant piping on roof

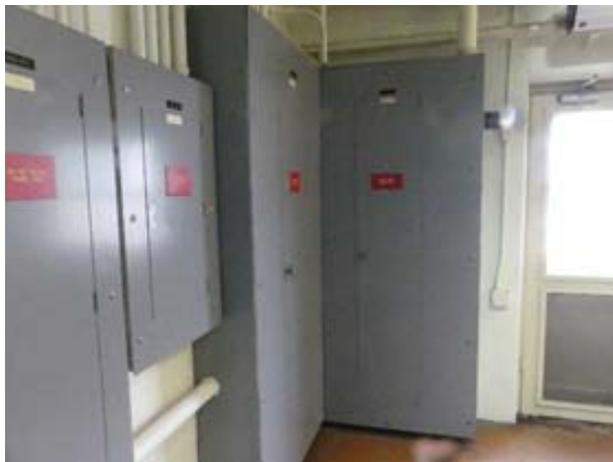
The main electrical service equipment is in good condition but will reach the end of its serviceable life in the next five to ten years.

Existing electrical service

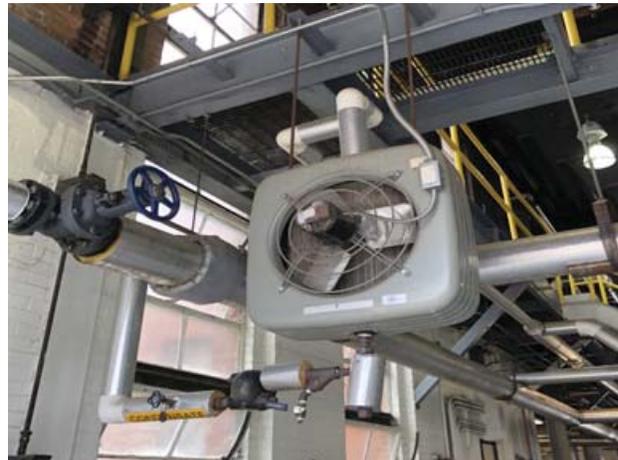
The unit heaters appear in fair condition with no major items to be noted. The steam pipe insulation serving the unit heaters appear in good condition.

Steam unit heater

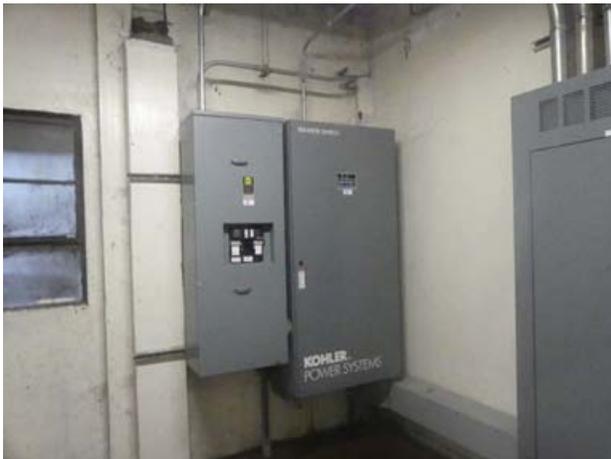
The main electrical service equipment, 500kw generator, and distribution panels were replaced in 2004 and are in good condition.

Electrical service and automatic transfer switch

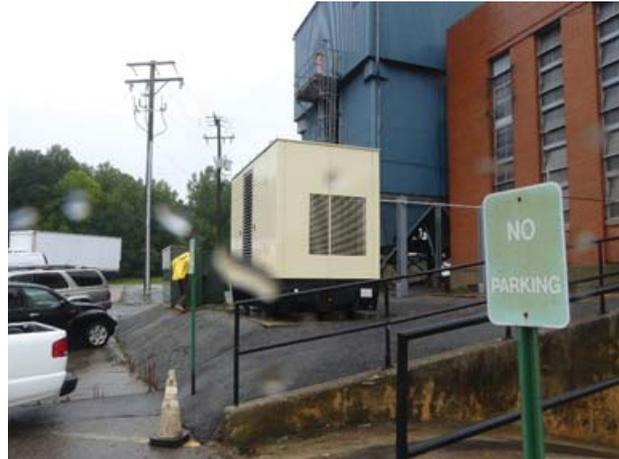
Existing 500kw diesel generator

The existing generator is set up as standby power only and does not meet the emergency lighting code. Additional emergency lighting fixtures are required to meet code.

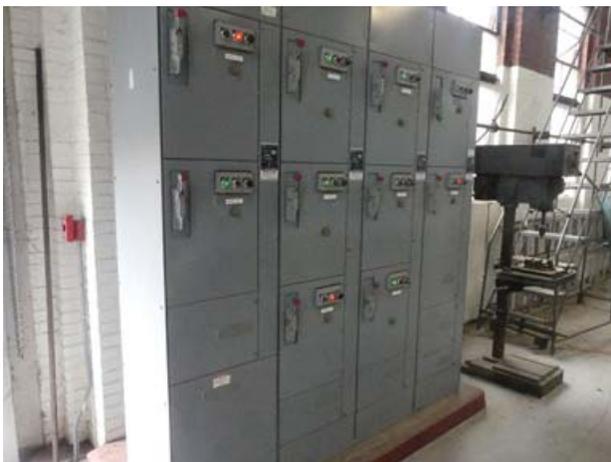
Existing motor control center

The existing motor control center is older than the rest of the electrical systems in the building and the replacement parts for this unit will become difficult to locate in the next five to six years.

The building's electrical system is in good condition; however, within the next eight to ten years the motor control center will reach the age that replacement parts will become an issue and no longer be serviceable. The emergency generator is 14 years old and should be replaced in the next six years. There is no secondary connection point in the electrical system to allow a temporary generator to be connected to the existing electrical system. If there is a utility failure and the standby generator also fails it will require several days to disconnect the existing generator and connect the temporary generator to the existing electrical system.

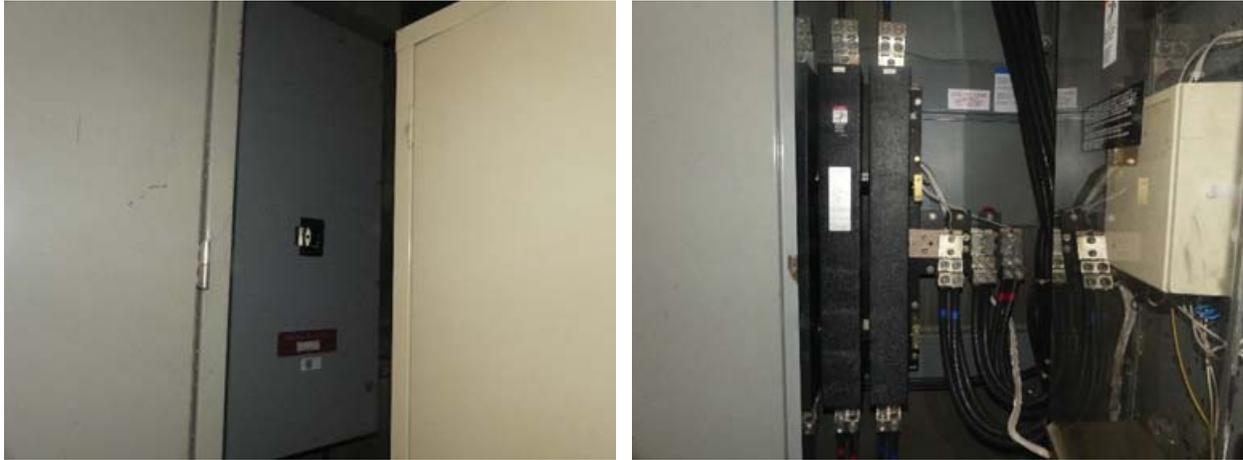
The entire electrical distribution system and generator system are no longer serviceable. The interior lighting does not meet emergency lighting codes.

Electrical service and automatic transfer switch

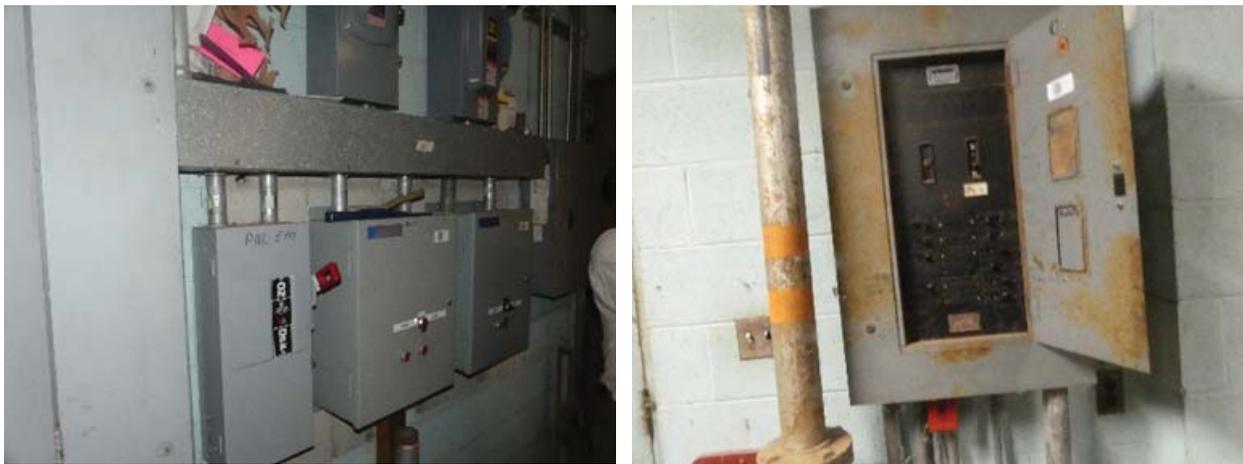
Existing electrical panels

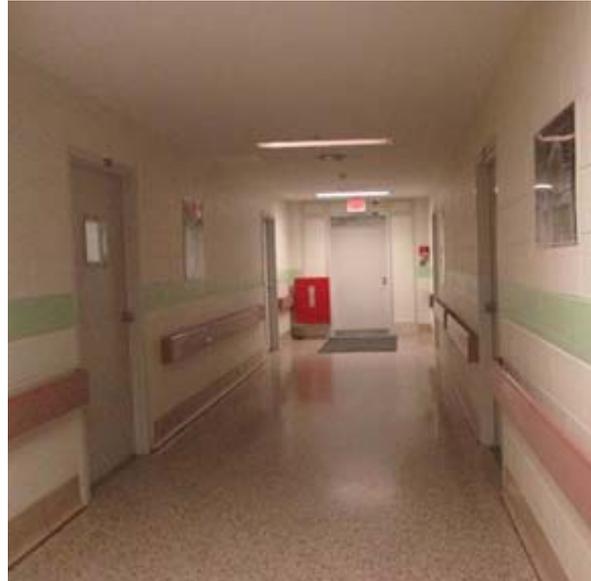
Each of the Ward areas, both administrative and residential/treatment areas, have sustained moisture damage from storm water seeping under doors or through the exterior walls. Other areas also have remedial moisture damage.

Patient wing corridor

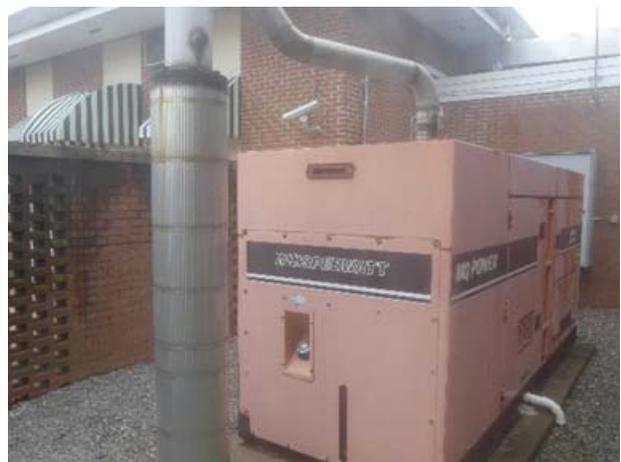
The standby generator system was added in 1999 along with a 600 amp service disconnect next to the automatic transfer switch. The generator is rated for 300 amp at 480v indicating the primary main service and the generator are not coordinated. Coordination between the primary main service and the standby generator is critical for protection from overloading of the generator and potential failure.

194 kw generator

The original service switchgear should be replaced. If there is a failure it would separate the building from the generator system and the building would be without power for several weeks. The standby generator is not coordinated with the building service and should be evaluated to either be upgraded or the building service reduced. The standby generator has nearly reached the end of its serviceable life and should be replaced in the next five years. There is no secondary connection point in the electrical system to allow a temporary generator to be connected to the existing electrical system. If there is a utility failure and the emergency generator fails it will require several days to disconnect the existing generator and connect the temporary generator to the existing electrical system.

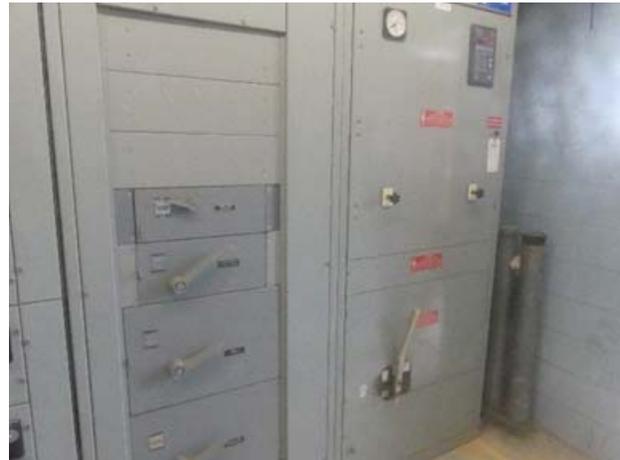
Original service switchgear

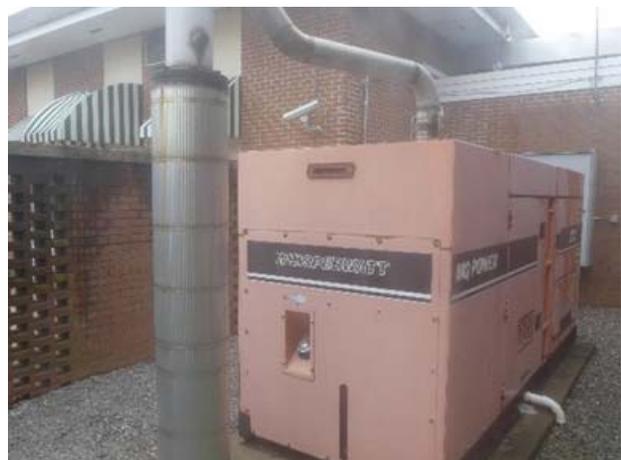
194 kw generator

The original service switchgear should be replaced. If there is a failure it would separate the building from the generator system and the building would be without power for several weeks. The standby generator is not coordinated with the building service and should be evaluated to either be upgraded or the building service reduced. The standby generator has nearly reached the end of its serviceable life and should be replaced in the next five years. There is no secondary connection point in the electrical system to allow a temporary generator to be connected to the existing electrical system. If there is a utility failure and the emergency generator fails it will require several days to disconnect the existing generator and connect the temporary generator to the existing electrical system.

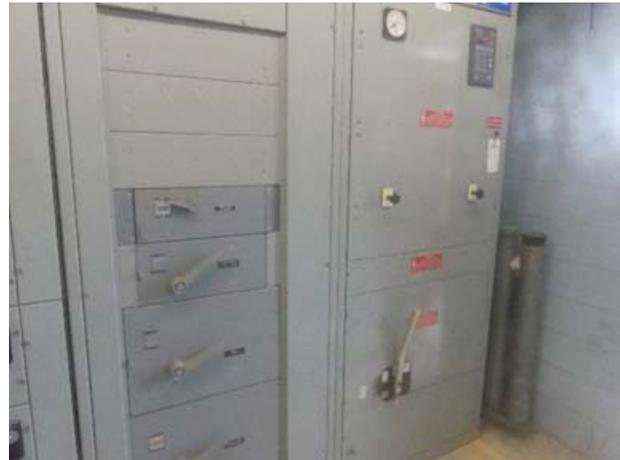
Original service switchgear

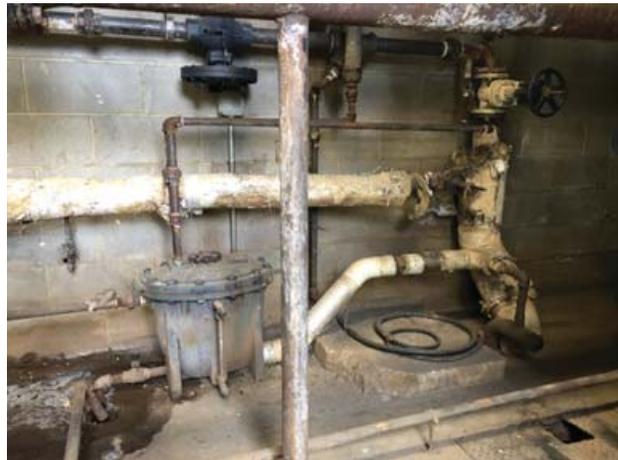
The HVAC equipment and systems serving the building are relatively new and appear in good working condition. Portions of the pipe and pipe insulation in the mechanical room were replaced in the recent renovation. Some of the older runs are corroded and missing insulation, resulting in a loss of efficiency.

Piping in mechanical room

Pipe insulation in the mechanical room is missing on several runs of pipe resulting in a loss of efficiency due to heat loss from the pipe to the room air. This poses a safety issue with exposed hot water and steam piping. In areas where the insulation is missing, the piping was observed to be severely corroded. It is not clear how much, if any, of the insulation contains asbestos.

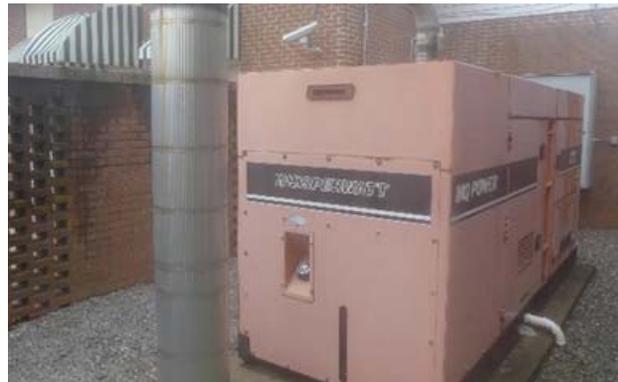
194 kw generator

The original service switchgear should be replaced. If there is a failure it would separate the building from the generator system and the building would be without power for several weeks. The standby generator is not coordinated with the building service and should be evaluated to either be upgraded or the building service reduced. The standby generator has nearly reached the end of its serviceable life and should be replaced in the next five years. There is no secondary connection point in the electrical system to allow a temporary generator to be connected to the existing electrical system. If there is a utility failure and the emergency generator fails it will require several days to disconnect the existing generator and connect the temporary generator to the existing electrical system.

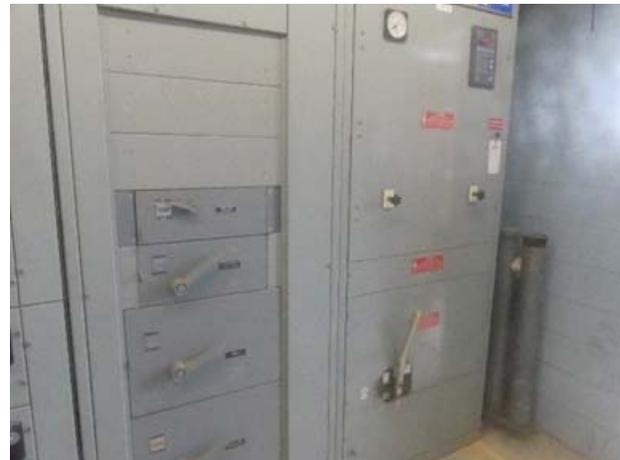
Original service switchgear

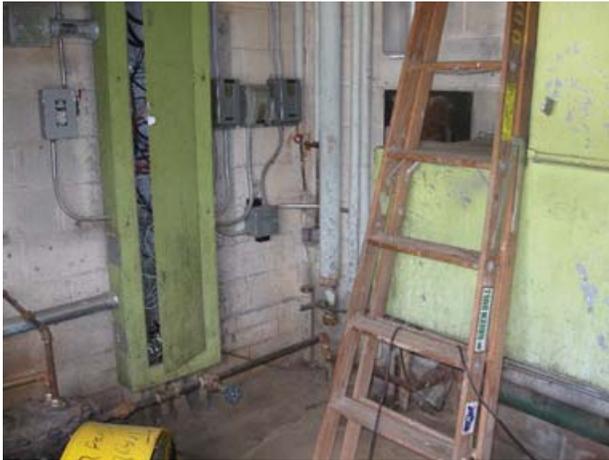
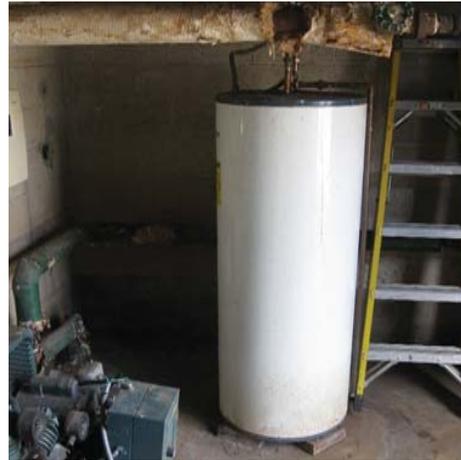
Deteriorated equipment in mechanical equipment closet

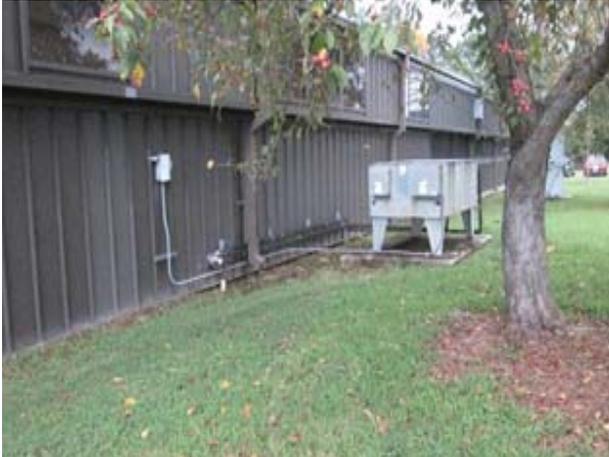
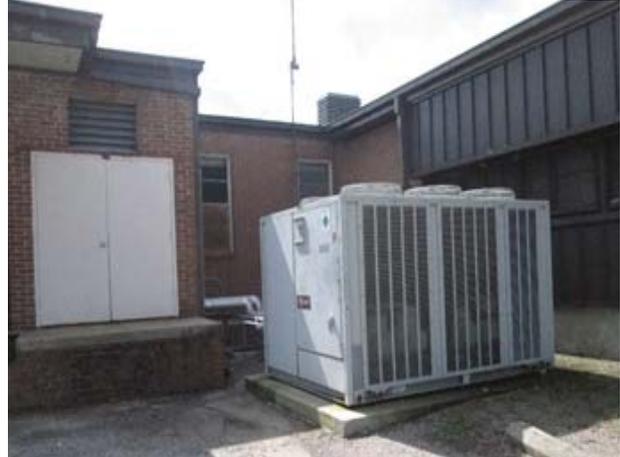
Mechanical equipment exterior conditions

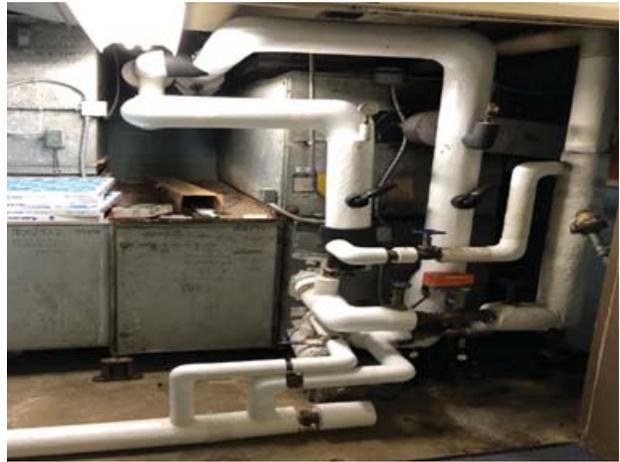
The air handling units have exceeded their useful life and appear in poor condition. The unit casings are showing signs of rust and deterioration and several of the flexible duct connectors are dry rotted with several punctures.

Indoor air handling unit (typical of four units)

The air handling units serving the building are beyond their median service life and may begin to fail over the next few years. Replacing equipment in-kind may require custom units for this building due to the limited access of the air handling units as currently installed. These five units should be replaced at the next opportunity.

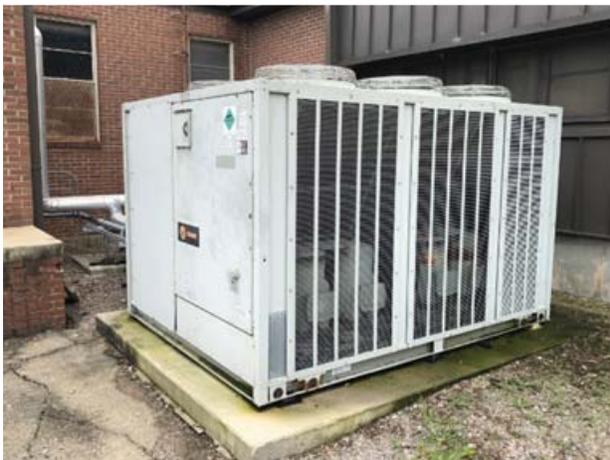
The air-cooled chiller is showing signs of age (such as rust), but it does not have any specific issues at this time. The chilled water pump appears in poor condition. It is dirty and showing signs of rust and deterioration.

Air-cooled chiller

The air-cooled chiller and chilled water pump should continue to operate for another five years with routine maintenance. Since the building only has one chilled water pump, there is no redundancy if the pumps fails or must be isolated for maintenance. A second pump should be provided if redundancy is desired.

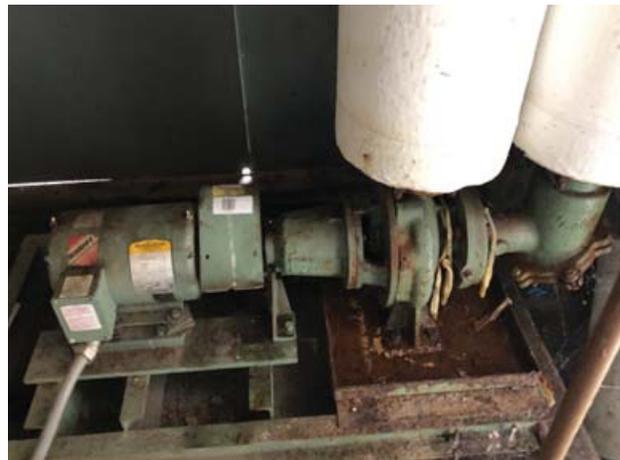
Chilled water pump

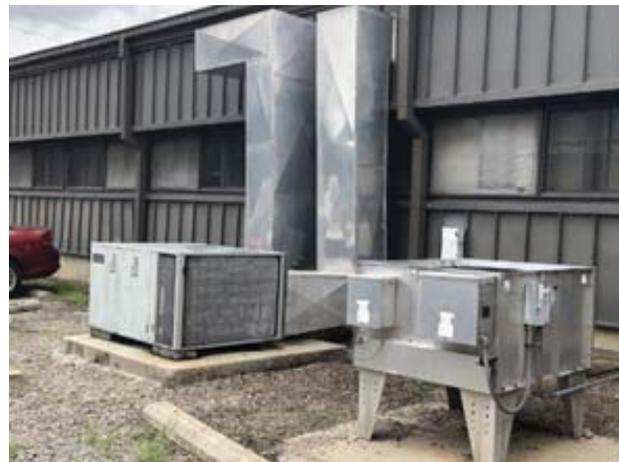
The computer room air conditioners and grade-mounted air handling unit appear in fair condition with no major issues at this time.

Grade mounted air handler and computer room air conditioner condensing unit

The computer room air conditioning units and grade-mounted air handler are still within their median life expectancy and should continue to operate for at least another five years with routine maintenance.

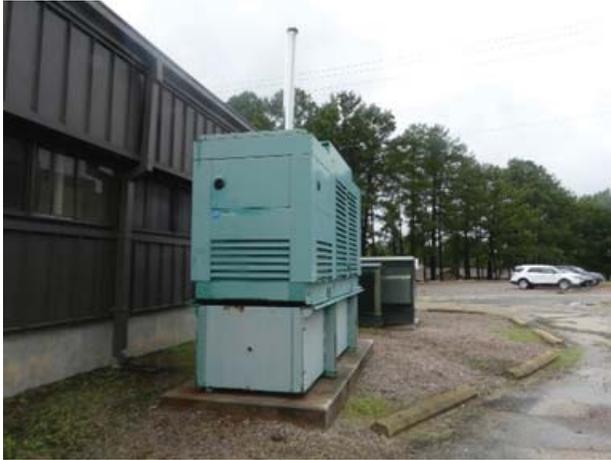
The generator system was added in 2005, as was a 1200 amp service disconnect next to the automatic transfer switch. The generator system is 13 years old and should be replaced within the next seven years.

300kw generator

The overall condition of the electrical system is good. The emergency generator should be replaced in the next seven years. There is no secondary connection point in the electrical system to allow a temporary generator to be connected to the existing electrical system. If there is a utility failure and the standby generator fails it will require several days to disconnect the existing generator and connect the temporary generator to the existing electrical system.

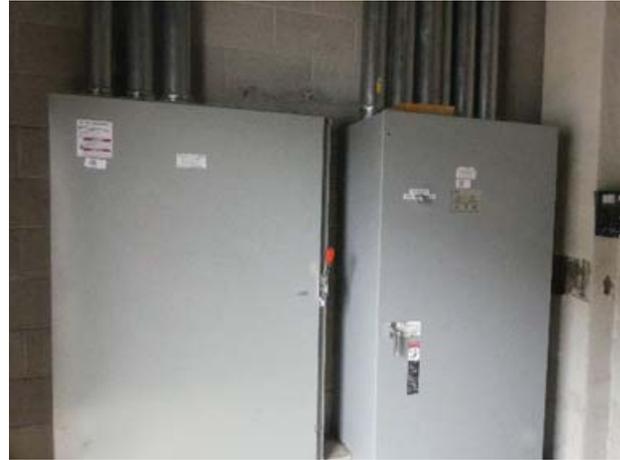
Service disconnect and ATS

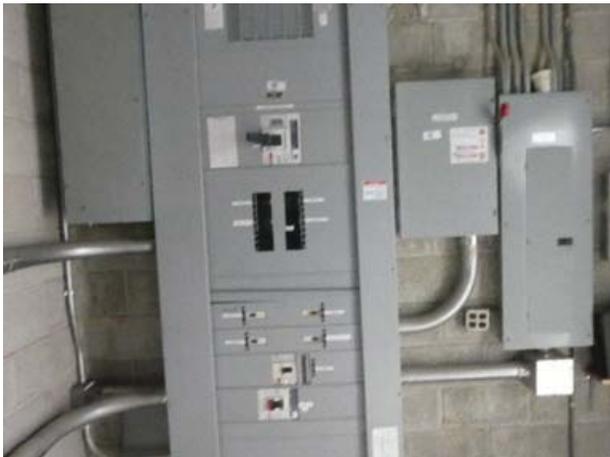
The main distribution panels have been replaced as well as most of the interior panels and are in good condition. Some of the smaller distribution panels in the building have reached the end of their serviceable life and should be replaced.

Main distribution panel

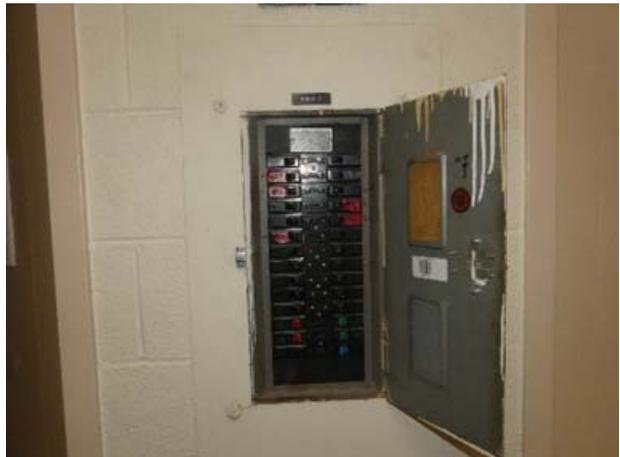
Original small distribution panels

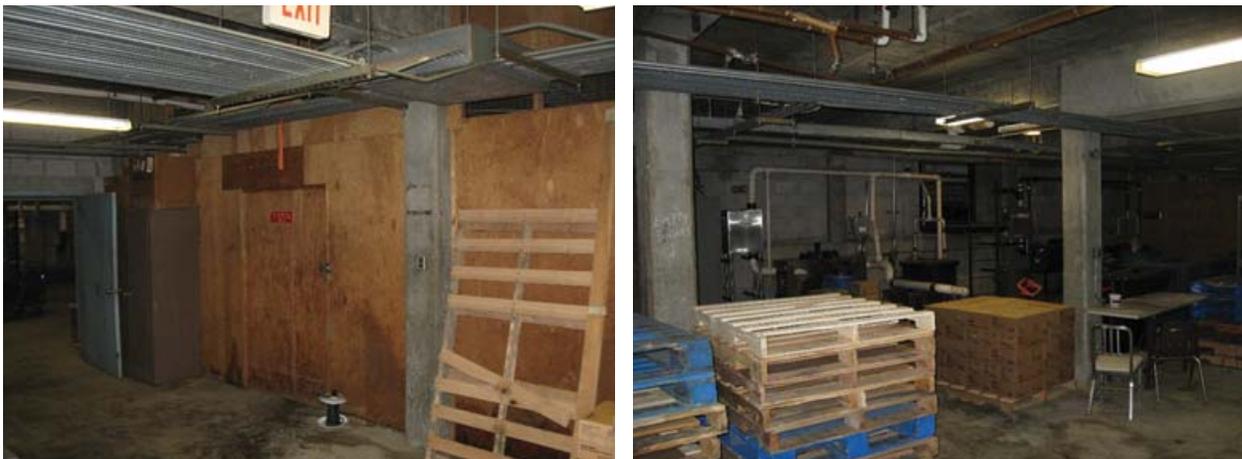
Food storage areas

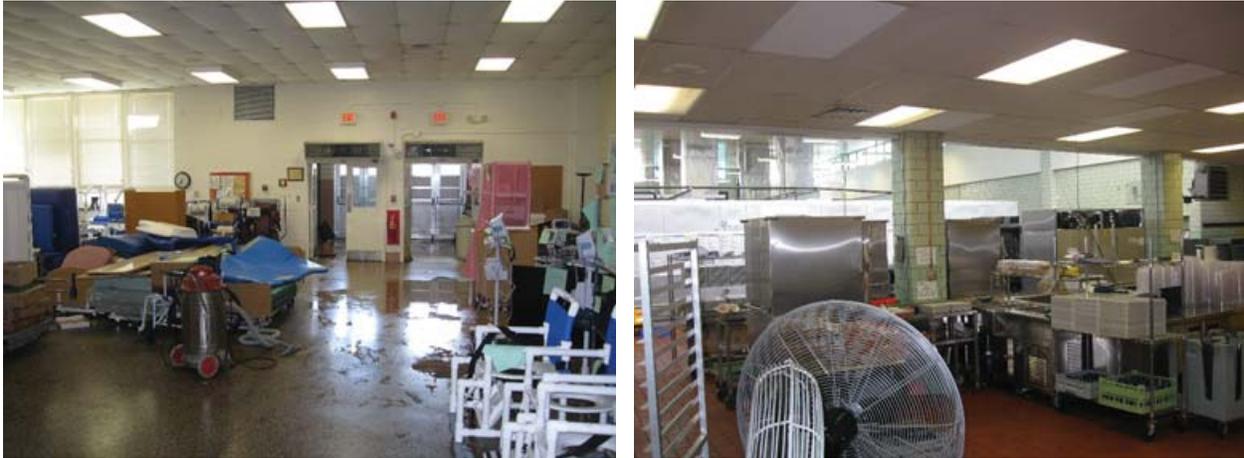
Food preparation areas

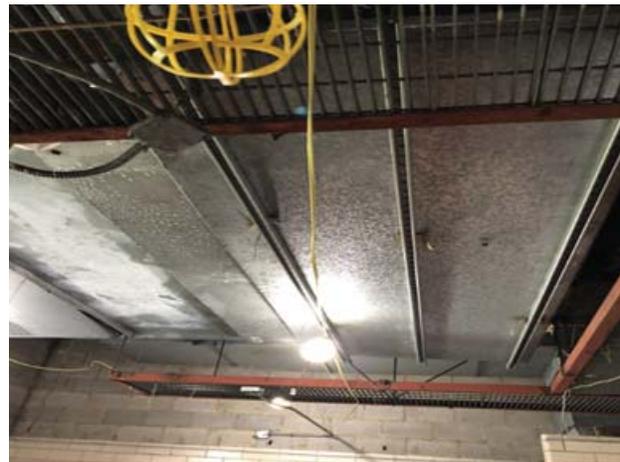
Indoor air handling unit with condensation forming on unit casing

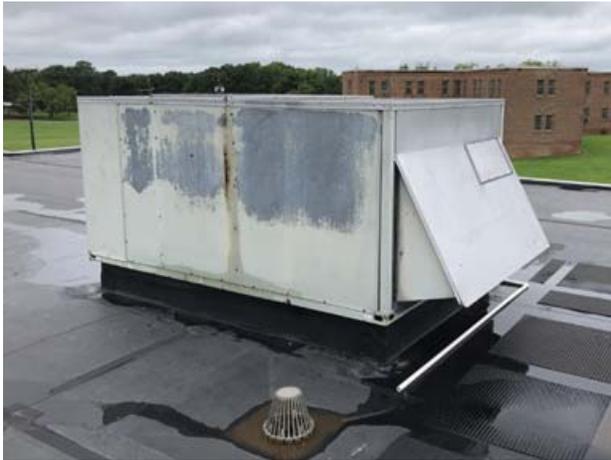
Rooftop air handling unit

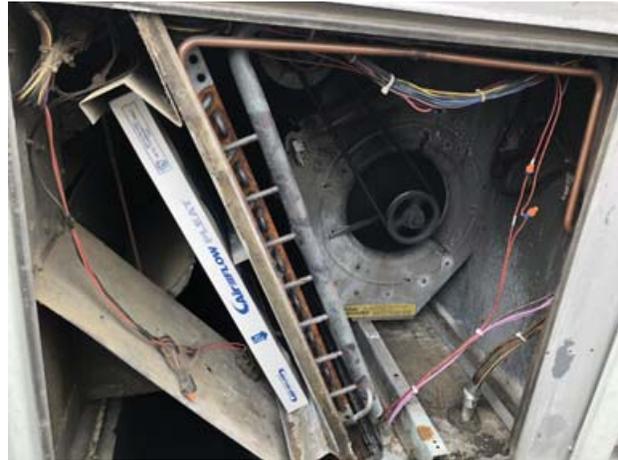
Inside of rooftop air handling unit

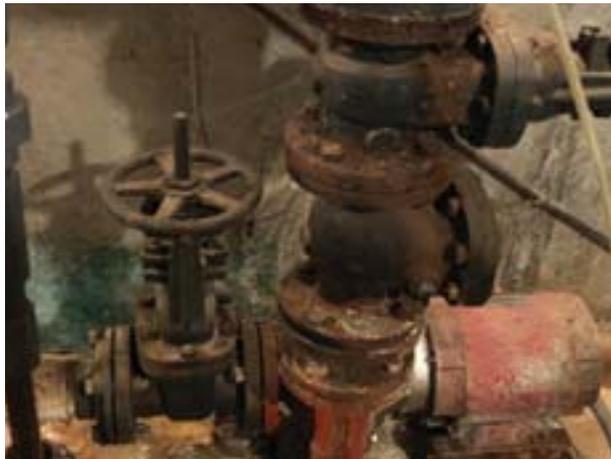
Condenser water pump for refrigerator compressives

basement. The cooling tower and condenser water pump are past their useful life. A different configuration of condensing units should be considered for the refrigerated equipment.

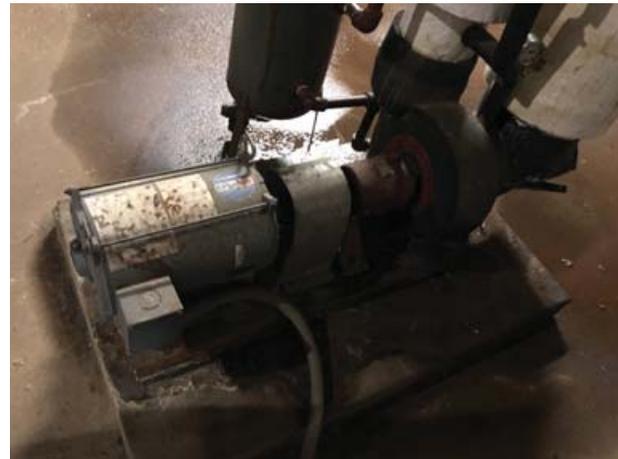
Chilled water pump

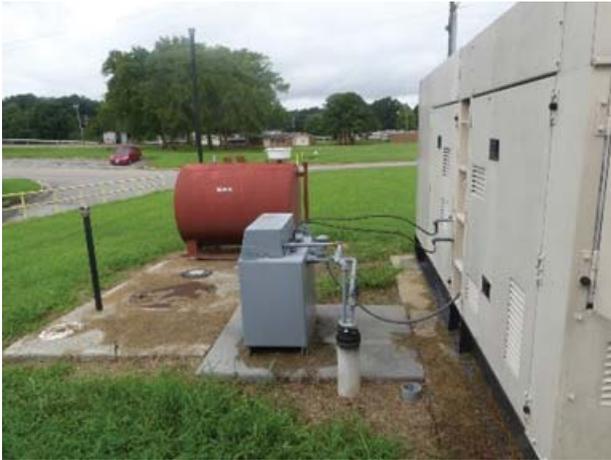
300kw generator

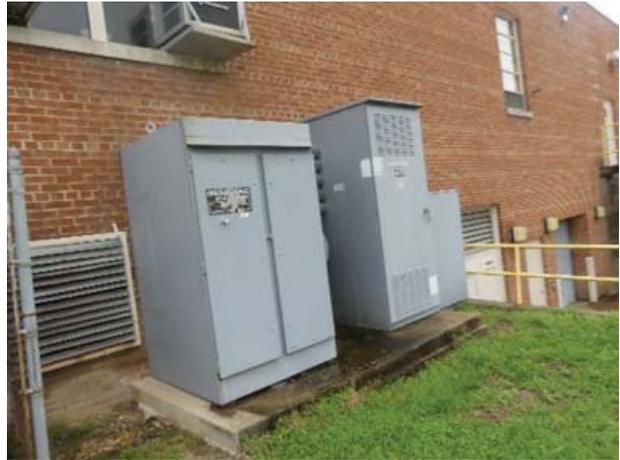
Service disconnect and ATS

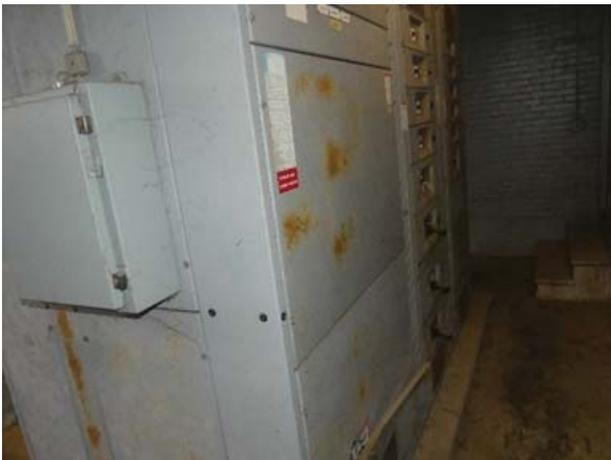
The main distribution panel and the motor control center are original and have reached the end of their serviceable life. The rest of the internal panels have four to five years left in their serviceable life and replacement parts will be difficult to find due to the age and manufacture of the equipment.

Main distribution panel

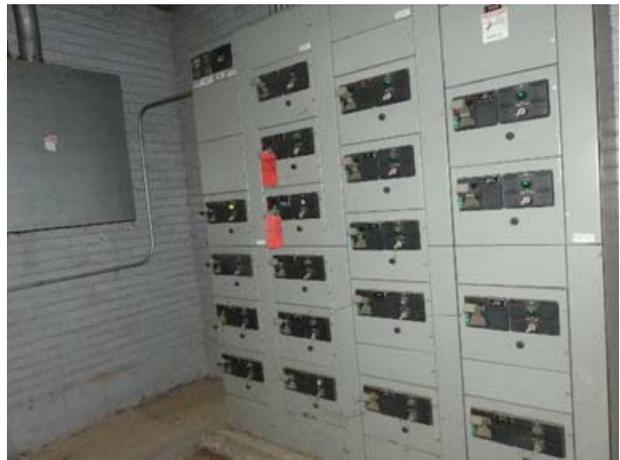
Motor control center

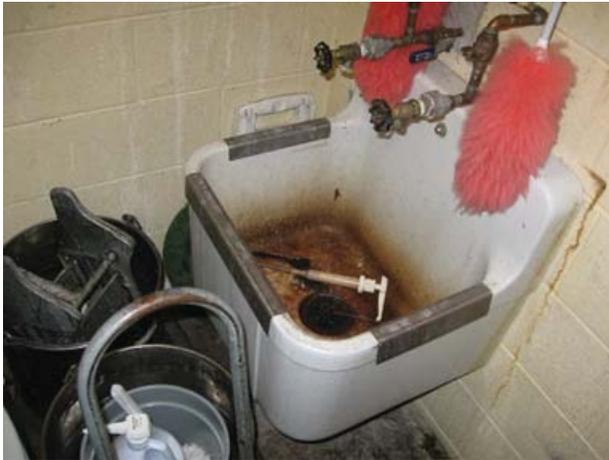
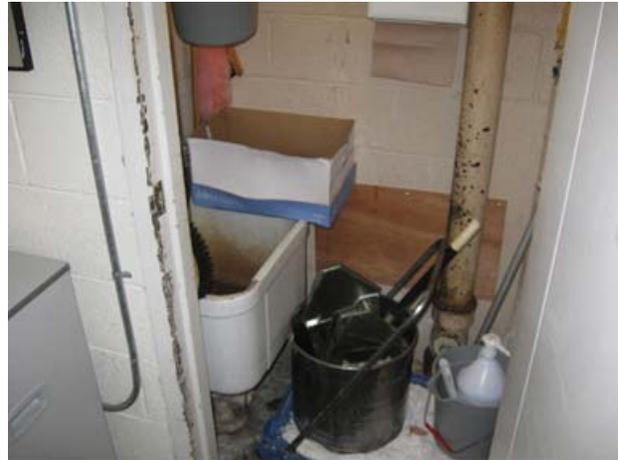
Utility sinks and janitorial areas

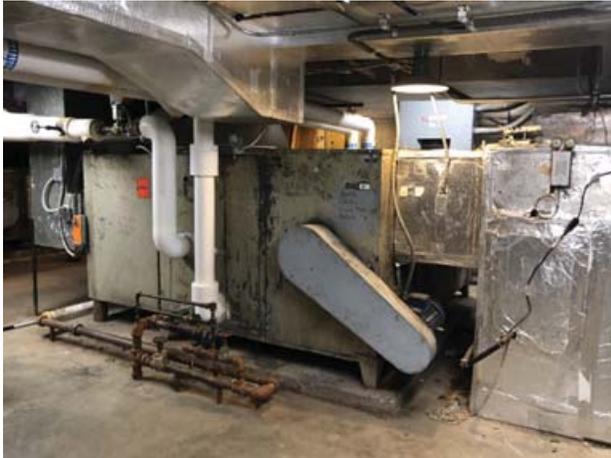
The three air handling units are in poor condition and show severe signs of deterioration on the unit casing as well as ductwork connections. The flexible duct connectors have dry rotted in some places, with large holes open to the mechanical room. Air can be felt leaking through several joints in the air handling units. The interior portions of the units are dirty and could be contributing to poor indoor air quality.

Air handling unit

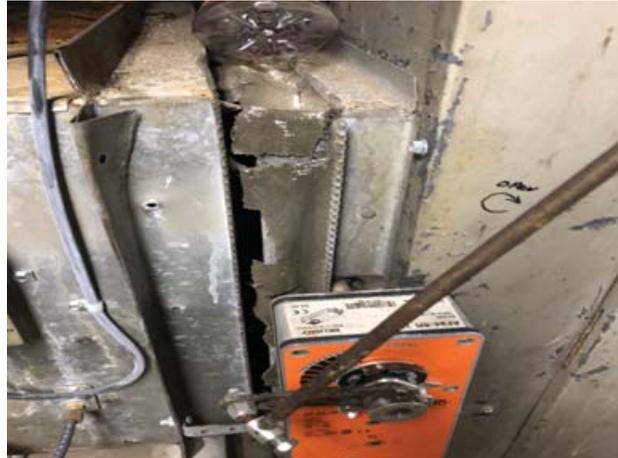
Dry rotted flexible duct connector

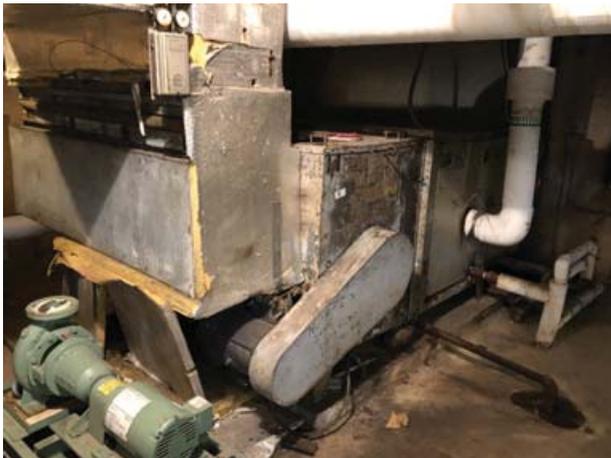
Air handling unit with damaged ductwork and insulation

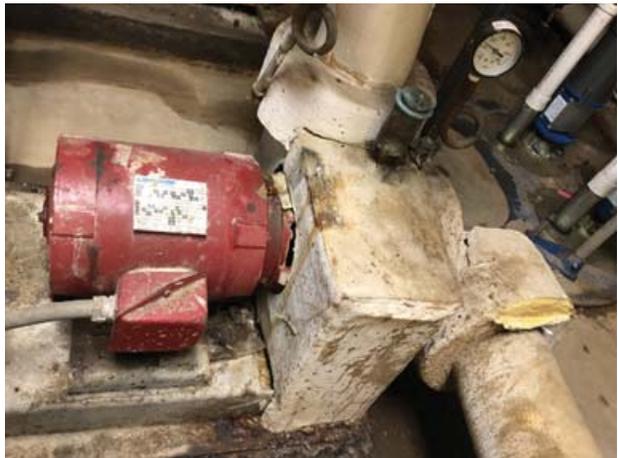
The hot water pumps appear in fair condition, but the chilled water pump is older and appears in poor condition. Much of the hot water and chilled water piping and valves show signs of rust and deterioration.

Chilled water pump

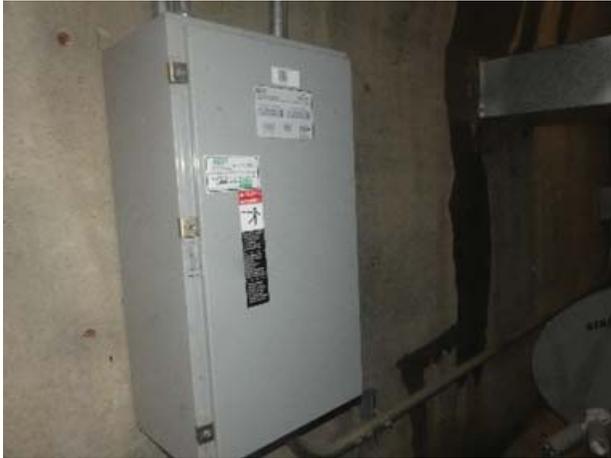
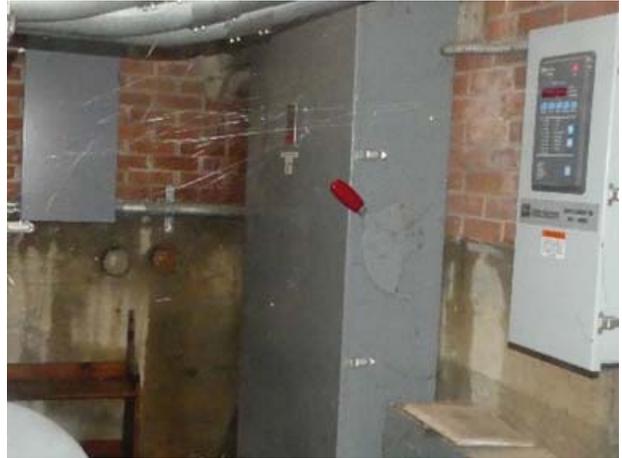
New electrical service and automatic transfer switch

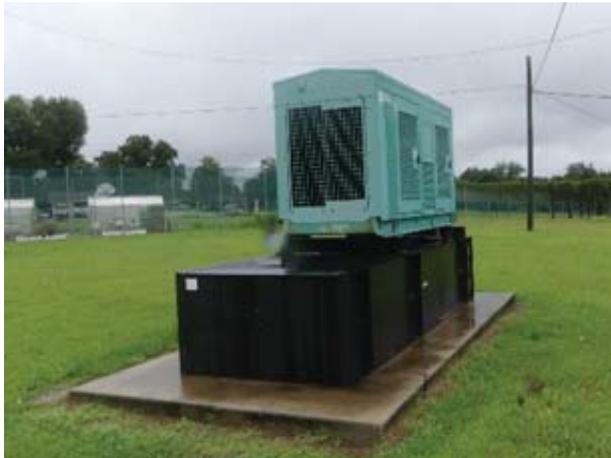
The building's electrical system is not reliable. Because this building houses the communication head end equipment for the campus, an outage will have a significant effect on the operations of CSH. The standby generator has nearly reached the end of its serviceable life and should be replaced in the next four years. There is no secondary connection point in the electrical system to allow a temporary generator to be connected to the existing electrical system. If there is a utility failure and the standby generator also fails it will require several days to disconnect the existing generator and connect the temporary generator to the existing electrical system.

Existing 250kw diesel generator

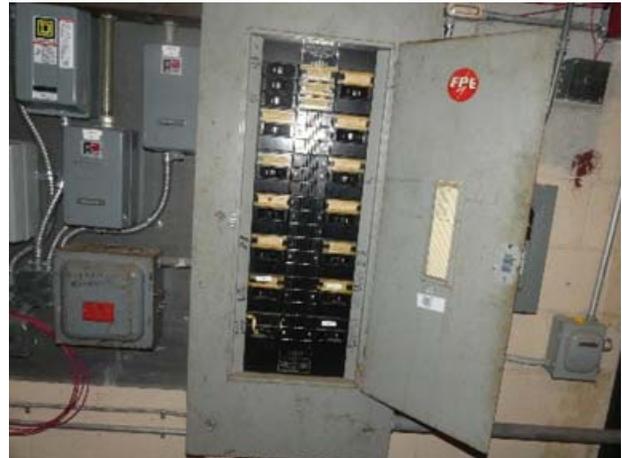
Electrical distribution panels

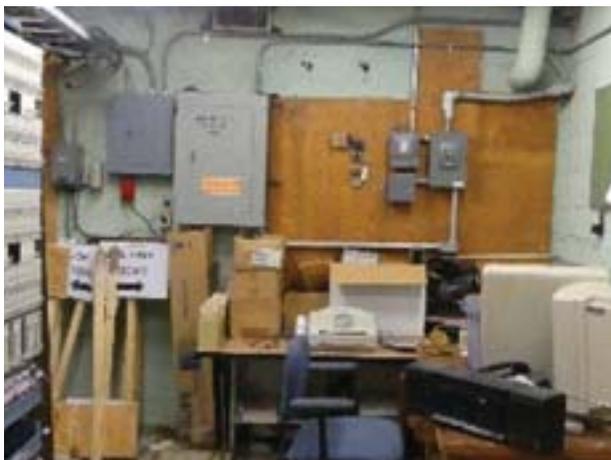
Telephone equipment

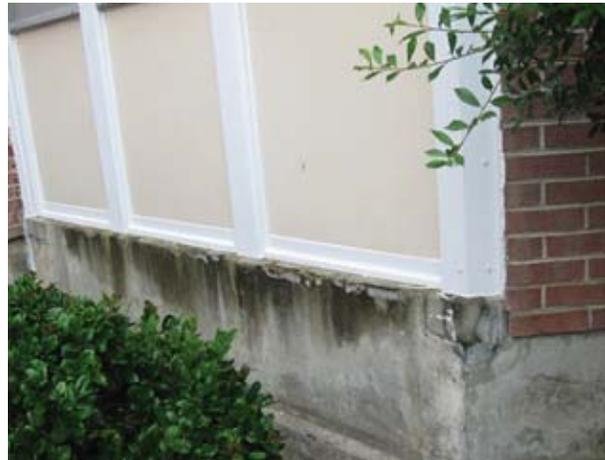
Mold and damaged foundation wall

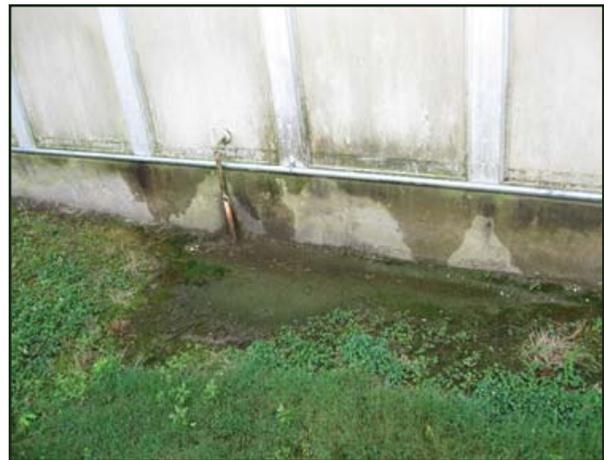
Apparent interior wall plumbing issue resulting in damage and mold on foundation wall
