Virginia Department of
Behavioral Health &
Developmental Services

Preplanning Study

Central State Hospital Full Replacement 2018

December 1, 2018 rev.1

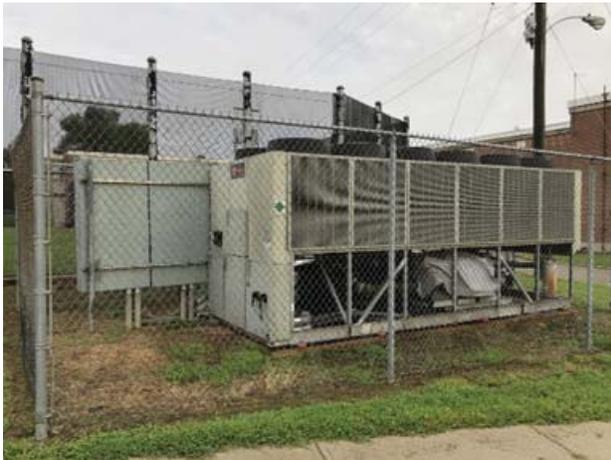
The HVAC equipment and systems serving this building are less than 10 years old and appear in good working order. Some locations on the second floor are not served by the outside air units, but rather small air handling units with outside air directly to the return side of the units. These spaces had a noticeably lower air quality than other parts of the building. Indoor air quality could be improved with more sophisticated controls to limit swings in humidity or by providing a separate 100% outside air unit for these spaces.

Air-cooled chiller

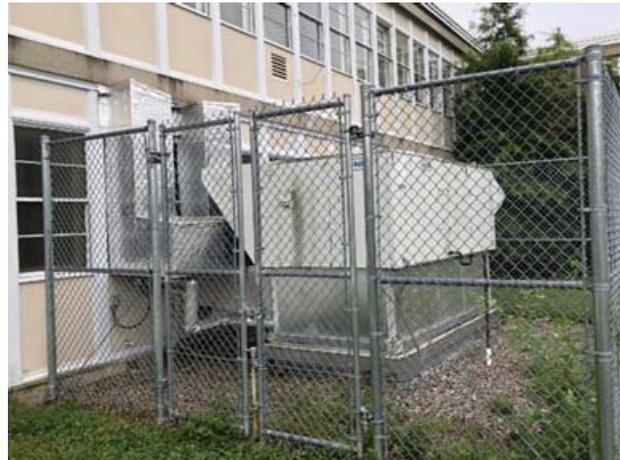
100% outside air unit

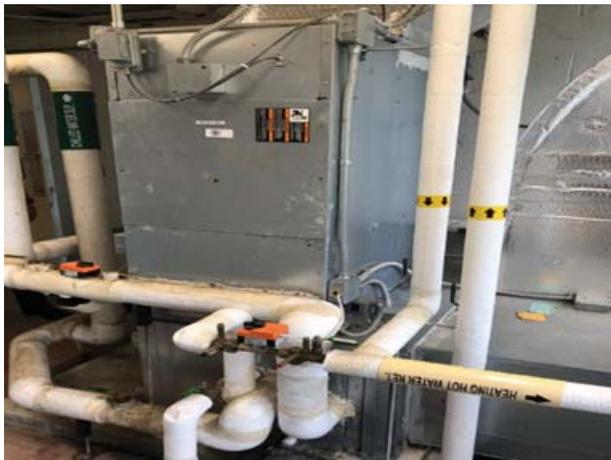
Indoor air handling unit

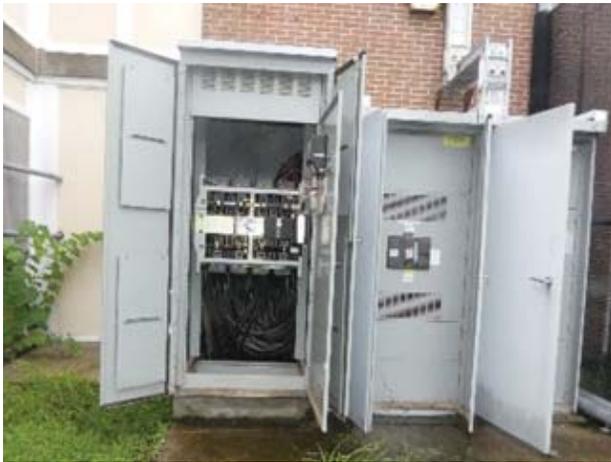
The main electrical service equipment has been replaced within the last five years and is in good condition. The 750kw generator was installed in 2007 and is in good condition. We believe the remaining serviceable life of each item is ten years before equipment replacement parts are no longer available.

Electrical service and automatic transfer switch

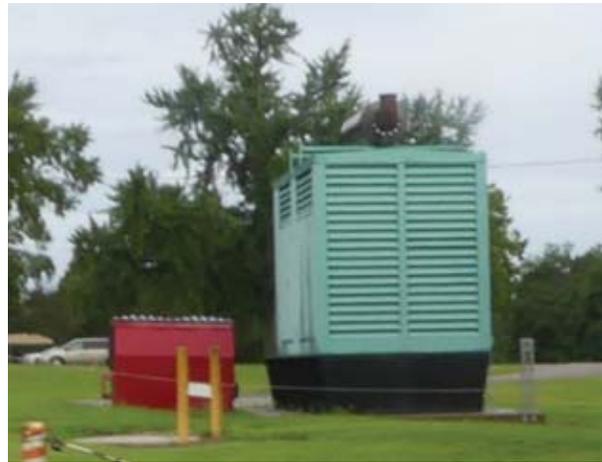
750kw diesel generator

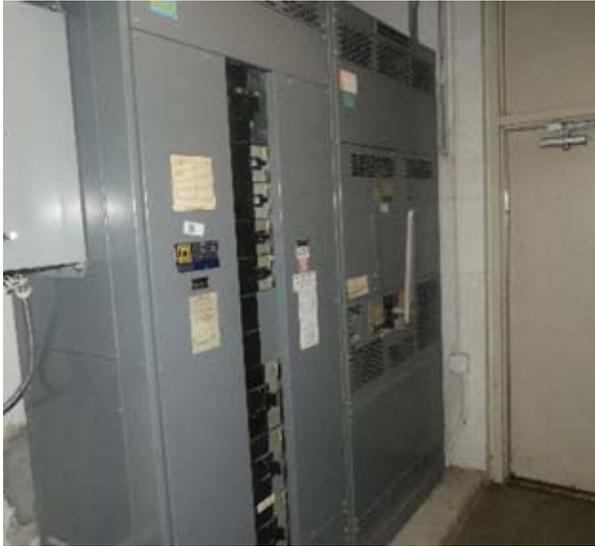
The distribution panels located throughout the facility are in fair condition and have eight to ten years of serviceable life remaining.

Main distribution board

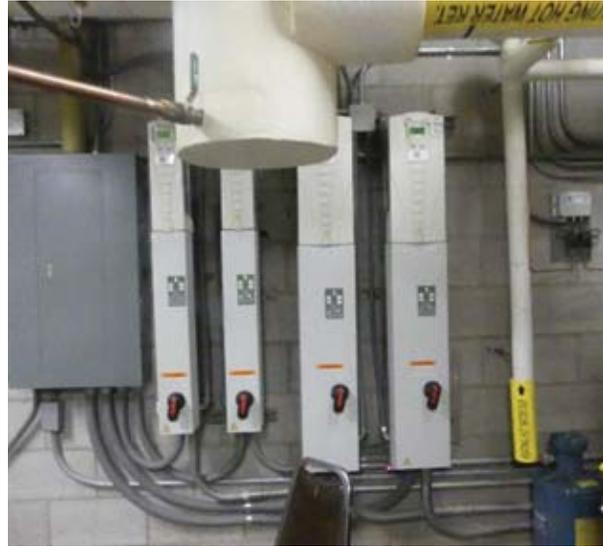
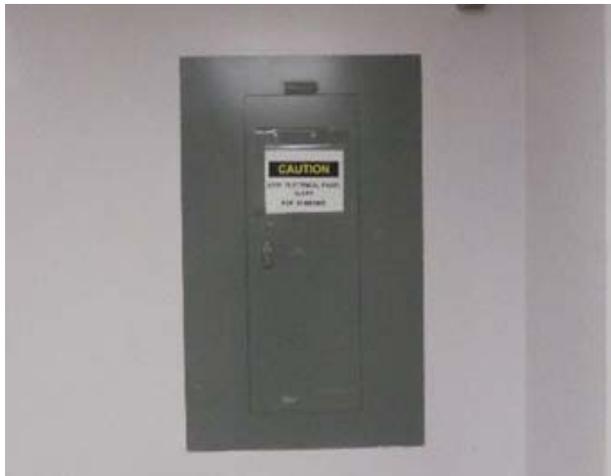
Typical electrical panel

The remaining interior electrical panels throughout the building are older panels but are still serviceable. The remaining serviceable life of the secondary distribution panels is approximately two to three years.

The main electrical system for Building 114 is in good condition with a serviceable life of eight to ten years. The distribution panels are nearing the end of their serviceable life and require replacement within the next two to three years. There is no secondary connection point in the electrical system to allow a temporary generator to be connected to the existing electrical system. If there is a utility failure and the standby generator also fails it will require several days to disconnect the existing generator and connect the temporary generator to the existing electrical system.

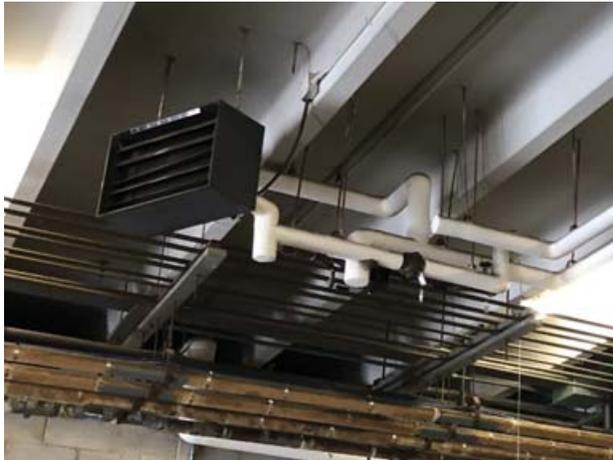
Steam unit heater

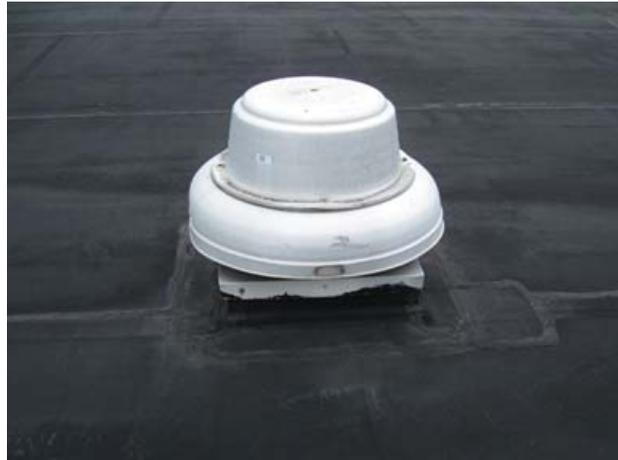
Rooftop exhaust fan

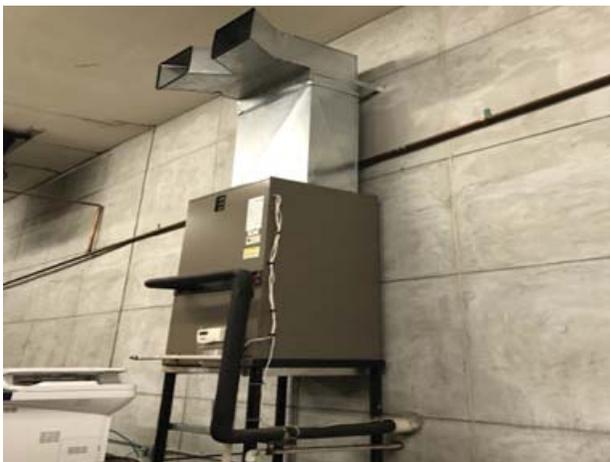
Split system air conditioner

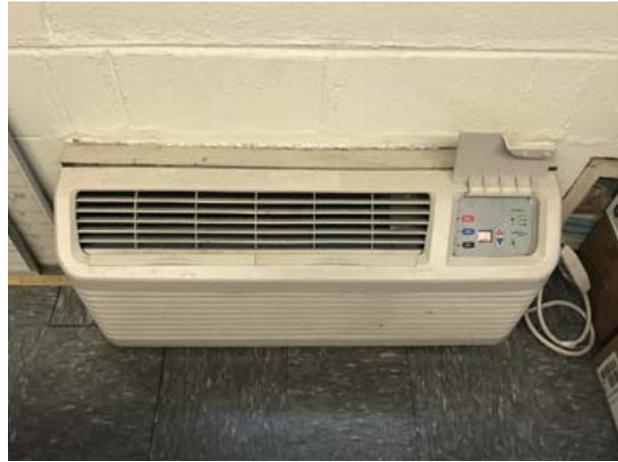
Through-the-wall air conditioner

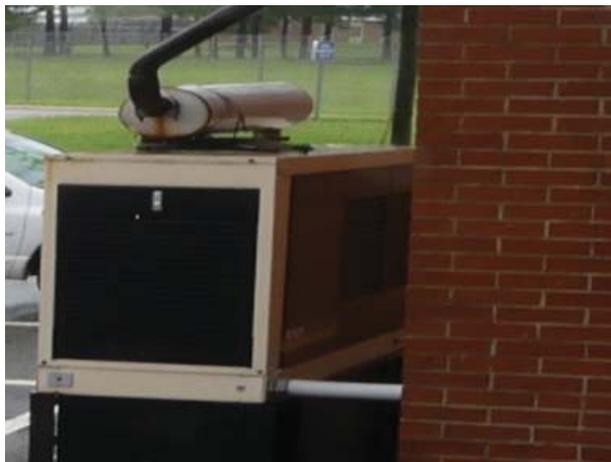
The generator system was installed in 1999 and included a 600 amp service disconnect next to the automatic transfer switch. The generator is rated for 300 amp service at 208v. Based on our observation the generator installation and main electric service are not coordinated. This means the building load could increase and overload the generator and this would not be known until the generator is needed and fails.

100kw generator

The generator system has been installed as a standby power generator. This means the generator system cannot be used as a life safety power source for emergency lighting. The building lighting system does not have the required battery backup for the egress lighting but depends on the generator to provide the egress lighting power. This is not code compliant and should be addressed.

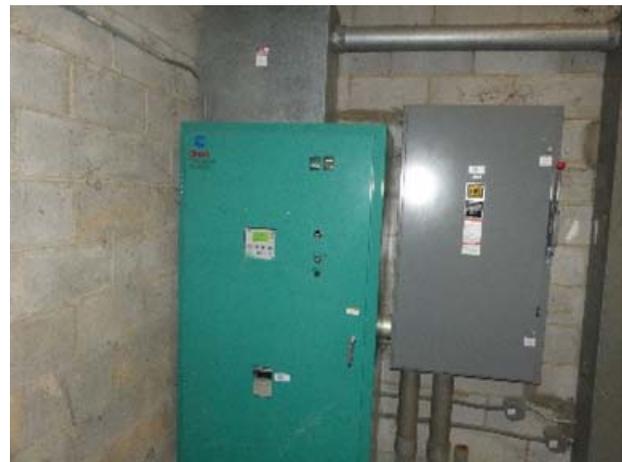
Service disconnect and ATS

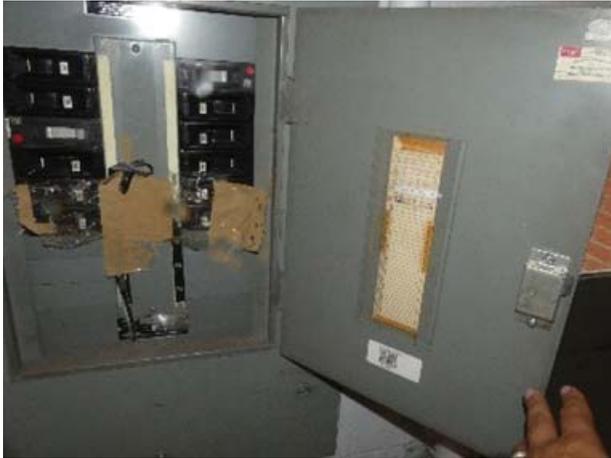
Typical electrical panel

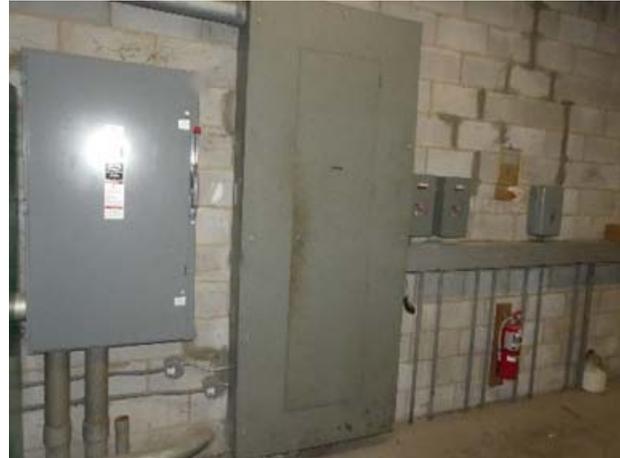
Original service panel board

The original service panel board was left in place to serve as the interior distribution system. This panel board is a Federal Pacific and is no longer in production. It has reached the end of its serviceable life.
